Building Information - Shaker Heights City (44750) - Shaker Heights High School

Program Type	Classroom Facilities Assistance Program (CFAP) - Regular
Setting	Urban
Assessment Name	Shaker Heights HS Assessment - Shaker Heights CSD - CFAP Update (11-2-21)
Assessment Date (on-site; non-EEA)	2015-02-09
Kitchen Type	Full Kitchen
Cost Set:	2016
Building Name	Shaker Heights High School
Building IRN	34108
Building Address	15911 Aldersyde Dr
Building City	Shaker Heights
Building Zipcode	44120
Building Phone	(216) 295-4200
Acreage	17.70
Current Grades:	9-12
Teaching Stations	125
Number of Floors	4
Student Capacity	2012
Current Enrollment	1735
Enrollment Date	2014-04-23
Enrollment Date is the date in which the current enrollment was taken.	
Number of Classrooms	95
Historical Register	NO
Building's Principal	Michael Griffith
Building Type	High

Building Pictures - Shaker Heights City(44750) - Shaker Heights High School (34108)

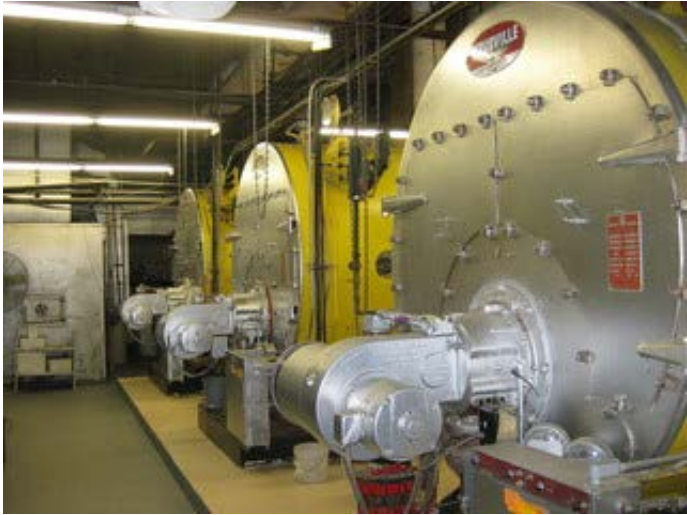
Steam boilers

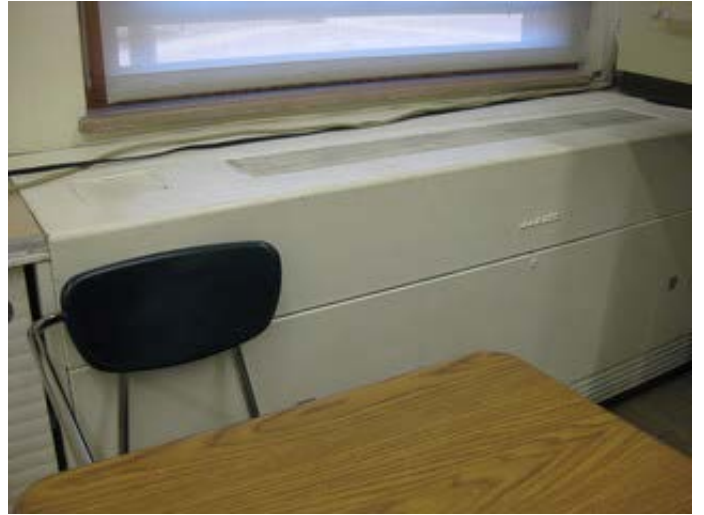
Steam unit ventilator

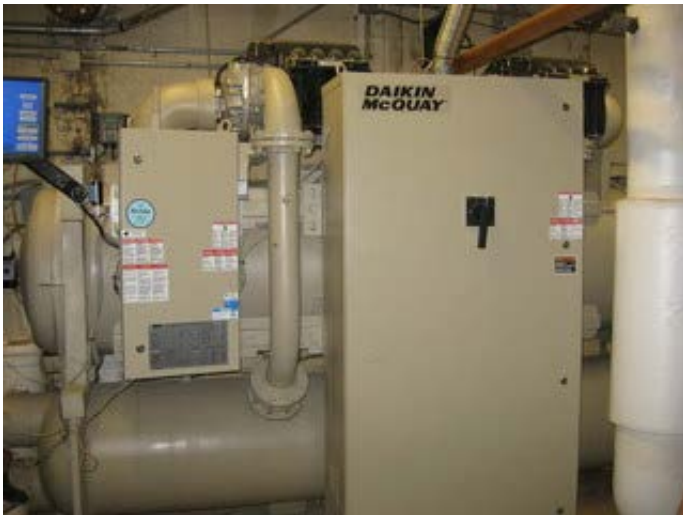
Chiller

Recommendations: Provide an air conditioning system to meet OBC and OSDM requirements. Pricing included in Item A.

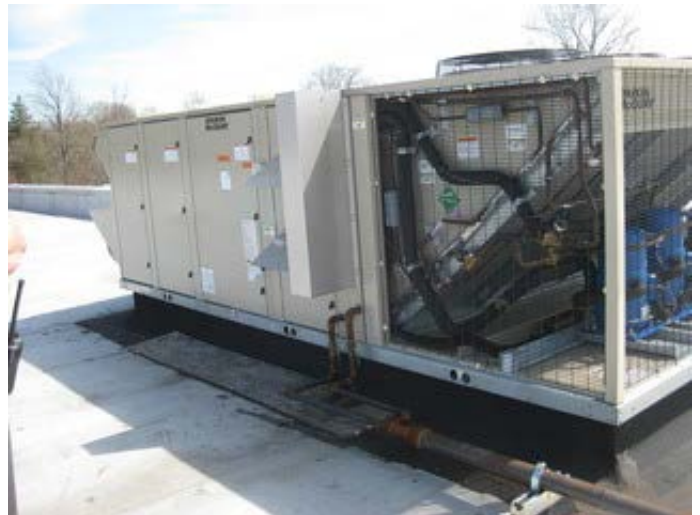
Rooftop unit

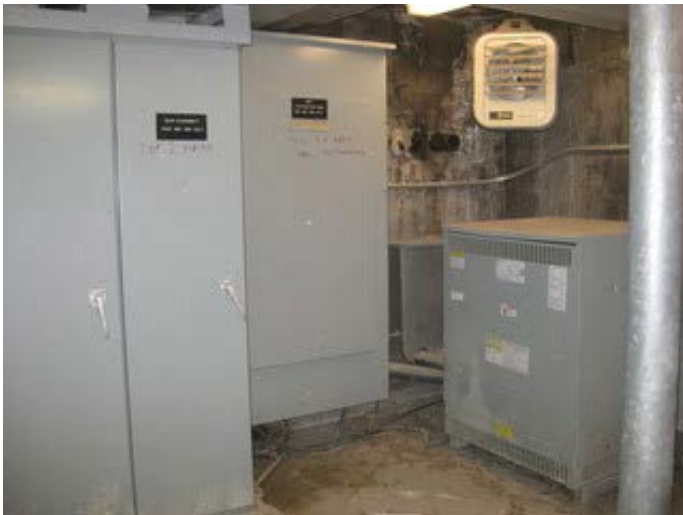
Main Electrical Switch Gear

Recommendations: The electrical system down stream from the main distribution panels requires replacement to meet Ohio School Design Manual guidelines for overall capacity due to poor condition and age for all areas except the 1998 and 2007 addition. This includes panels and wiring.

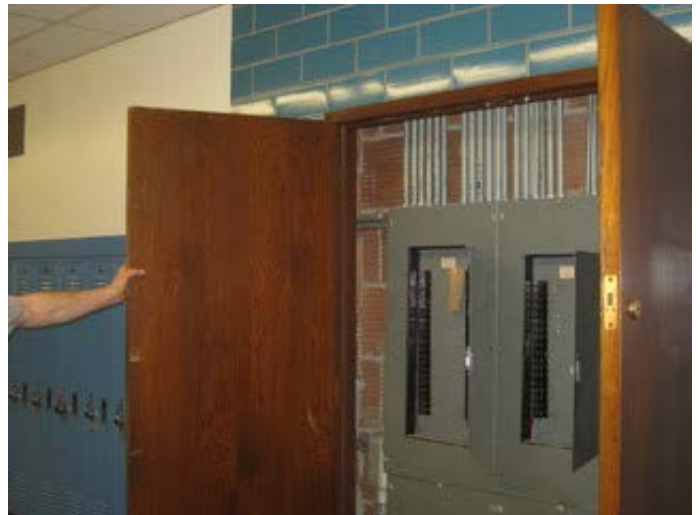
Panel Boards

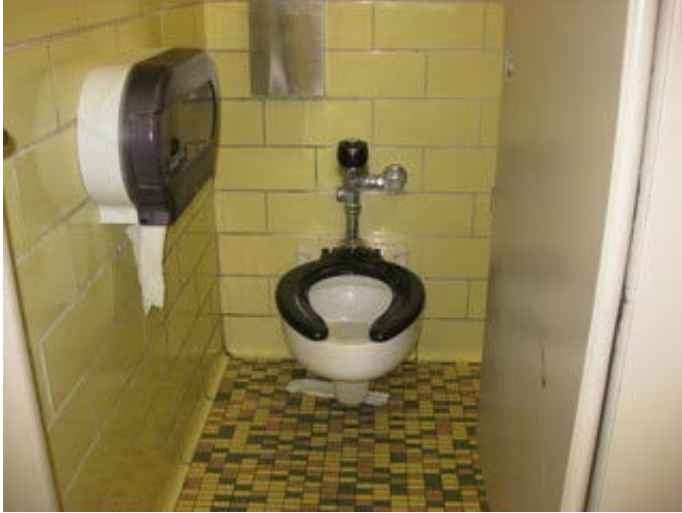
Toilet with sensor faucet

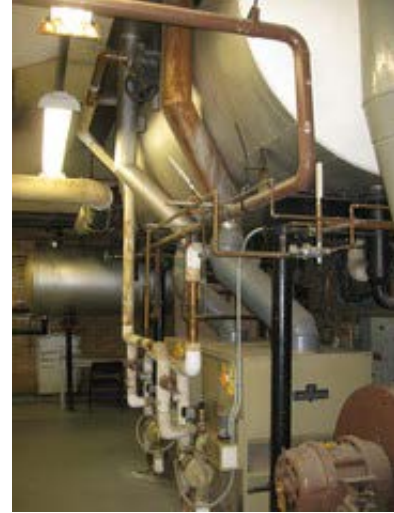
2 Water Heaters and 1 storage tank

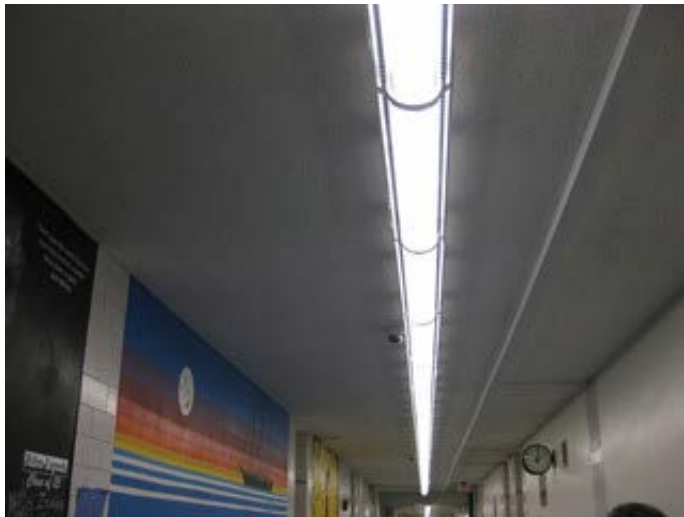
Corridor Lighting

Recommendations: Provide complete replacement of lighting system due to installation of ducted HVAC systems and fire suppression systems.

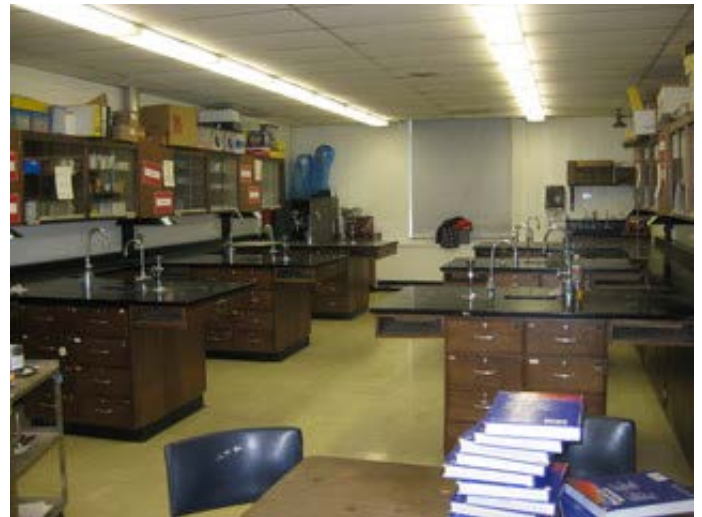
Typical Classroom lighting

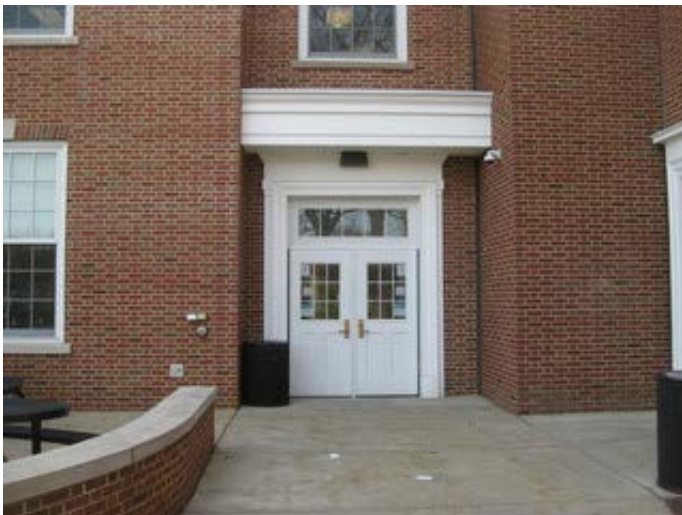
Side entrance door

Recommendations: Provide a partial security system upgrade due to installation of a new HVAC/suppression system. Increase security at the front door and other main access doors to meet OSFC design manual guidelines for the security system. Upgrade site lighting. 01-27-16 UPDATE: PROVIDE FOR COMPLETE REPLACEMENT.

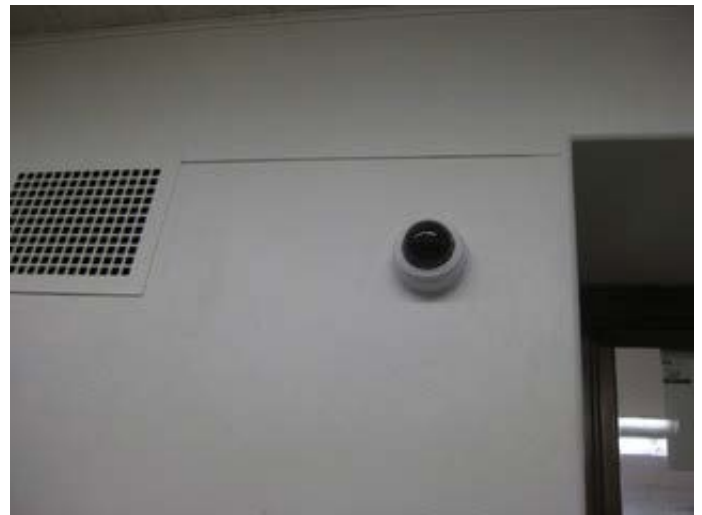
Interior Camera

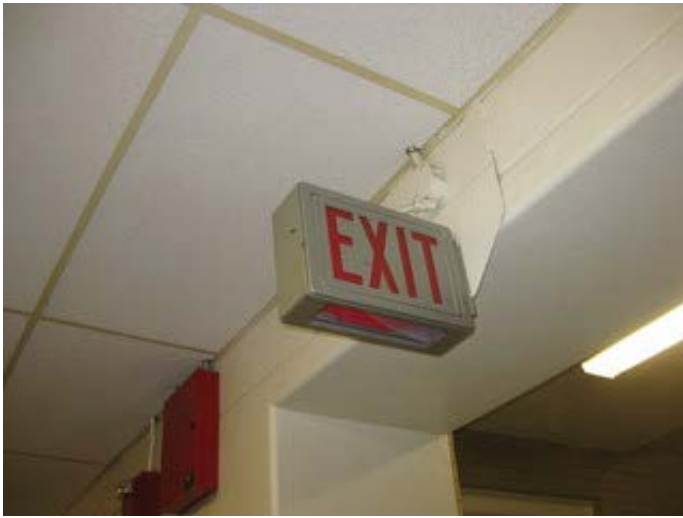
Exit sign

Recommendations: Provide a complete replacement of emergency egress lighting due to installation of systems outlined in J, K, and U.

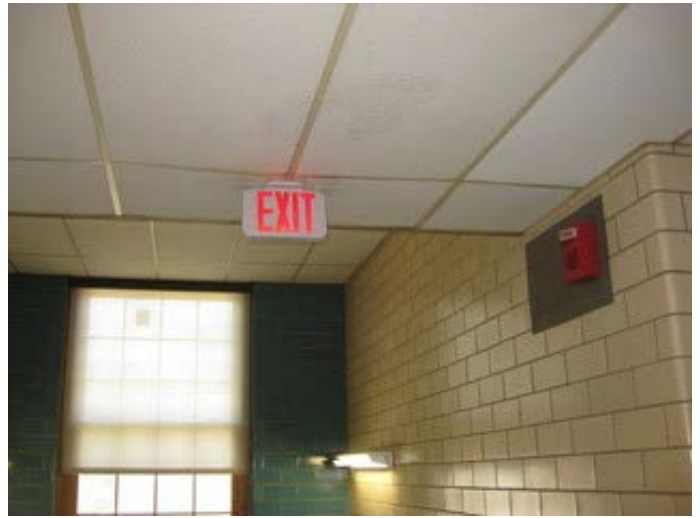
Exit sign

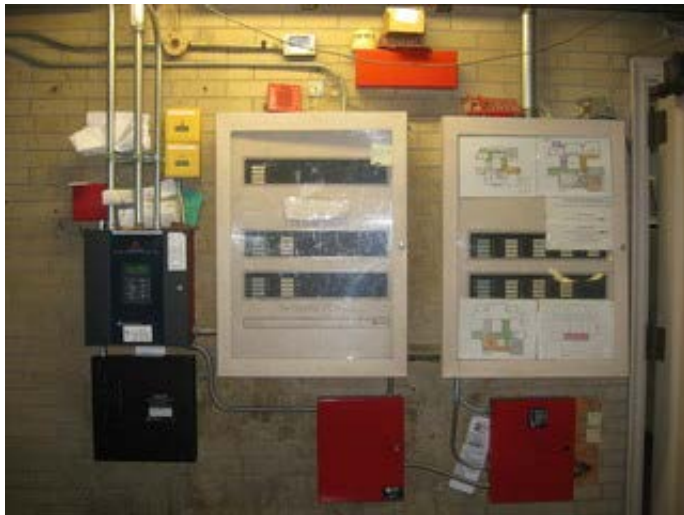
Main Fire Alarm panels

Recommendations: Replacement of the system will be required when the work in C - Upgrading the ventilation and air conditioning. At that time, the devices would be replaced and added to with addressable devices.

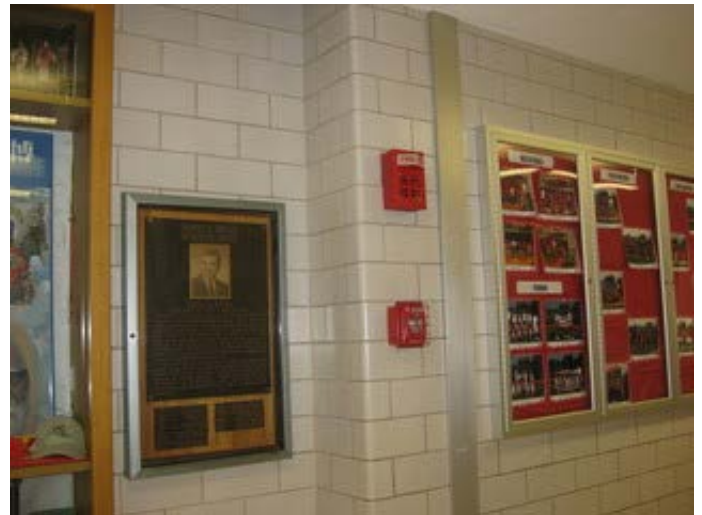
Fire Alarm devices

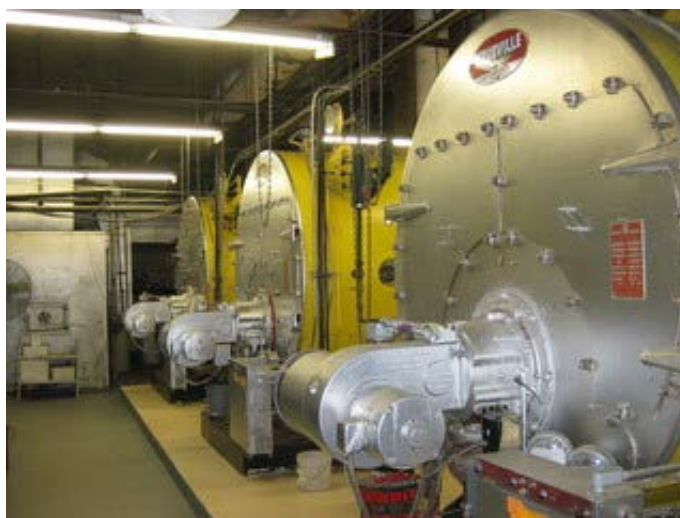
In the basement mechanical area, large vertical shearing cracks were observed on at least one concrete pier. One of the cracks is 1/4" wide and extends vertically several inches. This condition should be evaluated by a structural engineer. Additionally, during a large rainfall, the water backs up into the lower level boiler room through the floor drains.

flooding near boilers at floor drains

Recommendations: Take measures to prevent the water from backing up into the mechanical room during rain events. Utilize site allowance to grade for drainage away from building.

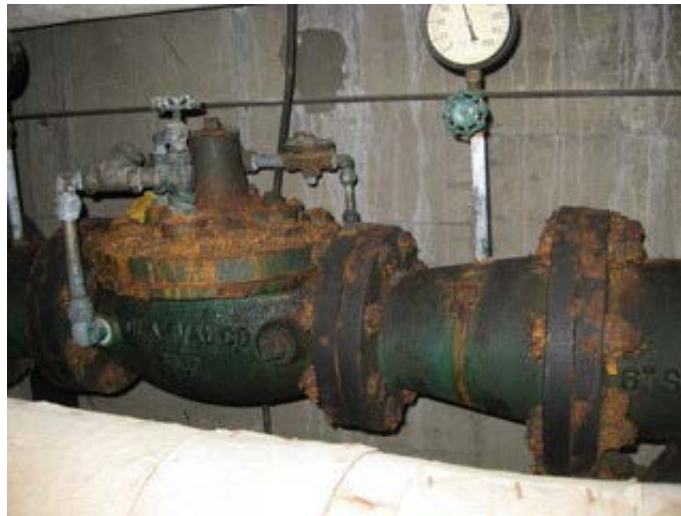
Pressure regulator on 6" water main

Recommendations: Replace water main to meet the sprinkler requirements and install a backflow preventer. 01-27-16 UPDATE: PROVIDE FOR NEW BACKFLOW PREVENTER ON EXISTING DOMESTIC WATER SUPPLY. 11-2-21 Update: Remove scope completed in 2018/19.

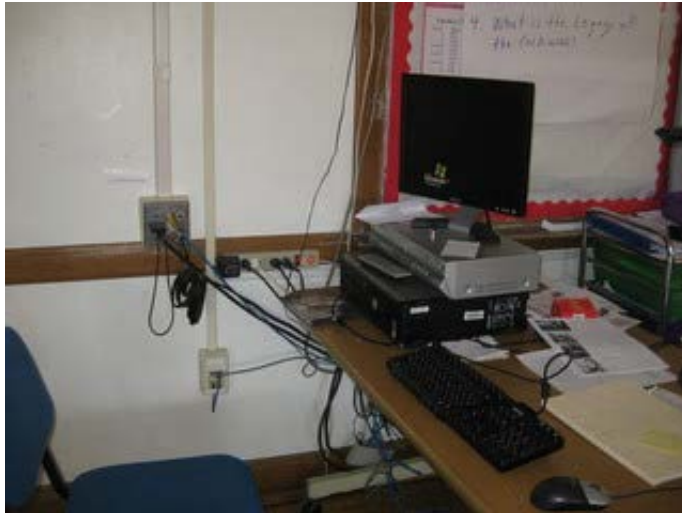
Typical Classroom Technology

Recommendations: The technology systems meet OSDM requirements, however, provide a full replacement of the Technology system due to the new HVAC/fire suppression system.

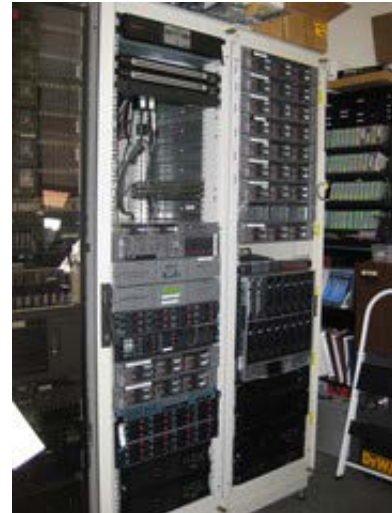
Server Room
