FACILITY ASSESSMENT - LUDLOW BUILDING

SHAKER HEIGHTS PUBLIC SCHOOL DISTRICT

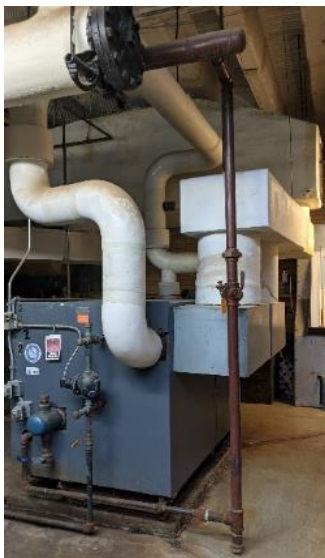
- The building heating system consists of two (2) Weil Mclain Steam Boilers, each 1820 MBH. The age is unknown, but they appear to be in good condition.
- The steam Condensate Vacuum system and pump are visibly in poor condition.
- Temperature controls are pneumatic technology.
- All Classrooms have steam radiators except the Computer Lab, which has a unit ventilator.
- The Student Dining/Auditorium space has steam radiators only.
- The Gymnasium has steam radiators and steam cabinet unit heaters.

Steam Boiler

- Boilers should be upgraded to condensing type, high efficiency type at the time of future replacement.
- Condensate return piping would need to be replaced if converted to a hot water system.
- Temperature controls should be upgraded to Direct Digital Controls (DDC) at time of equipment replacement.
- Provide a ducted HVAC system that provides mechanical ventilation as required by building codes.
- Eliminate steam radiators if not desired as part of future renovations.

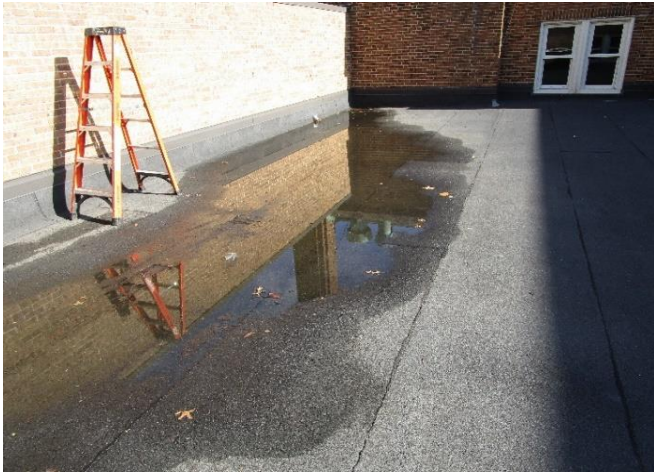
- Slate roof is in fair to good condition with very few damaged slate.
- Copper gutter liners in the stone coping were not accessible for inspection.
- Ponding was observed on Granulated Modified Bitumen Membrane flat roofs.

Ponding on Roof

- Inspect slate roofing and replace broken or missing slates annually as part of regular maintenance.
- Replace all flat roofs, and provide new tapered insulation that slopes to drains.
- Provide overflow drains.
- Replace batt insulation at sloped roofs with R38 insulation.
- Replace wood trim and missing slate at dormers
- Add access ladder from low to high flat roof.
- Replace one Corridor double hung window with an access window.

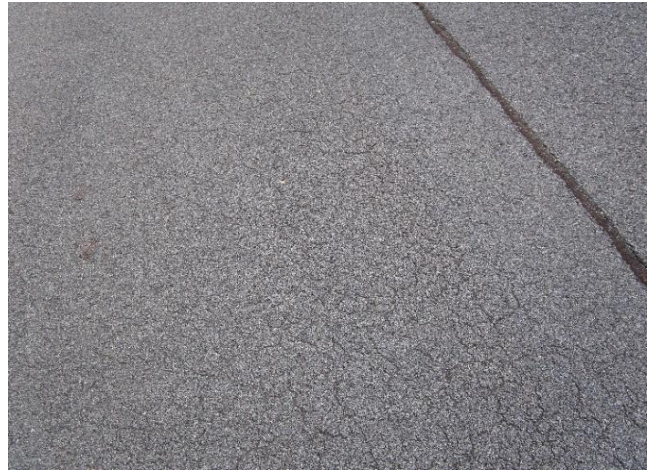
- The built up flat roof is showing signs of age with alligatoring.
- Metal coping is fading and has some rust starting.
- There are no overflow drains on the flat roof.

Alligatored Built Up Roofing

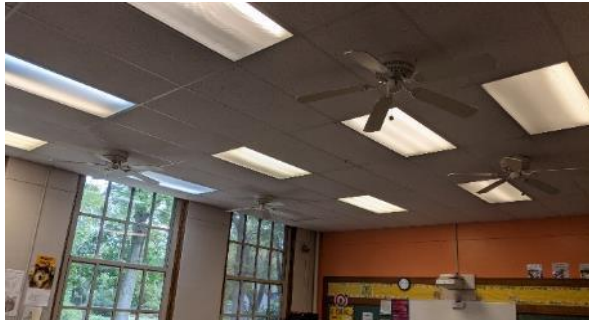
Ceiling Fans

- Install a ducted HVAC system that includes mechanical cooling and hydronic heating.
- Provide ventilation system that introduces the code required amount of air.
- Costs are addressed with Item A.

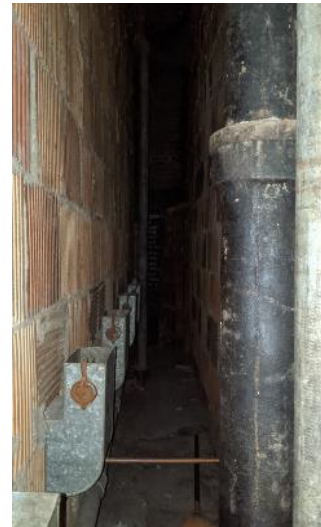
Toilet Exhaust in plumbing chase

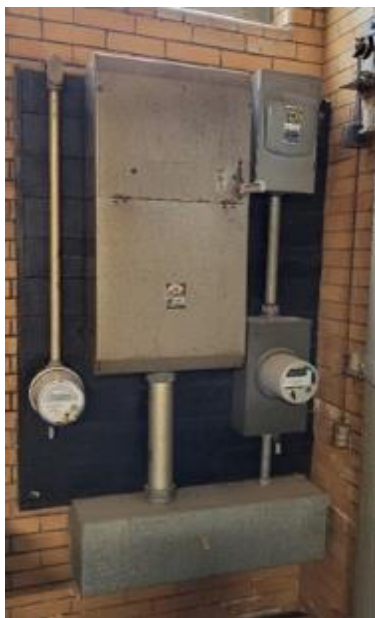
- The building has two main electrical services: 100A, 240V, 3PH, 3W and 400A, 120/240V, 1PH, 3W. The utility transformers are located in the basement vault.
- The power distribution system throughout the building is in poor condition and is past useful life. There is very little spare capacity.
- The building does not have a backup generator.
- Receptacles are lacking throughout the building.
- The overall electrical system does not meet OSDM requirements in supporting the current needs of the school, and will be inadequate to meet the facility's future needs.
- The lightning protection cables at ground level have been cut off leaving the building unprotected against lightning strikes.

Main Electrical Disconnect

- Provide replacement of entire electrical system. Remove transformers in vault and provide a pad-mounted utility transformer for a single service. Provide backup generator for critical loads.
- Replace all branch circuit wiring and devices.
- Provide surge protection.
- Repair lightning protection cables and inspect entire system.

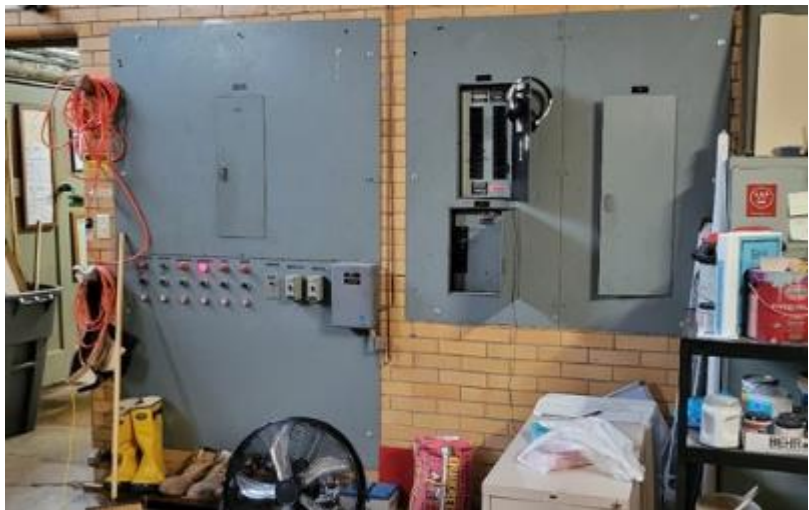
Main Distribution Panels

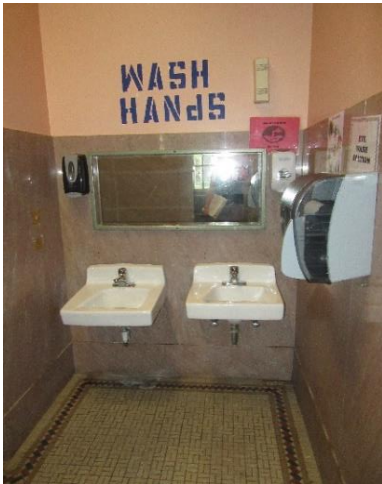
Typical Restroom Lavatory

- Replace plumbing fixtures at time of renovation and replace with low flow fixtures and sensor operated flush valves and faucets.
- Provide ADA-compliant lavatory-mounted drinking fountains.
- Renovate the Large Group Restrooms to provide ADA-compliant fixtures.
- Convert single-user restrooms into ADA-compliant Restrooms.
- Replace existing domestic hot water storage tank with a smaller tank sized for building loads.
- Domestic Water Heater should have a Master Mixing Valve installed to prevent bio growth.
- Cost for ADA compliance in Item O.

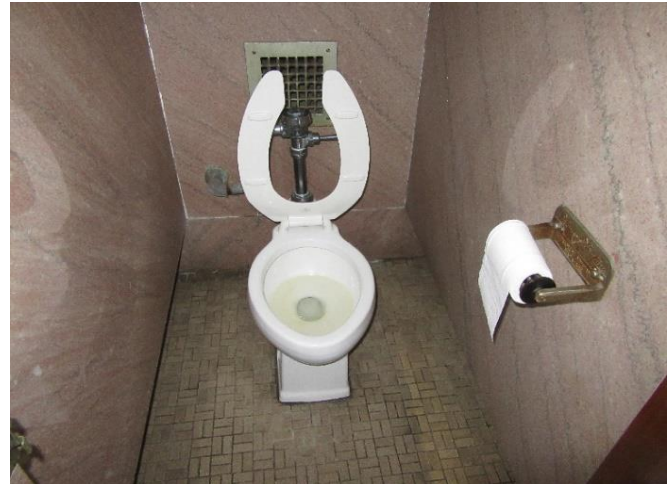
Typical Restroom Stall

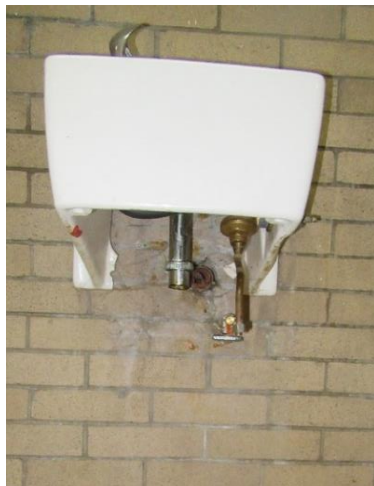
- The facility is equipped with (4) non-ADA partially recessed drinking fountains, in poor condition.
- The building does not meet the OBC requirements for fixtures. Relative to sustainability considerations, the building is not equipped with low flow type fixtures. Per OBC requirements this facility should be equipped with (22) toilets, (6) urinals, (23) lavatories, and (11) electric water coolers. Observations revealed that the building is currently equipped with (30) toilets, (9) urinals, (14) lavatories, and (0) electric water coolers. ADA requirements are not met for fixtures and drinking fountains (see item O).

Non-Functional Drinking Fountain

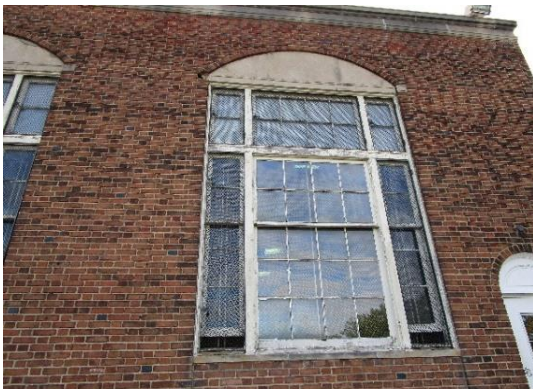
- Existing windows are thermally broken aluminum windows in fair condition.
- Gymnasium windows are single-pane wood in poor condition.
- Two (2) small, narrow windows on the easternmost end of the south facade are in poor condition.
- There are no limiters on the operable windows.
- 40 windows have missing insect screens.
- Roller shades are in fair to poor condition.
- Entry doors have insulated glazing and are in good condition.
- Glass block windows at the Boiler Room are in good condition.

Gymnasium Windows

- Replace Gymnasium Windows
- Replace two (2) windows on SW façade.
- Replace damaged and missing insect screens.
- Add Opening Limiters to existing windows

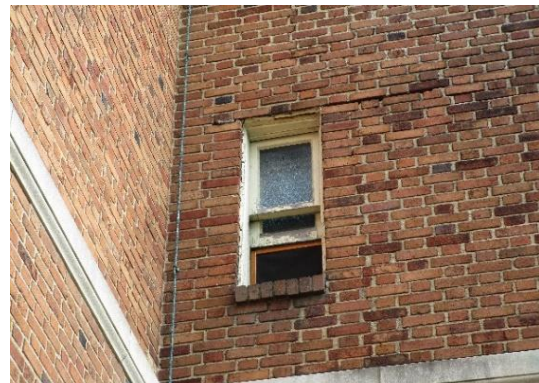
Southside Windows

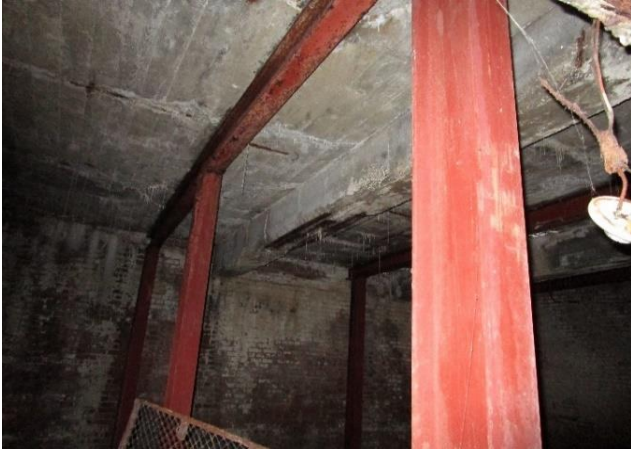
- The overall facility is equipped with brick and glazed brick foundation walls on spread footings, which displayed deficiencies throughout, including settlement, cracking, and leaking, and are in mostly good to fair condition.
- The Coal Room is no longer in use, and has significant structural deficiencies and water damage. Temporary structural steel bracing has been added to supporting the concrete deck, but it was never painted and is starting to rust.
- The District reports that there has been past leaking in the basement, which is evident in the large areas of interior efflorescence.
- The crawlspace floors are dirt throughout.
- No grading or site drainage deficiencies were noted around the perimeter of the structure that are contributing or could contribute to foundation structural deterioration.

Concrete Deck in Coal Room

- Provide foundation waterproofing system around the building perimeter.
- Provide drainage tile system around the basement perimeter.
- Clean basement walls and paint or seal.
- Install vapor barrier and mud slab throughout all crawlspaces.
- Remove Coal Room entirely. Include repairs to existing concrete columns and beams that support the window well above, excavation and resetting the masonry window well wall and infilling louvered openings, replacement of concrete slab and floor drains system in the window well, remove coal room doors and infill openings with cmu, clean and waterproof walls and the elevated concrete slab next to the boiler room, replacement of asphalt, replacement of railings.

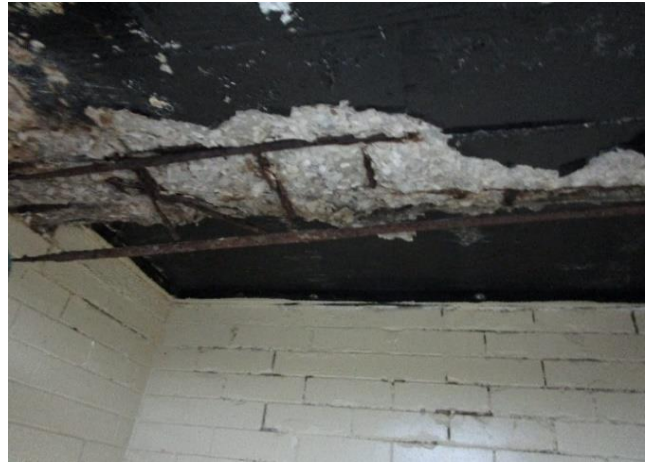
Concrete Deck in Boiler Room Restroom

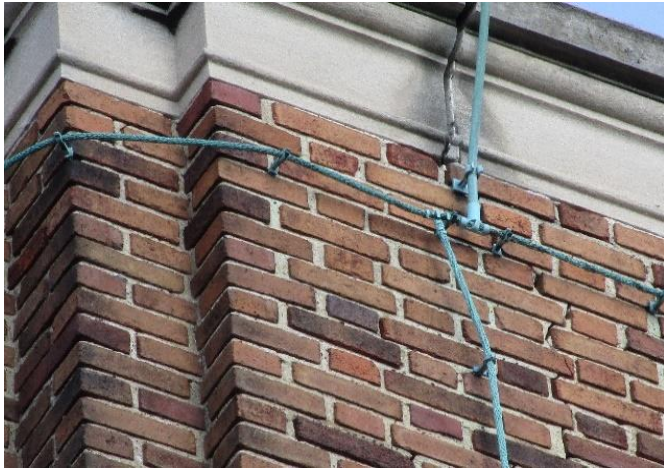
- The chimney on the south end of the building appears to be in fair condition, but should be removed if it is longer in use.
- The chimney from the Boiler Room has a 16 foot long by 1/2 inch wide crack running down the south side. It starts at the stone coping at the top of chimney next to the lightning rod. The black marks on the stone coping indicate a lightning strike.

Lightning Strike Damage to Chimney

- Provide tuckpointing in all areas of mortar deterioration as required throughout the overall facility.
- Remove and replace displaced brick above bay windows.
- Provide masonry cleaning and sealing as required throughout the overall facility.
- Sawcut and caulk new appropriately spaced control joints in existing masonry throughout the facility.
- Remove and replace brick veneer at the SE corner of the building and at the NW Gymnasium wall.
- Replace steel lintels throughout the facility.
- Repair or replace broken or missing stone accents throughout the overall facility.
- Repoint stone window sills throughout the overall facility.
- Repair Boiler Room chimney. Remove chimney if new HVAC system will not require it.
- Exterior wall insulation deficiencies are addressed in Item J.

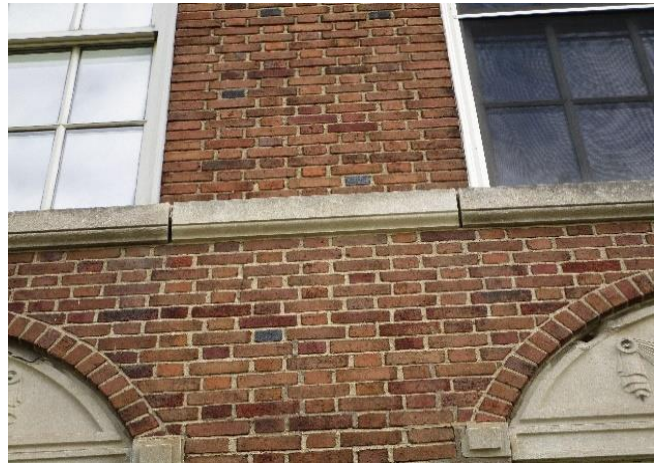
- Exterior walls in the overall facility are inadequately insulated. Brick veneer masonry walls are not cavity walls.
- The exterior masonry has not been cleaned and sealed in recent years, shows evidence of mortar deterioration throughout, and has locations of efflorescence and mold.

- Architectural exterior accent material consists of stone, which is in mostly fair condition with some pieces in poor condition.
- Interior corridor and demising walls are glazed brick and brick with plaster, project full height from floor to bottom of deck, and are in poor condition.

Damaged Stone and Missing Grout

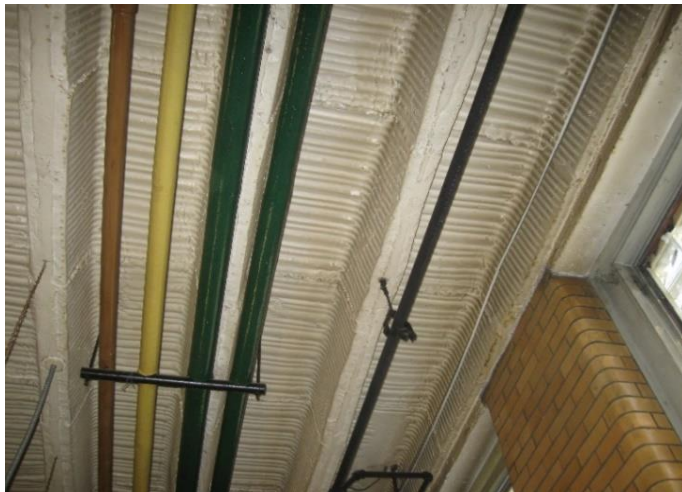
- The basement floor construction is slab-on-grade concrete type construction, and is in fair condition.
- The floor construction of the ground floor, second floor and roof deck of the overall facility is cast-in-place concrete type construction, and is in fair condition.
- Crawl space is located under much of the facility.
- Ceiling to structural deck spaces are insufficient to accommodate HVAC, electrical, and plumbing scopes of work in required renovation.
- The roof construction of the sloped roof portions of the building is wood deck on wood joist type construction, and is in fair condition.

Typical Concrete Floor Structure

- Provide fire separation assembly for wood roof structure in the sloped roof portions of the building.
- Refer to Item U for pricing of fire separation system for wood structures.
- Refer to Item A for funding of architectural soffits to accommodate HVAC, electrical, and plumbing scopes of work.

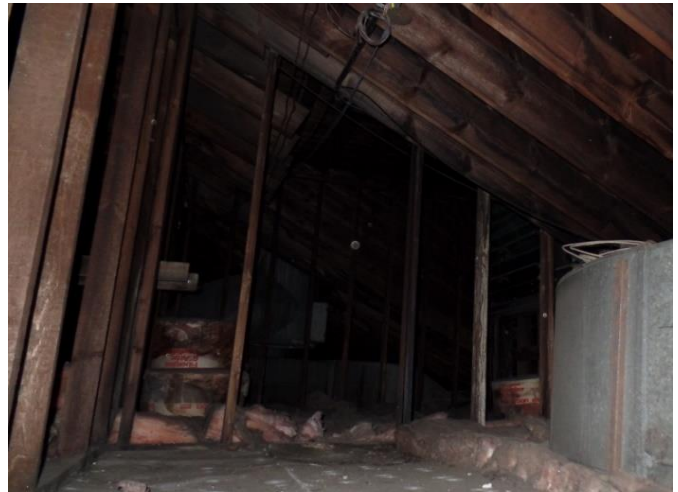
Typical Wood Structure at Sloped Roofs

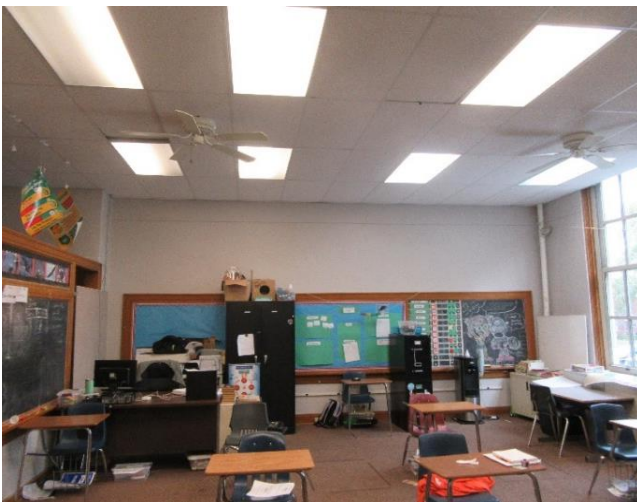
- The overall facility consists of conventionally partitioned Classrooms with broadloom carpet or wood type flooring, 2x4 acoustical type ceilings, and plaster type wall finishes in poor condition.

Typical Classroom Finishes

- Provide complete replacement of finishes and casework due to poor condition and advanced age as well as obsolete material use.
- Funding for replacement of interior doors is provided in Item O, including doors here noted as being in poor condition.
- Provide for a complete Warming Kitchen replacement due to observed conditions.
- Provide additional wall insulation as noted in Item H.

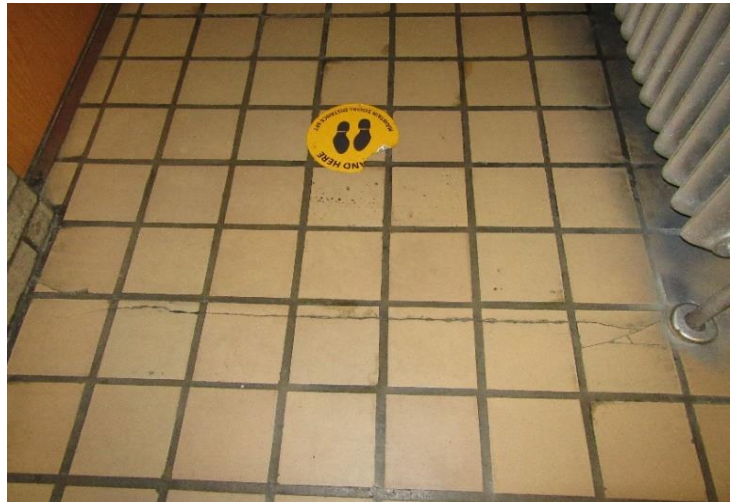
- The overall facility has Corridors with quarry tile type flooring, spline type ceilings, and a combination brick and plaster type wall finishes, and they are in poor condition.

Typical Corridor Flooring

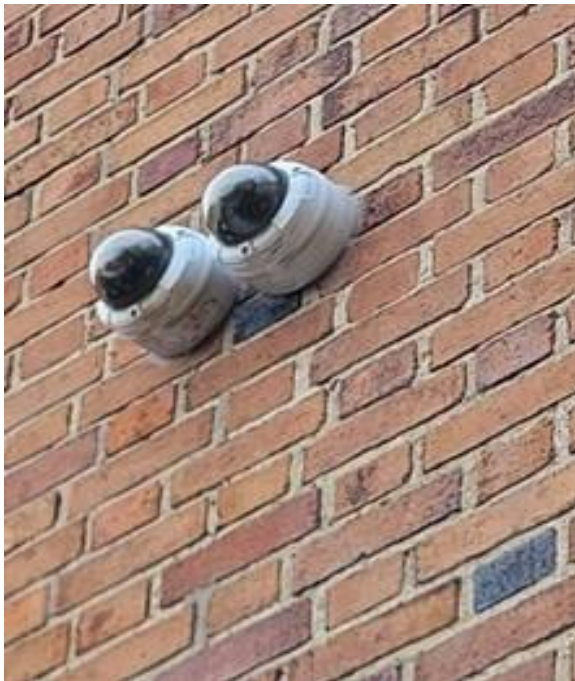
Security Cameras

- Provide new site lighting for walkways, entrances, and parking per current OSDM standards.
- Provide additional cameras inside the building to conform to OSDM standards.

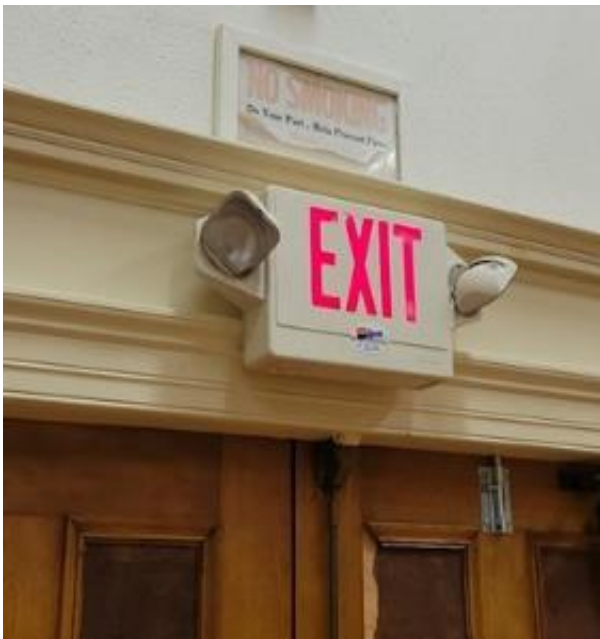
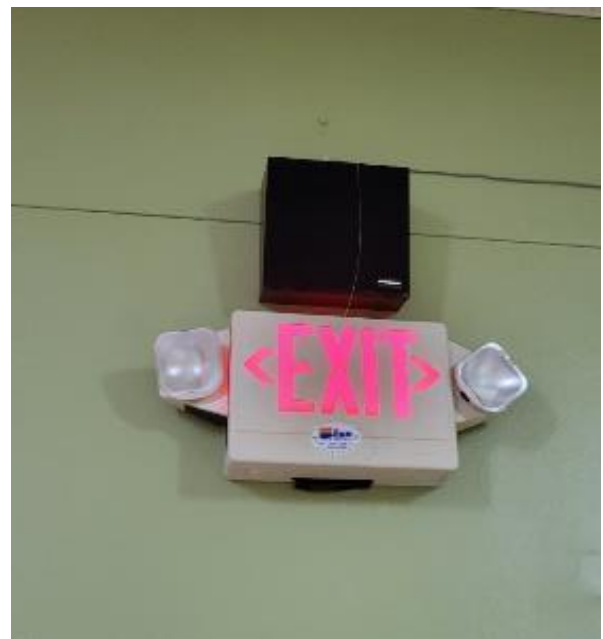
- The facility contains plastic exit signs and emergency lights with internal battery packs. The fixtures are in poor condition and do not provide adequate coverage.
- There is no exterior egress lighting at exit doors.
- The system does not adequately meet the current OSDM standards.

Exit Sign

- Provide new exit signs and emergency lighting.
- Provide emergency egress lighting at exterior doors.

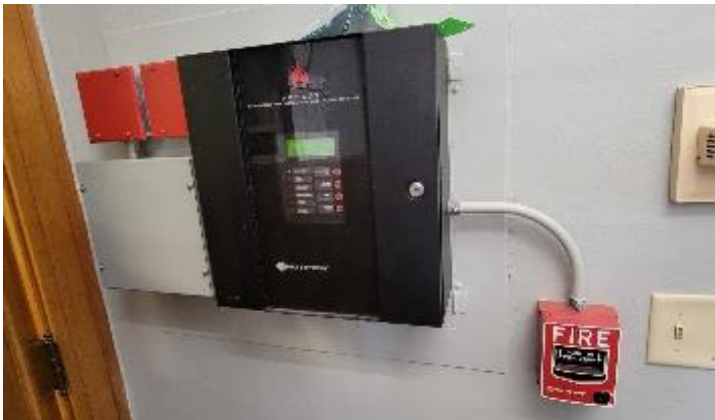
- The building is provided with a Notifier AFP-200 fire alarm control panel that is in poor condition. The system consists of manual pull stations, smoke detectors, and horn/strobe notification devices throughout the building.
- The system appears to be a hard-wired non addressable type system with no capacity for future expansion.
- The system does not provide proper notification coverage for the entire building.
- The system is not compliant with NFPA and OSDM requirements.

Fire Alarm Control Panel

- Provide replacement of entire system with addressable type system.

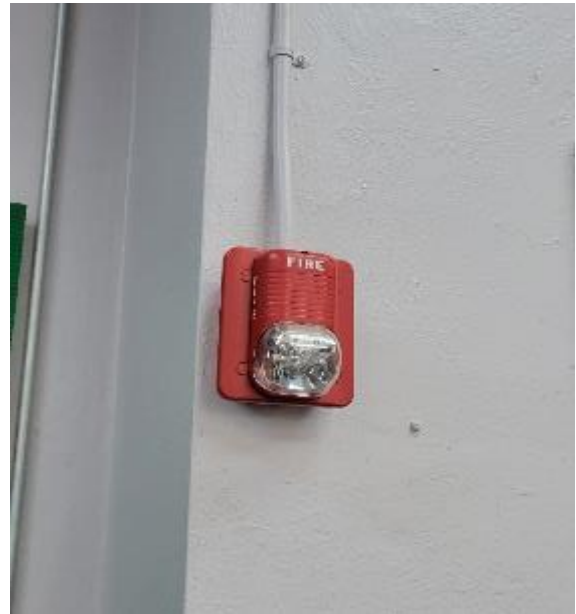
Typical Notification Device

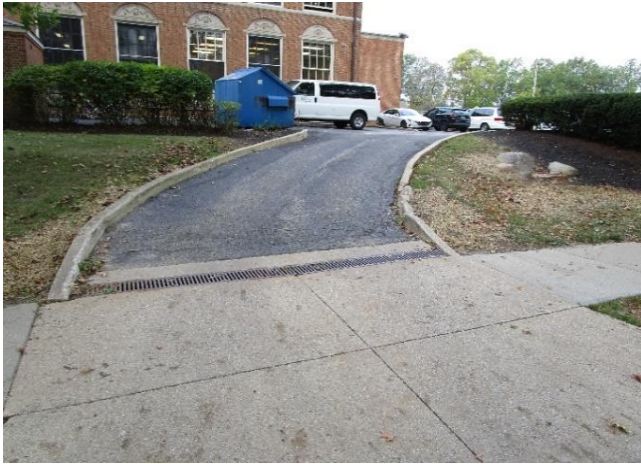
- Concrete curbs are appropriately placed, and in fair to poor condition. Concrete sidewalks are properly sloped and located to provide a logical flow of pedestrian traffic, and are in good condition. Trash pick up service drive is heavy duty and in fair to poor condition, and is not equipped with a concrete pad area for dumpsters.

Broken Concrete Curbs

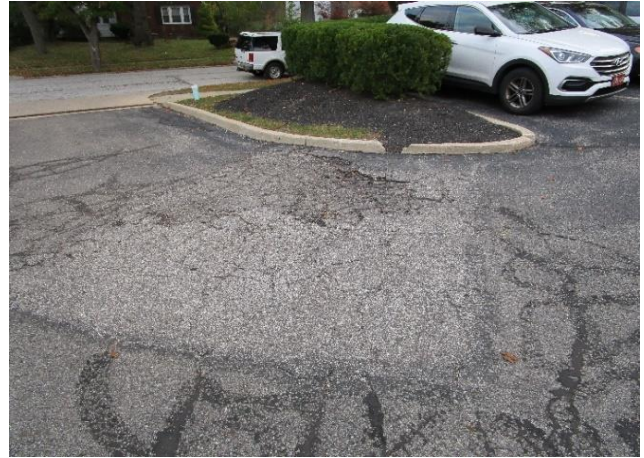
- The site is bordered by lightly traveled city streets. There are two entrances to the parking lot.
- Staff and visitor parking is facilitated by an asphalt parking lot in fair condition containing 34 parking spaces, which does not provide adequate parking for staff members, visitors and the disabled. The site and parking lot drainage design consists of sheet drainage, catch basins and storm sewers, provides adequate evacuation of storm water, and no problems with parking lot drainage were observed.

Asphalt Pavement

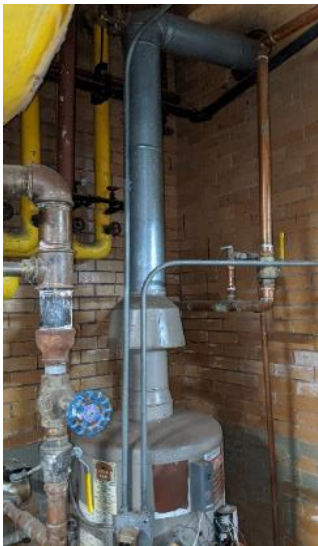
- The buildings domestic water heater is a gas fired AO smith 120 MBH input, 109 GPH recover. Heater is in good condition (Installed in 2009). The storage tank is functional but appears to be aged.

Domestic Hot Water Heater

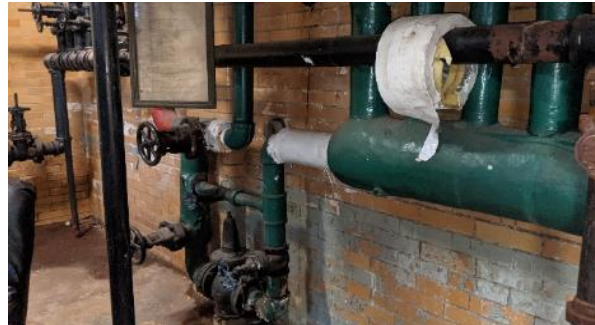
Galvanized Pipe Water Entry

- Install a reduced pressure backflow preventer.
- Install copper piping throughout the building for domestic hot and cold water.

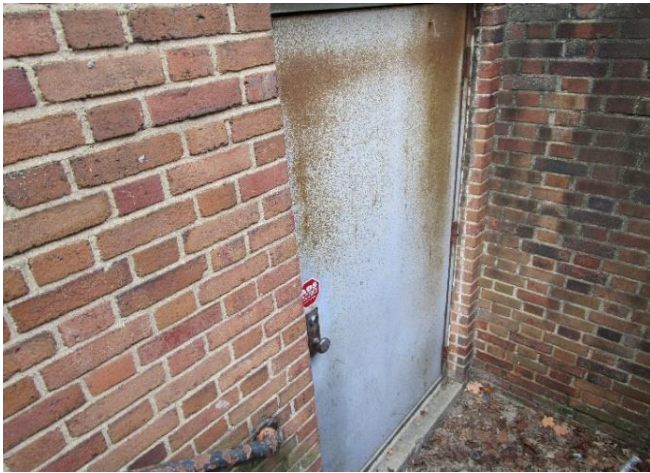
Exterior Door to Boiler Room

- Replace hollow metal doors to basement Mechanical Room and Gymnasium doors.
- Automatic door operator is in item O.

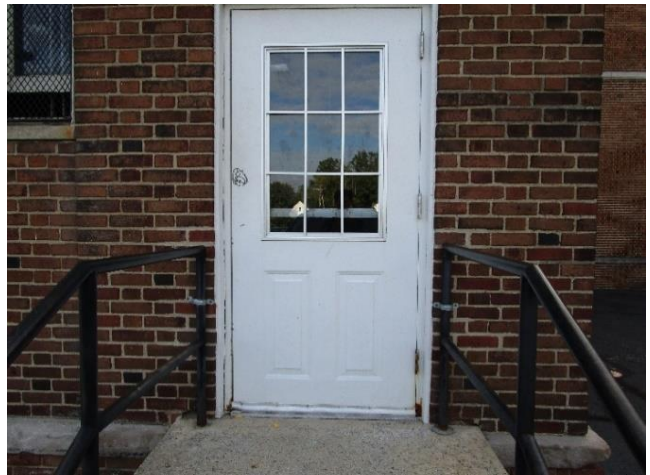
Exterior Door to Gymnasium

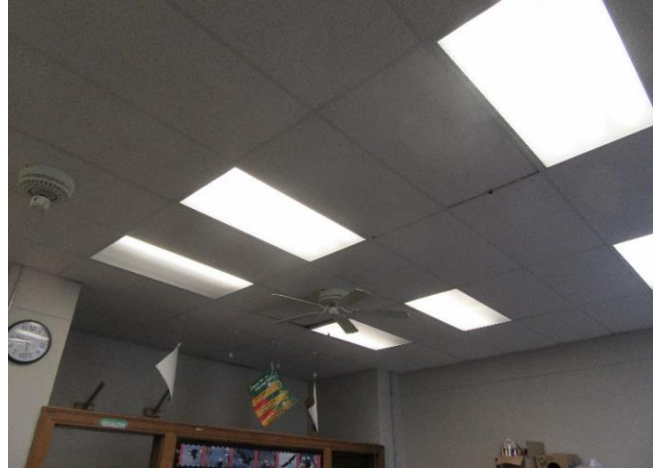
Fluorescent Lighting

- Provide for disposal of fluorescent lighting.

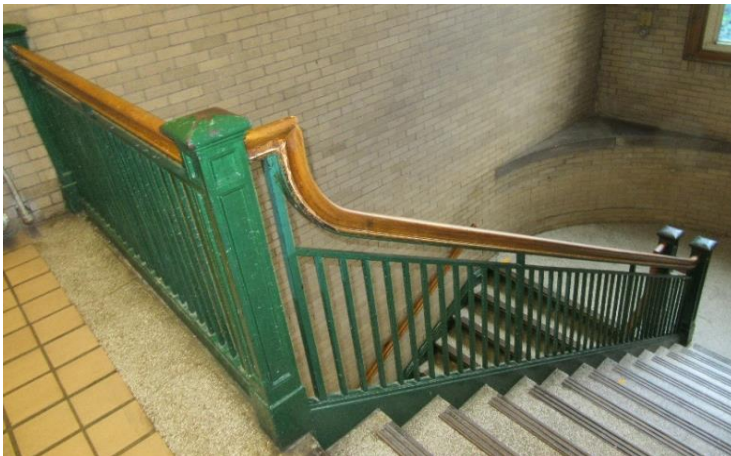
Typical Staircase Handrails

- Provide new handrails to meet the requirements of the Ohio Building Code.
- Provide fire-rated enclosure around existing stair towers.
- Provide allowance for new fire extinguishers.
- Provide emergency generator as part of the complete replacement of the electrical system.

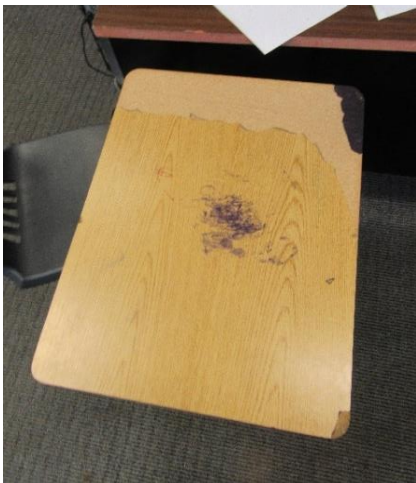
Damaged Furniture

- Provide for replacement of outdated or inadequate furnishings.

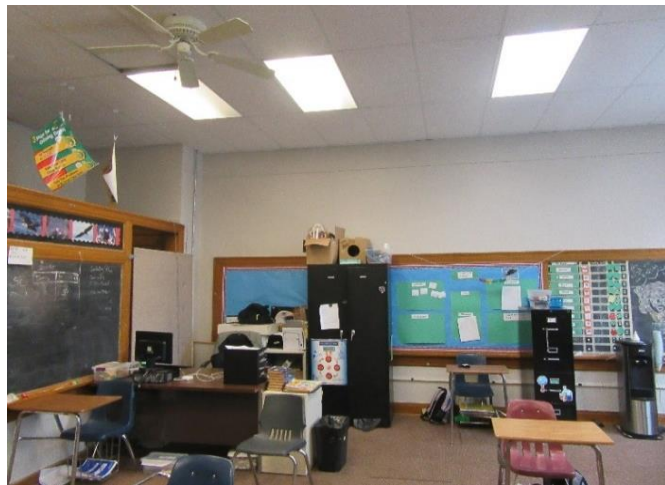
Mismatched Furniture
