Building Information - Shaker Heights City (44750) - Boulevard Elem

Program Type	Classroom Facilities Assistance Program (CFAP) - Regular
Setting	Urban
Assessment Name	Boulevard ES Assessment - Shaker Heights CSD - CFAP Update (11-2-21)
Assessment Date (on-site; non-EEA)	2015-02-17
Kitchen Type	Full Kitchen
Cost Set:	2016
Building Name	Boulevard Elem
Building IRN	3244
Building Address	14900 Drexmore Rd
Building City	Shaker Heights
Building Zipcode	44120
Building Phone	(216) 295-4020
Acreage	5.10
Current Grades:	K-4
Teaching Stations	27
Number of Floors	3
Student Capacity	407
Current Enrollment	355
Enrollment Date	2014-04-30
Enrollment Date is the date in which the current enrollment was taken.	
Number of Classrooms	19
Historical Register	NO
Building's Principal	Coleen Longo
Building Type	Elementary

Building Pictures - Shaker Heights City(44750) - Boulevard Elem(3244)

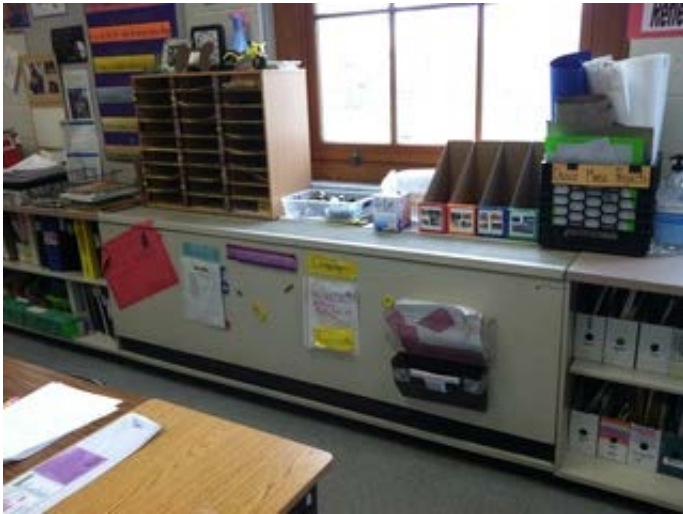
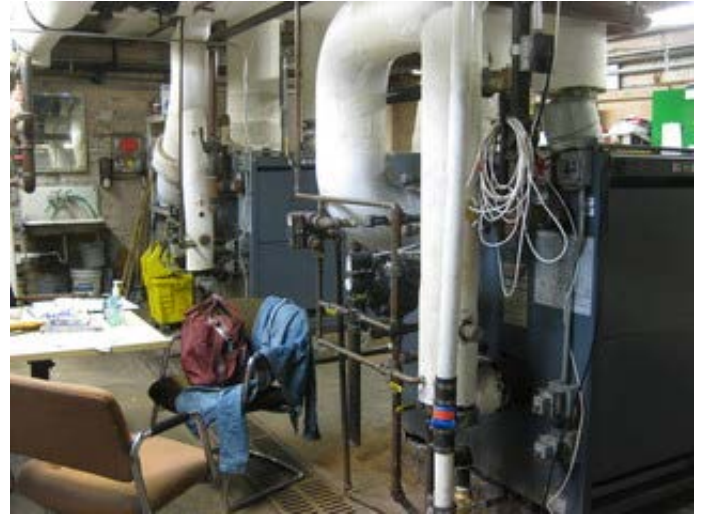
Description: The existing system for the building consists of two Weil-McLain steam boilers at 1690 MBH each installed about ±10 years ago (±2004). The boilers appear to be in satisfactory condition. The older part of the building is heated with steam by steam radiators. The newer section of the building is heated with heating water from a steam to hot water heat exchanger. There are two heating water building pumps that serve the unit ventilators. One pump was replaced last year, 2013 and the other pump is starting to show some corrosion due to age. The whole building ventilation fan is no longer functional. The fan room is used as a storage area. The gym is heated with steam unit ventilators and steam radiators. The office air handling unit (1989) has electronic control valves and is controlled along with the boilers by the DDC controls. The rest of the controls are pneumatic and in fair to poor condition due to the equipment age. Generally, all the equipment has been well maintained. Each ventilator has an outside air grilled at the exterior wall. The age of the unit ventilator is unknown, however, the equipment in the building does not provide the required outside air delivery to meet OBC mechanical code. The DDC controls were added two years ago under an energy performance contract. The staff indicates they turn off the boilers on mild temperature days to avoid over heating the school, but generally they try to leave the controls enabled. The steam or two-pipe system does not provide a capacity for simultaneous heating and cooling operation which is not compliant with the OSDM requirements. The staff indicated that the site does not contain underground fuel tanks.

Rating: 3 Needs Replacement

Recommendations: Provide a new overall heating ventilating and air conditioning system to achieve compliance with OBC and OSDM standards. Convert to ducted system to facilitate efficient exchange of conditioned air. Provide new DDC temperature controls with the new system. The new ducted system will likely require architectural soffits to accommodate the installation of the ductwork.

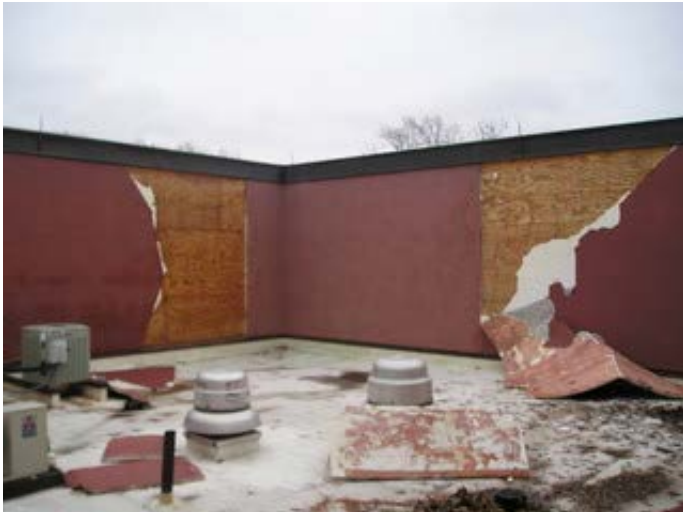
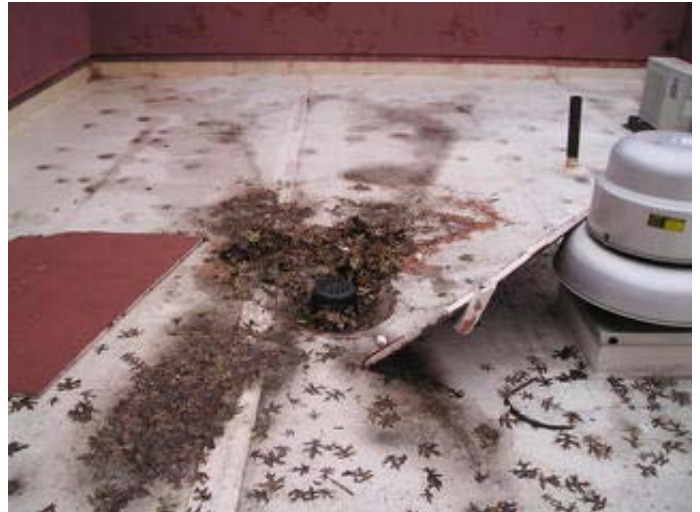
Description: Pitched roofs around the building's perimeter are covered with slate shingles. Box gutters with downspouts are present at the roof overhangs. The interior face of the pitched roof is vertical and clad with EIFS over plywood. The plywood is saturated with water in several areas, thus causing the EIFS adhesive to completely delaminate, resulting in a failure of this cladding. Built-up roofing is used over the low-slope areas. The built-up roof has passed its expected service life. A white reflective coating has been added to the top of this roofing system. Roof drains are provided in the low-sloped areas.

Rating: 3 Needs Replacement

Recommendations: At vertical surfaces around the interior low-slope roof, replace existing plywood and EIFS sheathing with new pressure treated plywood and membrane. Provide a new built-up roof as well as overflow drains. 01-10-16 Update: PROVIDE FOR ROOF REPLACEMENT ON 1925 W & E CLASSROOM WINGS. REPLACE GUTTERS ON ORIGINAL 1914 BUILDING, 1925 ADDITION AND 1991 ADDITION. REPLACE DORMER LOUVERS ON 1914 ORIGINAL BUILDING. PROVIDE FOR REPLACEMENT OF LOW SLOPE ROOF AREAS ON 1914 ORIGINAL BUILDING AND 1991 ADDITION. 01-27-16 UPDATE: REPLACE SLATE ROOF WITH ASPHALT ROOFING TO INCLUDE COPING AND FLASHING ON 1914 ORIGINAL BUILDING, 1925 ADDITION AND 1991 ADDITION. REPLACE DORMER LOUVERS ON 1914 ORIGINAL BUILDING. REPLACE GUTTERS AND DOWNSPOUTS ON 1914 ORIGINAL BUILDING, 1925 ADDITION AND 1991 ADDITION. REPLACE ROOF DRAINS AND STORM LEADERS ON LOW SLOPE ROOF AREAS ON 1914 ORIGINAL BUILDING, 1925 ADDITION AND 1991 ADDITION.

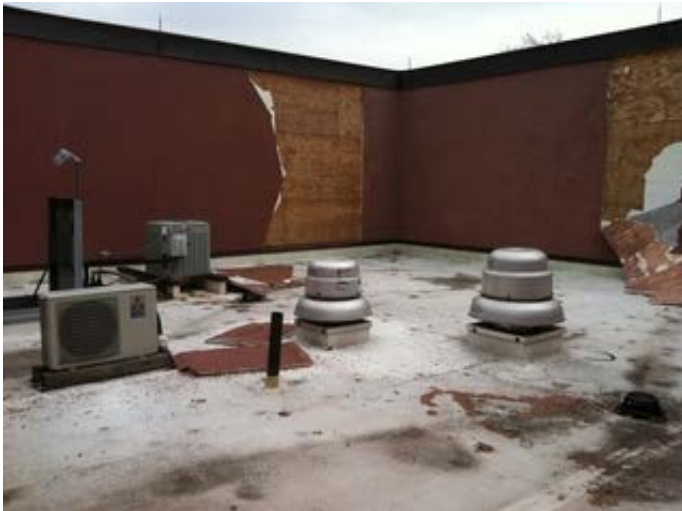
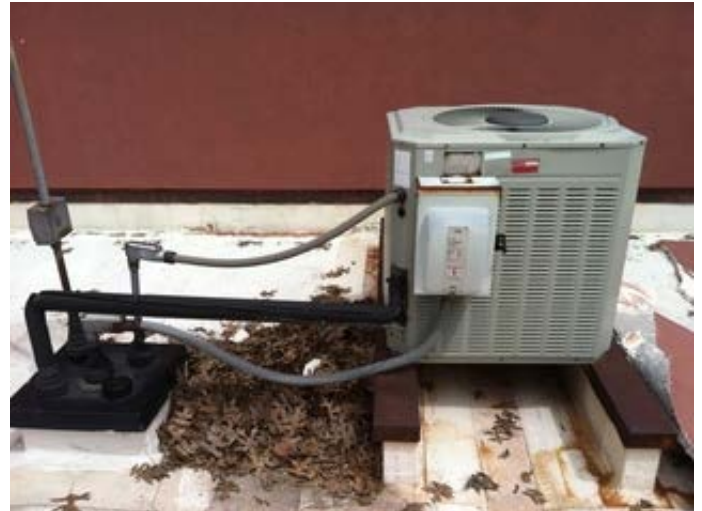
C. Ventilation / Air Conditioning

Description: There is no central air conditioning for this building. The office is served by 1989 Air Handling units with hot water heat and Dx cooling. There are a few window air conditioning units for offices. The overall system is not compliant with Ohio School Design Manual requirements. The general building exhaust systems located in the restrooms are functional and in satisfactory condition.

Recommendations: Provide an air conditioning system to meet OBC and OSDM requirements. Pricing included in Item A.

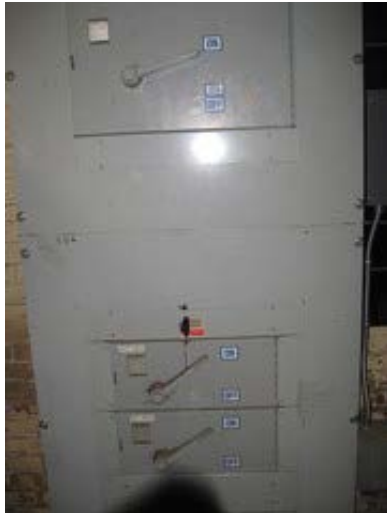
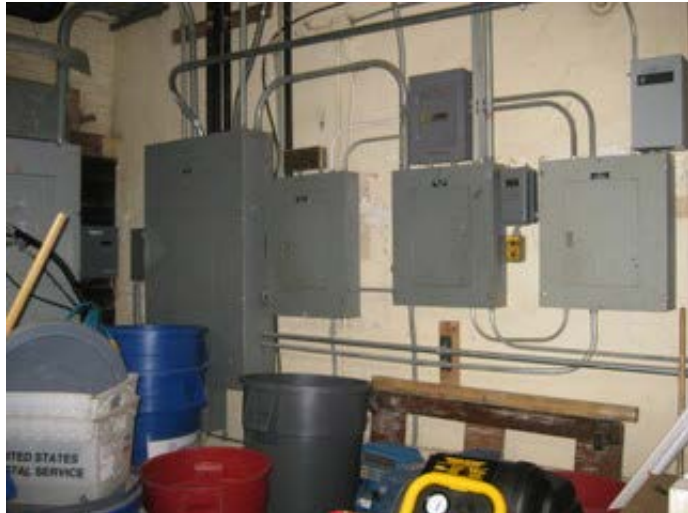
Description: The main power enters the building underground to a locked transformer vault. The transformers are owned by the utility. The service described is leaving the transformer vault to serve the building. The electrical system in the overall facility has two power feeds; one 3 phase and one single phase. The 3 phase electrical gear is 240V, 3 phase, 3 wire, 400 amp gear. The single phase gear is 240V, 1 phase, 400 amp. Each power feed has a DDC power recording device to track the power used. The electrical gear appears to be as least 15 years old in good condition. The panels boards appear to be older in fair to poor condition with no extra capacity on the main panel. Additional outlets have been added to the classrooms, but the classrooms are still not equipped with adequate electrical outlets. Adequate GFI protected exterior outlets are not provided around the perimeter of the building. There is no lightning protection. The overall electrical system does not meet OSDM requirements in supporting the current needs of the school and will be inadequate to meet the facility's future needs.

Rating: 3 Needs Replacement

Recommendations: The entire electrical system requires replacement to meet Ohio School Design Manual guidelines for overall capacity due to poor condition and age.

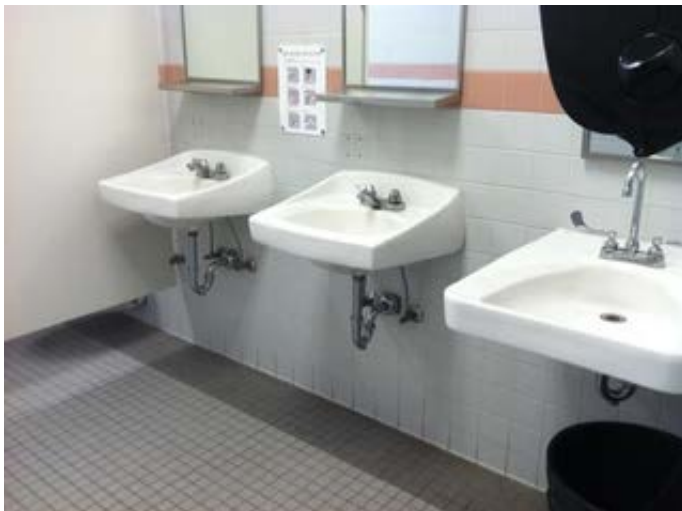
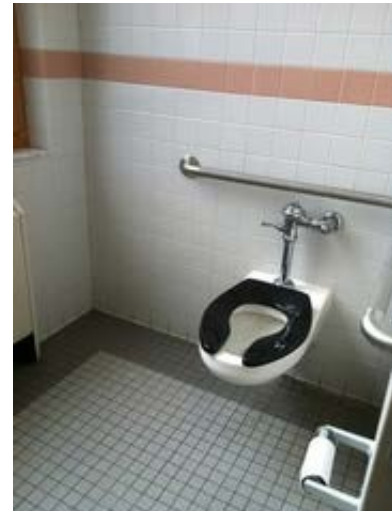
E. Plumbing and Fixtures

Description: The 2" domestic water supply piping in the building is copper piping at the building entrance. The water piping in the building is estimated to be 50% galvanized and 50% copper. There is a backflow preventer and a pressure reducing valve on the water service line. This equipment appears to be in fair condition. There were no water pressure issues indicated by the staff. A water treatment system is not required for the domestic water system. There is a small water softener for the boiler water make-up. A 2009, 50 gal AO Smith 40 MBH gas water heater with storage tank (1970) provides the domestic hot water for the main building. The galvanized piping has been replaced with copper water piping in the building as renovations have been completed. In 2005, the plumbing fixtures were updated with wall hung toilets, ADA fixtures and double LAV units with electronic sensor faucets and flush valves. There are no electronic sensor faucets and flush valves in the building in the newer section of the building. All of the toilets are floor mounted. The plumbing fixtures are generally in good condition. The school contains 3 restrooms for boys, 3 restrooms for girls, and 2 restrooms for the staff. The first floor there is 1 boys ADA restroom. The second floor there is 1 boys ADA restroom and 2 girls ADA restrooms. There are 11 LAVs, 2 ADA LAVs, 2 Double wall unit ADA LAVs with sensor faucets, 15 toilets, 3 toilets with electronic flush valves, 2 ADA toilets, 2 ADA toilets with electronic flush valves, 4 urinals, and 2 ADA urinals with electronic flush valves. There are 8 classroom sinks. There are 7 electric water coolers and 2 ADA electric water coolers in the school in generally good condition. There is no kitchen in this school.

Rating: 2 Needs Repair

Recommendations: Replace all electronic faucet/flush valve fixture with low flow fixtures and sensor faucets and flush valves to meet OSFC requirements. Replace galvanized piping with copper piping. 01-27-16 UPDATE: REPLACE ELECTRIC WATER COOLERS IN 1914 ORIGINAL BUILDING. PROVIDE REPLACEMENT OF WATER COOLERS. PROVIDE FOR 2 NEW ADA COMPLAINT ELECTRIC WATER COOLER IN 1914 ORIGINAL BUILDING AND 2 IN 1991 ADDITION. REPLACE SANITARY WASTE PIPING IN 1914 ORIGINAL BUILDING AND 1925 ADDITION. PROVIDE MIXING VALVE ON DOMESTIC WATER HEATER FOR 10 NEW WATER CLOSETS,

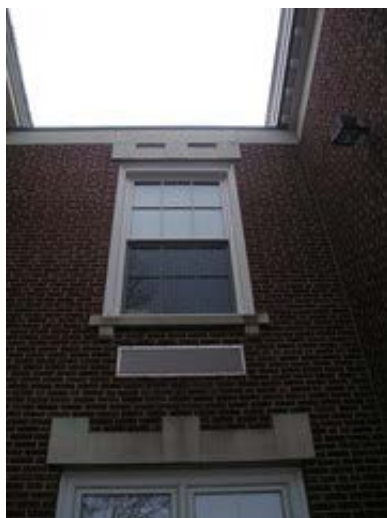
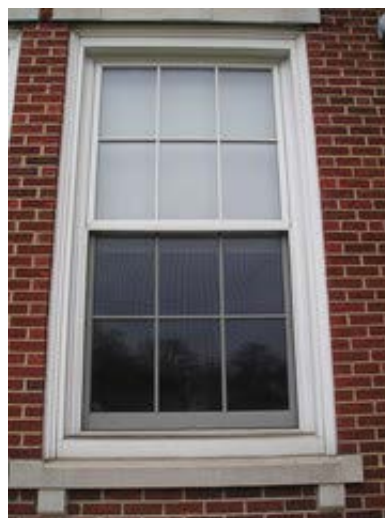
Description: All windows throughout the building have been replaced within the last 10 years. The units are double paned with white painted aluminum frames on the exterior and an interior wood finish. False muntins are between the glass panes. The windows, however, are not equipped with integral blinds.

Recommendations: No work is recommended at this time. 01-27-16 UPDATE: REPLACE SIDE LIGHTS AND TRANSOM ON EXTERIOR DOOR OF 1914 ORIGINAL BUILDING.

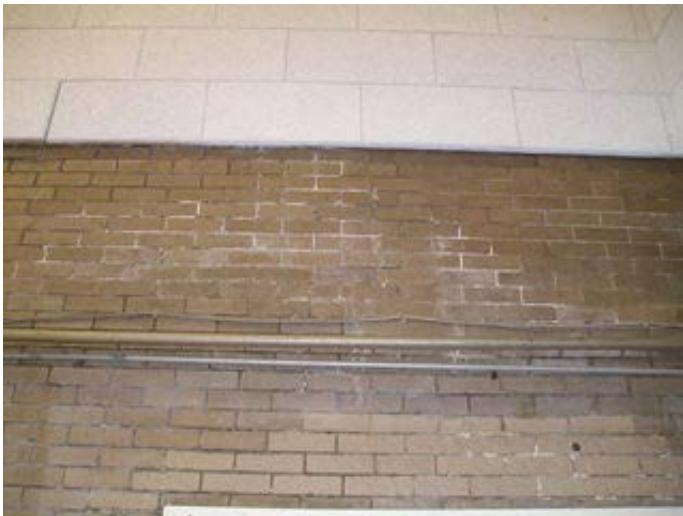
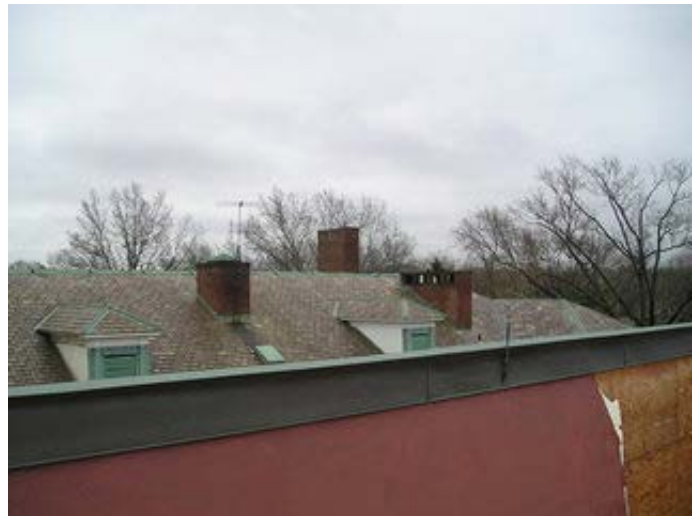
Description: Load bearing masonry walls were observed throughout the facility. Numerous instances of efflorescence were observed on the interior side of the gymnasium exterior walls. Approximately 1/2 dozen brick clad stacks were observed on the roof. Several areas of mortar repair were observed. However, the current condition of the stacks appears to be stable.

Rating: 2 Needs Repair

Recommendations: Masonry cleaning and sealing should be provided at all exterior walls around the gymnasium and the stacks. Masonry cleaning should occur on the interior surface of the gymnasium walls to eliminate efflorescence and visual inconsistencies. 01-27-16 UPDATE: REPLACE CAULK AT ORIGINAL 1914 BUILDING, 1925 ADDITION AND 1991 ADDITION. PROVIDE FOR EXTERIOR MASONRY CLEANING AND SEALING ON 1914 ORIGINAL BUILDING AND 1991 ADDITION. INFILL OPENINGS FOLLOWING REMOVAL OF UNIT VENTILATOR OUTSIDE ARE GRILLES IN 1925 ADDITION AND 1991 ADDITION. ADD WEEPS AT LINTELS ABOVE WINDOWS IN 1914 ORIGINAL BUILDING, 1925 ADDITION AND 1991 ADDITION. CAULK WINDOWS IN 1914 ORIGINAL BUILDING, 1925 ADDITION AND 1991 ADDITION. REBUILD AREA WELL MASONRY WALLS. 11-2-21 Update: Remove work performed in 2019: partial masonry infill; partial tuckpointing; cleaning & sealing.

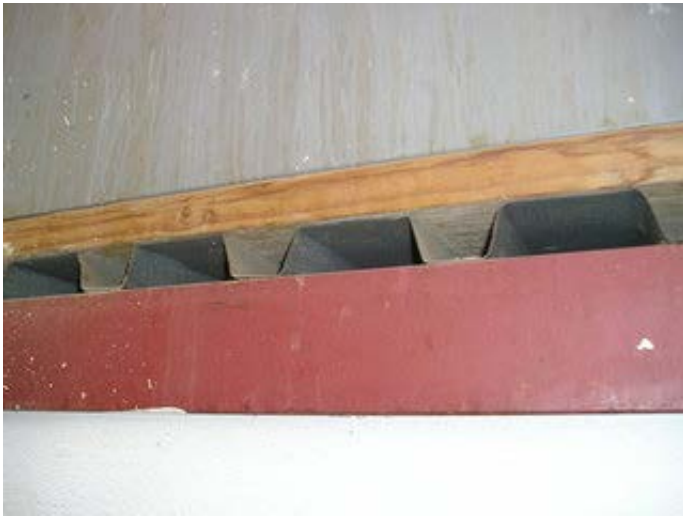
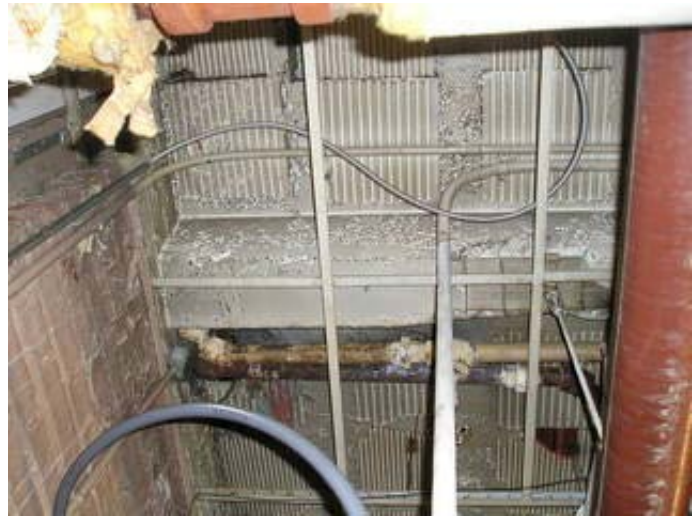
Rating: 2 Needs Repair

Recommendations: No deficiencies were observed with the floor or roof structures. 01-27-16 UPDATE: REPAIR SPALLING CONCRETE IN 1991 ADDITION..

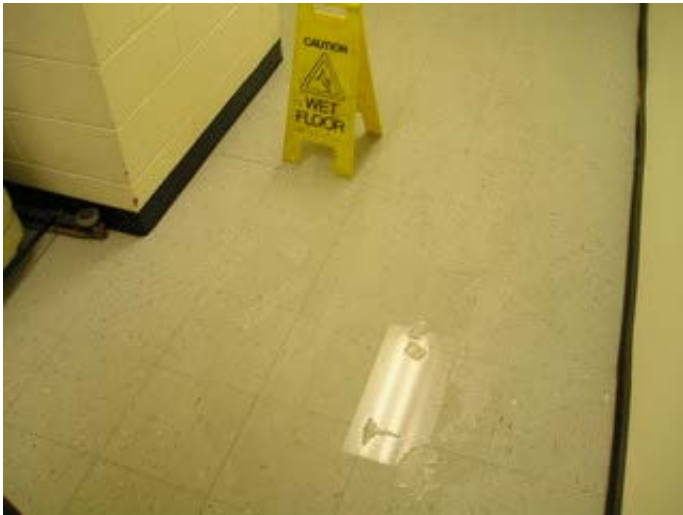
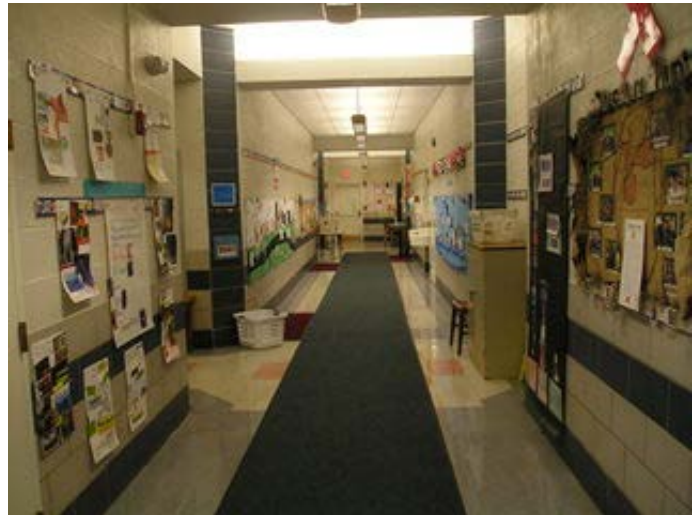
Description: VCT floor were observed throughout common areas of the school. Many classrooms in the original building have original wood floors. New classrooms have VCT floors. In the original building corridor walls are finished with plaster walls with direct adhered acoustic tile. Corridors in the 1991 addition have glazed CMU wainscot with painted CMU above. Suspended acoustic tile ceilings are used in the 1991 addition. The finishes consist mostly of materials which continue to perform after extended periods of use. Painted brick walls were observed in the basement of the original building. Newer partitions were observed in restrooms throughout the building. Kitchen equipment is not used. Basketball assemblies and other fixed equipment are provided for physical education. Some of the practice basketball assemblies were observed to be crooked and damaged.

Rating: 3 Needs Replacement

Recommendations: Finishes in the original building and East and West wings have passed their expected service life and should be replaced. Provide new practice basket ball assemblies. 01-27-16 UPDATE: REPLACE PLASTER WALLS IN 1914 ORIGINAL BUILDING DUE TO REMOVAL OF ACM PLASTER UNDER ITEM T. DRYWALL REPLACEMENT FOR REMOVAL OF EXISTING DRYWALL TO ACCESS ACM BEHIND WALLS IN 1914 ORIGINAL BUILDING AND 1925 ADDITION NOTED UNDER ITEM T. REPLACE 9 BASKETBALL BACKBOARDS. PROVIDE FOR COMPLETE REPLACEMENT OF FURNISHINGS TO INCLUDE CASEWORK IN 1991 ADDITION. REPLACE KITCHEN EQUIPMENT. PROVIDE FOR 1 KILN IN 1991 ADDITION.

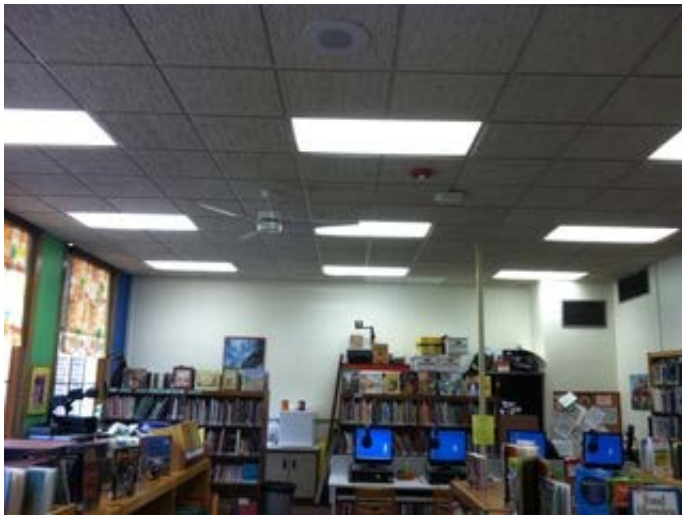
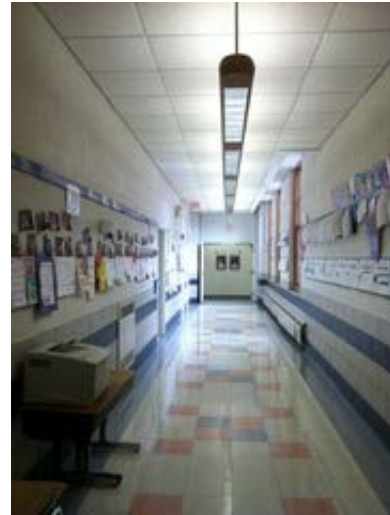
Description: The florescent lighting is a mixture of recessed with acrylic lense, surface mounted with acrylic lense, and pendent mounted with acrylic lense. The gym fixtures are high bay forescent fixtures. In 2012, the ballast and lamps have been upgraded to electronic energy efficient ballast and T8 lamps. The lighting is in good condition. Newer Classroom lighting levels is 24 FC, Older classroom lighting level are 48 FC and 44 FC, the Corridor lighting level is 44 FC, the Gym is 25 FC and the Art Room is 55 FC. The classrooms have dual level lighting controls. (One row of lights per switch.) There are no dimming controls in the building.

Rating: 3 Needs Replacement

Recommendations: Provide complete replacement of lighting system due to the installation of ducted HVAC systems and fire suppression systems.

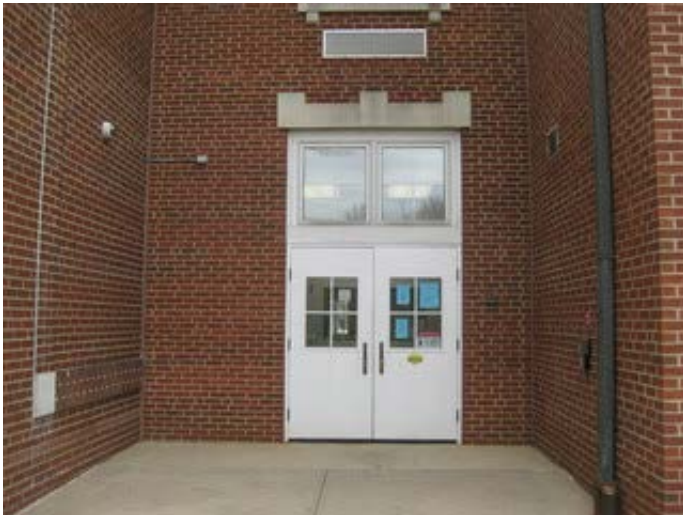
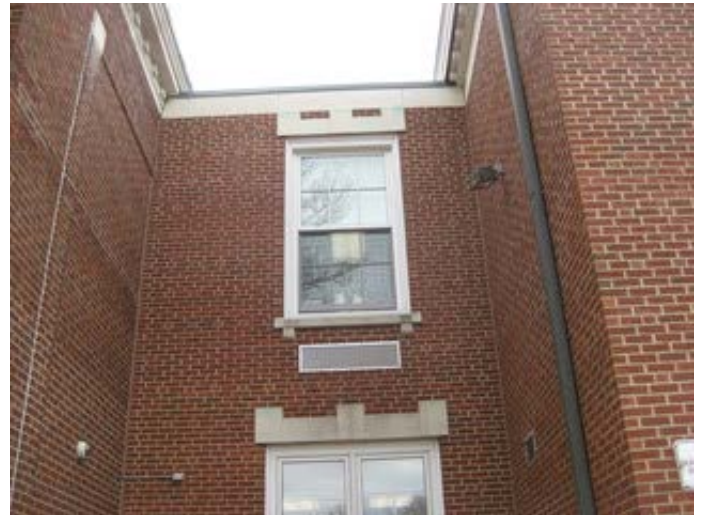
Rating: 3 Needs Replacement

Recommendations: Provide new security system to meet OSFC design manual guidelines and due to the installation of the HVAC and fire suppression systems. Upgrade the exterior lighting.

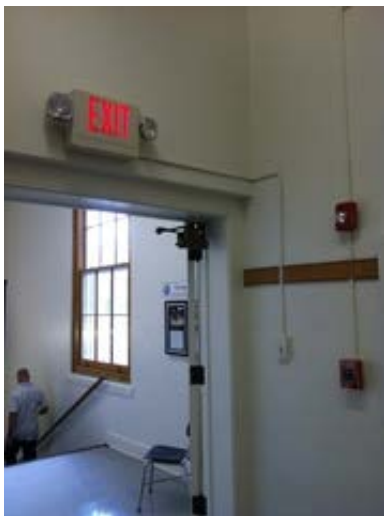
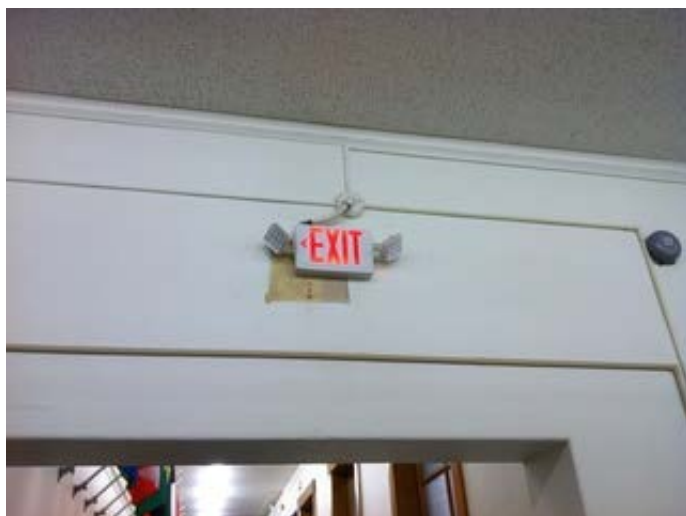
Rating: 3 Needs Replacement

Recommendations: Provide a complete replacement of emergency egress lighting due to installation of systems outlined in J, K, and U.

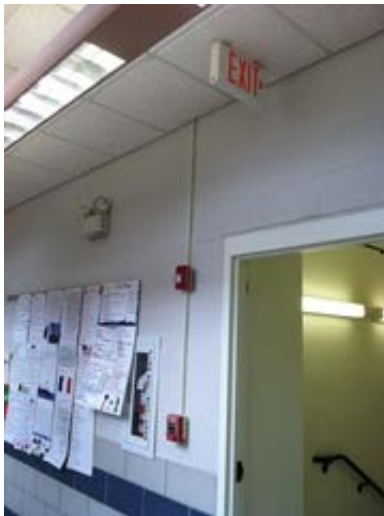
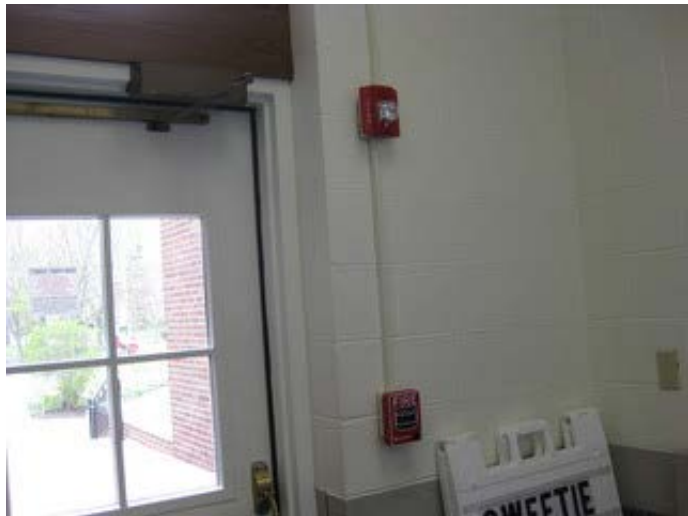
Rating: 3 Needs Replacement

Recommendations: Replacement of the system will be required when the work in C - Upgrading the ventilation and air conditioning. At that time, the devices would be replaced and added to with addressable devices.

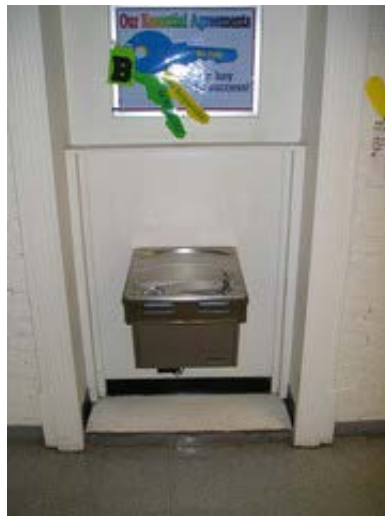
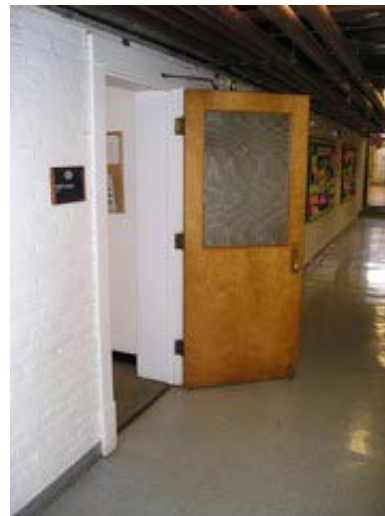
Rating: 2 Needs Repair

Recommendations: Replace turn knob door hardware with levers. Provide latches at egress stair doors. Provide high contrast signage and way finding with braille. A lift should be provided for access to the stage. 01-27-16 UPDATE: PROVIDE FOR HANDRAILS REPLACEMENT @ INTERIOR STAIRS IN 1914 ORIGINAL BUILDING AND 1925 ADDITION AND RAMP IN 1914 ORIGINAL BUILDING. RECESS 4 DOORS IN BASEMENT OF 1914 ORIGINAL BUILDING TO ACHIEVE ADEQUATE CLEARANCE. PROVIDE FOR RECESSED ADA WATER COOLERS IN 1914 ORIGINAL BUILDING. PROVIDE ADA DOOR OPENER ON 1914 ORIGINAL BUILDING EXTERIOR ENTRY DOOR AT RAMP.

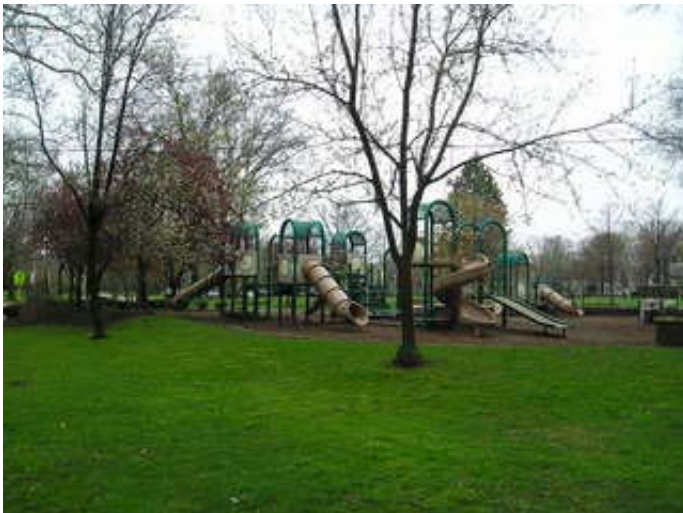
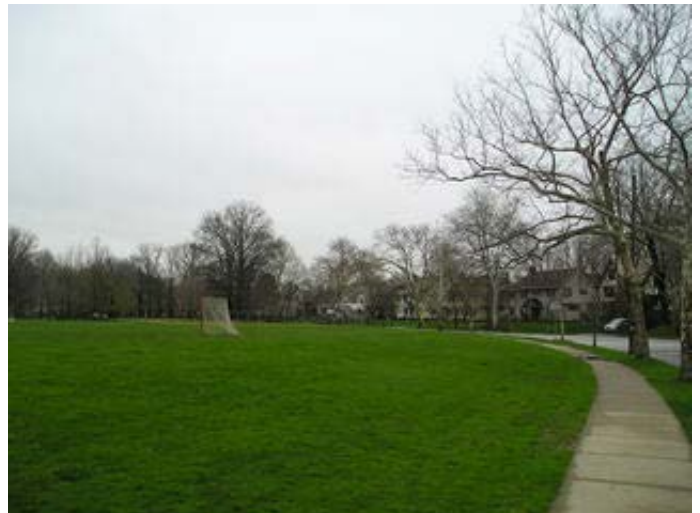
P. Site Condition

Description: Only a nominal number of cracks were observed in the pavement. Slopes and paved areas do not consistently drain away from the building. Soft surface play areas consist of playground assemblies on mulched surfaces. Hard surfaces areas with painted markings are provided as well. No concrete pad is provided for the dumpster/recycling bin area.

Rating: 2 Needs Repair

Recommendations: Provide dedicated on-site bus drop-off. Provide concrete pad for dumpsters and recycling bins. 01-27-16 UPDATE: REPLACE HANDRAILS AT 1914 ORIGINAL BUILDING, 1925 ADDITION AND 1991 ADDITION. REPLACE STAIRS, RAMPS, SIDEWALKS AND LANDSCAPING AT 1914 ORIGINAL BUILDING, 1925 ADDITION AND 1991 ADDITION DUE TO EXCAVATION FOR WATERPROOFING OF FOUNDATION WALLS. REBUILD RETAINING WALL AT 914 ORIGINAL BUILDING. REBUILD WALK AND ADD STEPS AT NORTH ENTRANCE OF 1914 ORIGINAL BUILDING. PROVIDE FOR SOFT SURFACE PLAYGROUND SURFACE AND SWING. PROVIDE FOR ADDITIONAL PARKING SPACES. 11-2-21 Update: Remove partial work completed in 2020: Handrail replacement; concrete steps replacement; retaining wall.

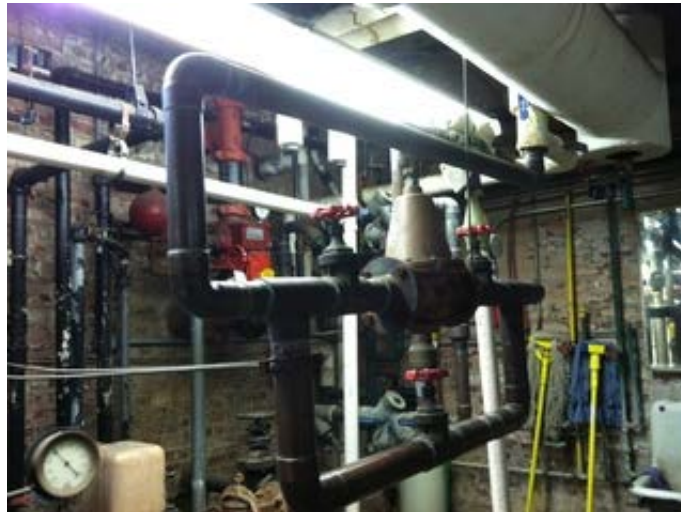
Rating: 3 Needs Replacement

Recommendations: Renovate water main entrance to meet the sprinkler requirements. 01-27-16 UPDATE: PROVIDE FOR BACKFLOW PREVENTOR.

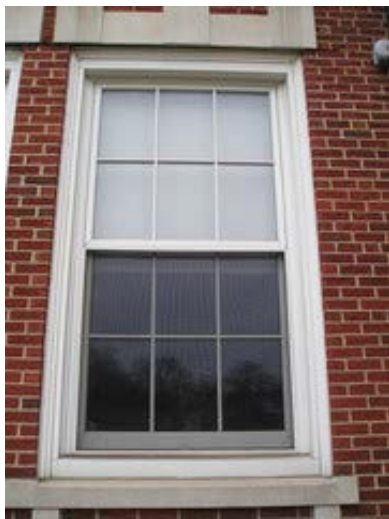
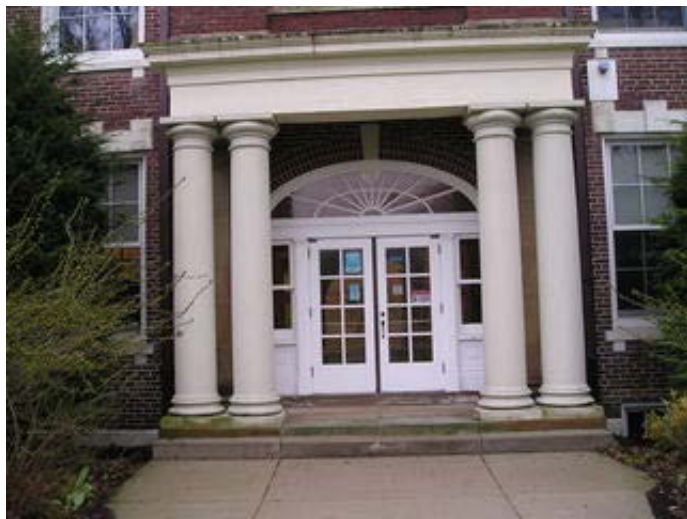
Description: Most of the doors around the exterior have been replaced less 2004. They are white hollow metal painted insulated doors. The doors are 1/2 or fully glazed having false muntins in the vision panel.

Recommendations: No work is recommended at this time. 01-27-16 UPDATE: REPLACE EXTERIOR DOORS ON 1914 ORIGINAL BUILDING, 1925 ADDITION AND 1991 ADDITION.

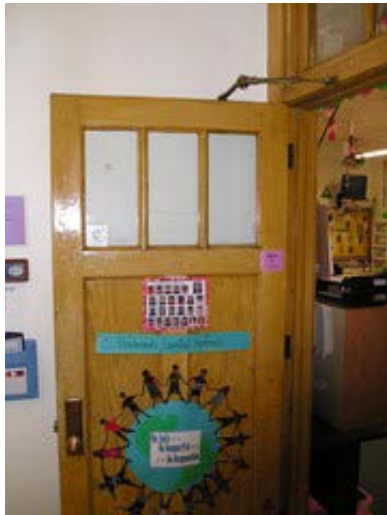
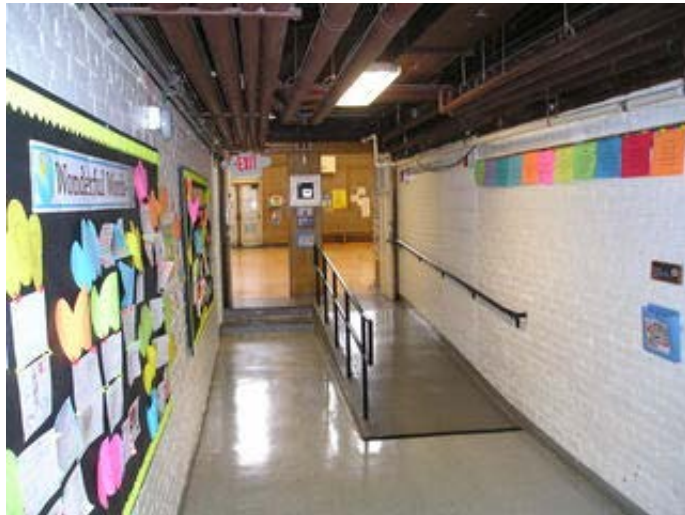
Rating: 3 Needs Replacement

Recommendations: Provide a new automated fire suppression system to meet OSDM guidelines. Provide modification to the water service to support the fire suppression system, funding included in Water Service section R for new water service for fire suppression. Provide an emergency generator to meet the needs for this building. Provide door vision panels and sidelights under Section F. Windows. 01-27-16 UPDATE: DELETE EMERGENCY GENERATOR FROM 1914 ORIGINAL BUILDING (GENERATOR INCLUDED IN FULL ELECTRICAL SYSTEM REPLACEMENT UNDER ITEM D). PROVIDE FOR A NEW BACKFLOW PREVENTER. PROVIDE FOR PRE-ACTION FIRE SUPPRESSION SYSTEM IN ATTIC SPACE OF 1914 ORIGINAL BUILDING, 1925 ADDITION AND 1991 ADDITION.
