FACILITY ASSESSMENT

Shaker Family Center

Project # 2125

December 15, 2021

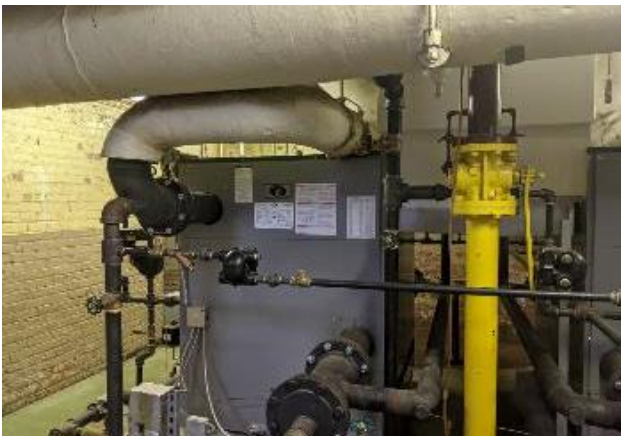
- New steam boilers were installed circa 2021 in the Original Building Mechanical Room. There is asbestos on the existing piping that should be removed. Insulation has been tagged as such.
- There is an existing boiler in the Addition Mechanical Room that may not be in use anymore. The steam system is back fed from the Original Building.
- Classrooms and most non-classroom rooms have steam radiators. Covers have been built around radiators to prevent burns on children.
- Offices surrounding the Muscle Room and rooms in the 1990 renovation are served from gas fired RTUs with DX cooling.

Steam Boiler Serving Entire Building

- Replace insulation tagged as containing asbestos.

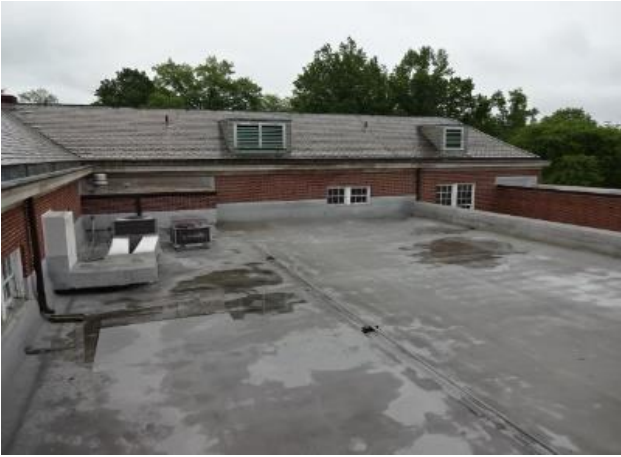
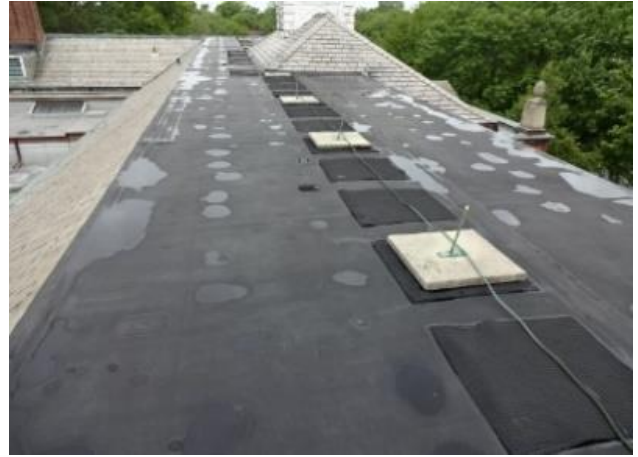
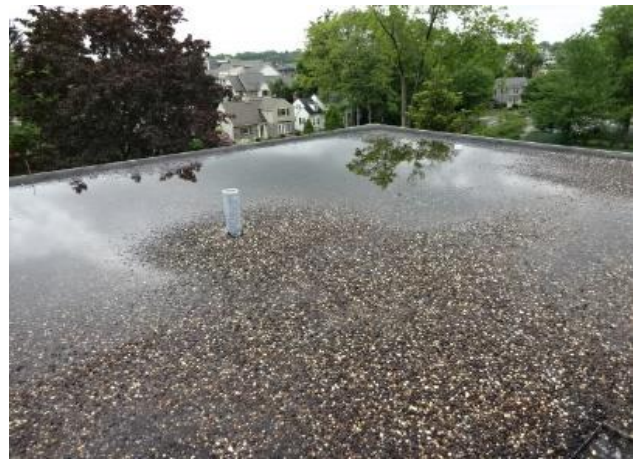
- The roof over the Original Construction has a spray applied system on the lower flat roof areas, and is in fair condition. There are reports of current leaking. The upper flat roof area is EPDM in poor condition.

- The roof over the Addition has a built up system on the flat roof areas, and is in poor condition. There are areas that need repairs. There are no reports of current leaking.

Roofing to be Replaced

- The lower flat roof over the Original Construction requires replacement due to system condition, projected lifecycle, and ponding, with work recommended within 4-7 years.
- The upper flat roof over the Original Construction requires replacement due to system condition and projected lifecycle, with work recommended within 2-4 years.
- The flat roof over the Addition requires replacement due to system condition, projected lifecycle, and ponding, with work recommended within 2-4 years.
- Replace roof drains on the addition during roof replacement.
- Replace cupola.

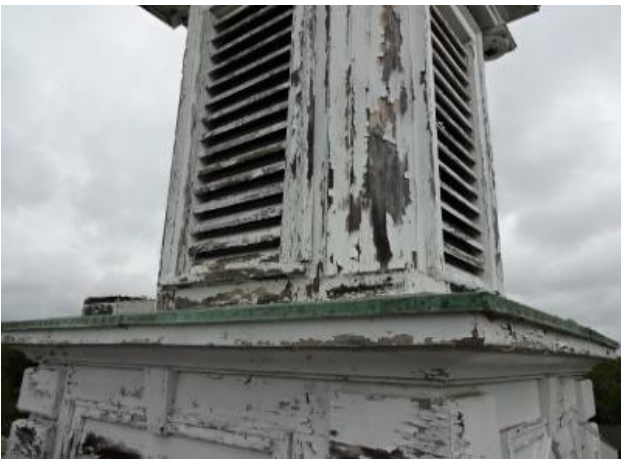
- The Original Construction has a cupola constructed of wood with a copper roof and is in poor condition.

Cupola to be Replaced

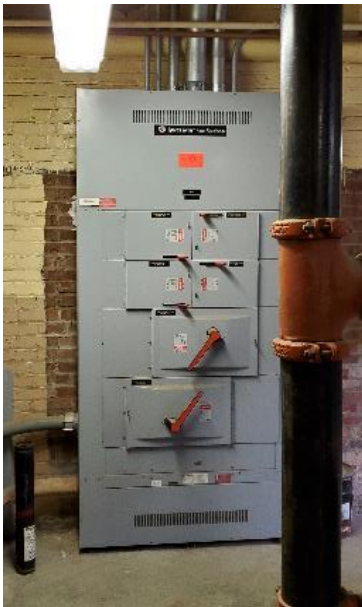
- The main electrical service is 800A, 208/120V, 3-phase with (5) fused main disconnects in the main panelboard. An additional 600A, 208/120V, 3-ph service disconnect serves the fire pump. The utility transformers are in a vault in the basement.
- There is no emergency generator for the building.
- Electrical equipment is in fair condition, but is older and reaching the end of useful life.

Main Electrical Panel

- Provide replacement of electrical system, including back-up generator for fire pump.

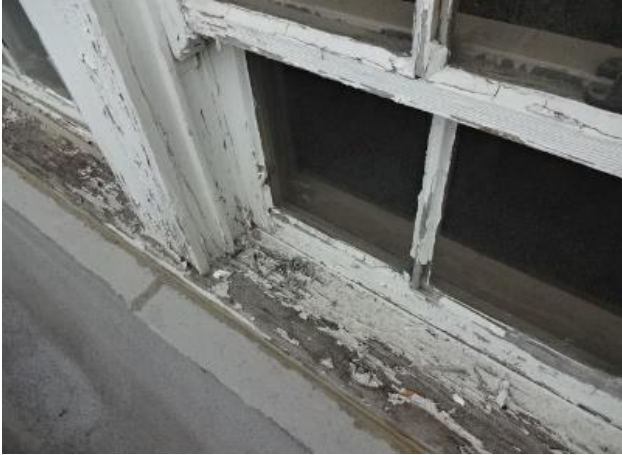
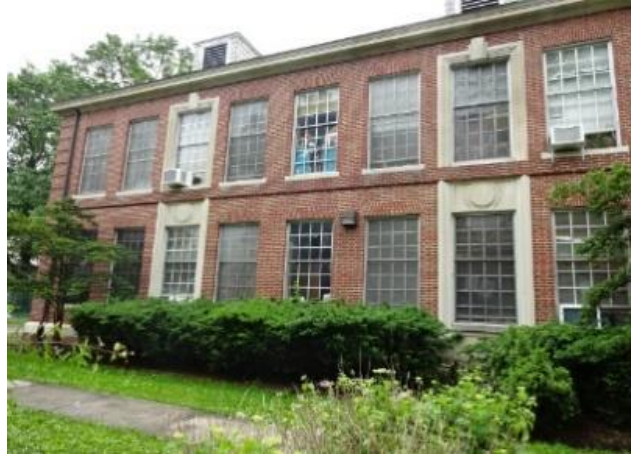
- The Original Building windows that have not been replaced are wood with single glazed type window system, and are in fair to poor condition. The window system features operable windows not equipped with opening limiters, and some windows have insect screens. Window system seals are in fair condition, with minimal to moderate air and water infiltration being experienced. Window system hardware is in fair condition. The window system features surface mounted blinds, which are in fair condition.

- The Addition is equipped with aluminum frame windows with single glazed type window system which are in fair condition. The window system features operable windows which are not equipped with opening limiters, and some windows have insect screens in fair or poor condition. Window system seals are in fair condition, with minimal air and water infiltration being experienced. Window system hardware is in fair condition.

Window to be Replaced

Windows to be Replaced

- Due to age and condition, provide a new insulated window system, with work recommended within 0-2 years.
- Replace sealant and flashing at skylights.

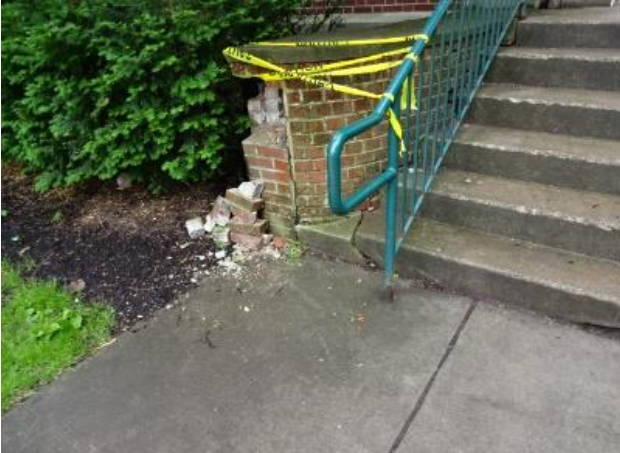
North Steps to be Repaired

- Repair masonry and concrete at north steps.
- Repair grout in stone stairs at east doors to the Addition.
- Repair edge of concrete slab at ramp on the east side of the building.
- Repair wall crack in Storage Room 133.
- Provide tuckpointing in all areas of mortar deterioration at stone band at first floor level.
- Repair cracks in stone lintels and sills.
- Provide sealer to wood framing at entrance canopy.

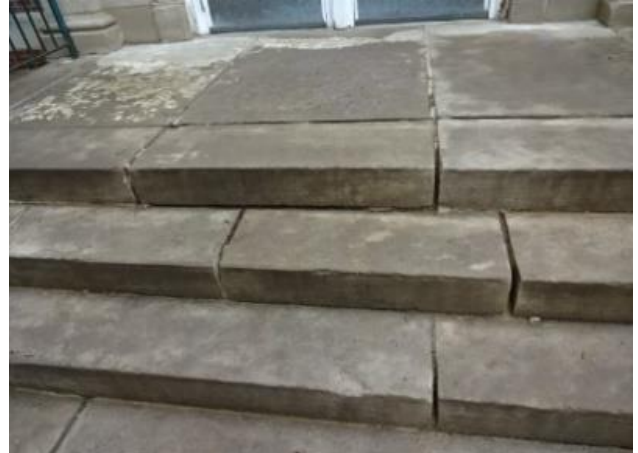
East Steps to be Repaired

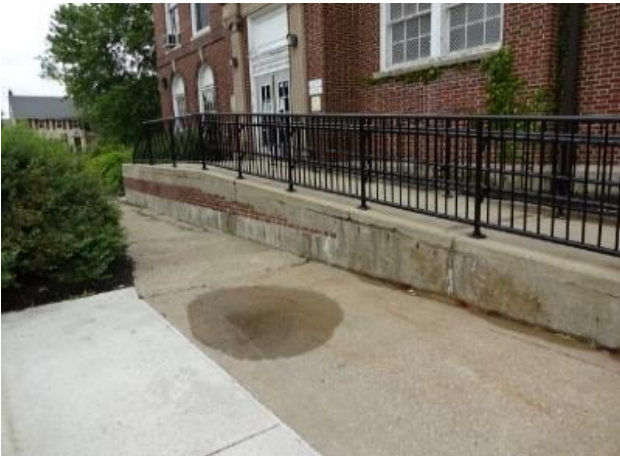
East ADA Ramp to be Repaired

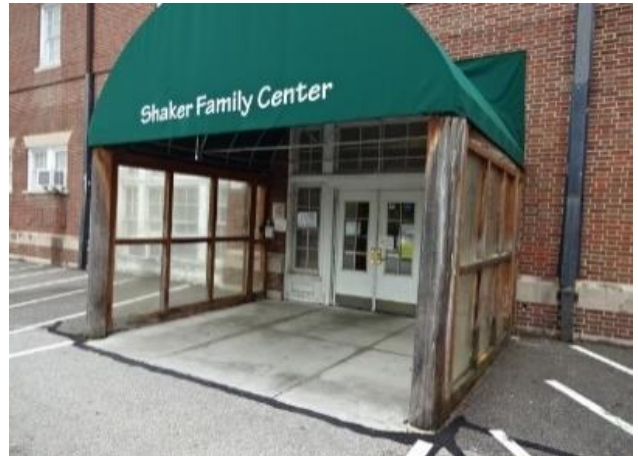
Canopy Structure to be Repaired

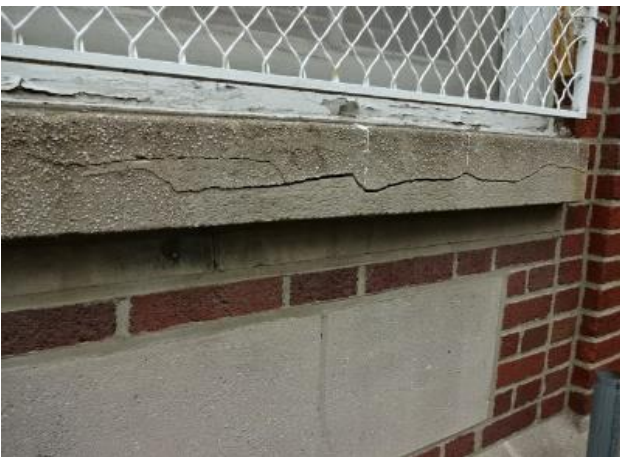
Crack to be Repaired

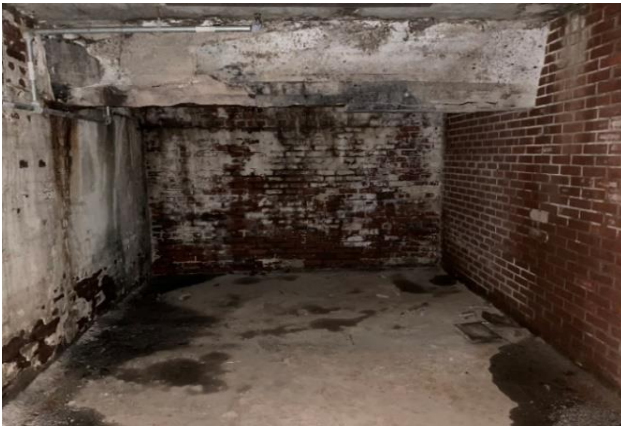
- The floor construction of the base floor of the overall facility is concrete slab on grade type construction, and is in good condition. Crawl space is located under the facility.
- The floor construction of the intermediate floors of the overall facility is cast-in-place prestressed concrete type construction, and is in good condition. The construction of the attic floor is cast-in-place concrete on steel joists.
- Ceiling to structural deck space is sufficient to accommodate HVAC, electrical, and plumbing scopes of work in required renovations.
- The sloped roof construction is wood deck on wood joist type construction, and is in good condition.
- The cast-in-place concrete ceiling beam in the Coal Storage Room is spalling and in poor condition.

Concrete Beam in Coal Storage Room

- Repair cast in place concrete beam in the Coal Storage Room.

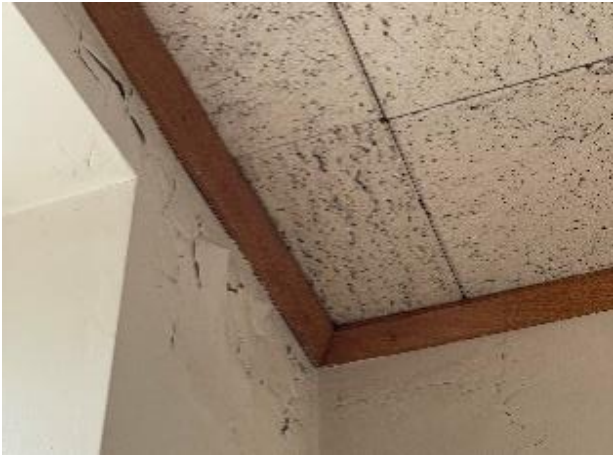
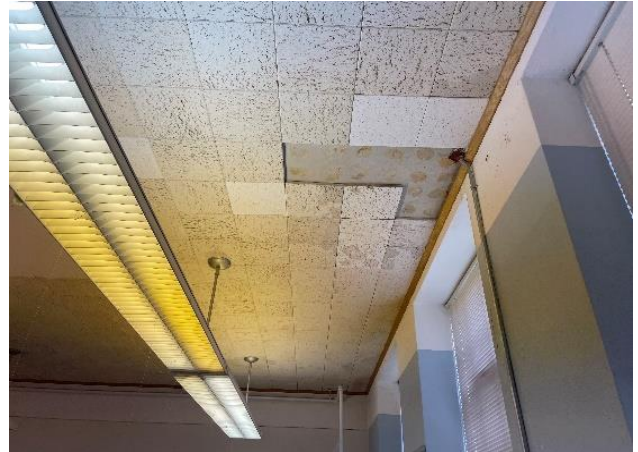
- The overall facility features conventionally partitioned classroom spaces with carpet, VAT, and sheet vinyl type flooring, suspended acoustical ceiling tile, adhered acoustical ceiling tile and plaster ceilings, as well as plaster type wall finishes, and they are in poor condition.

Wall and Ceiling Condition

Missing Ceiling Tiles

- Provide complete replacement of finishes and casework due to condition and installation of systems outlined in Items A, C, D, E, I, K, L, M, N, T, U, and W, with work recommended within 0-2 years.

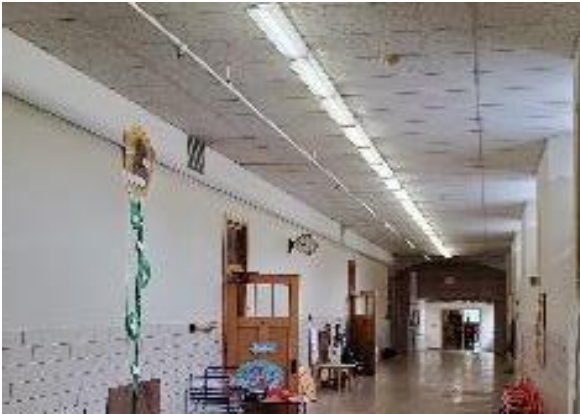
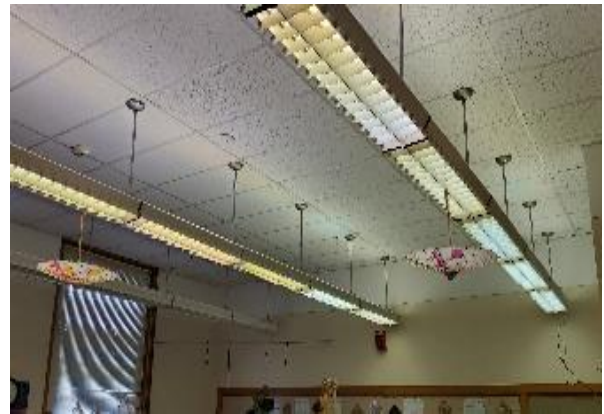
- Most of the building contains older fluorescent lighting in poor condition.
- The First Floor Corridor contains newer fluorescent fixtures in good condition.
- The Gym contains newer LED high-bay fixtures in good condition.

Typical Corridor Lighting

Typical Classroom Lighting

- Replace fluorescent lighting in poor condition.
- Provide lighting controls to conform to energy code.

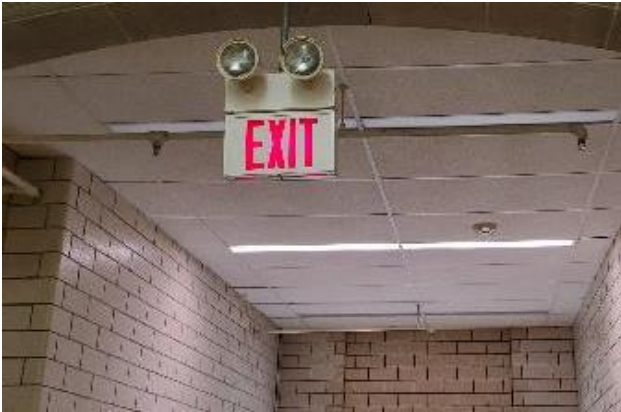
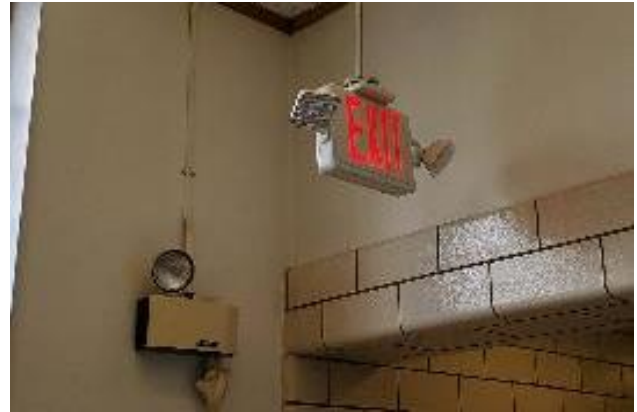
- Building contains battery-powered emergency exit sign and unit equipment.
- There is no emergency egress lighting at exterior doors.
- Most egress lighting is older and in poor condition.

Exit Sign

- Replace older emergency lights and exit signs.
- Provide emergency egress lighting at exterior doors.

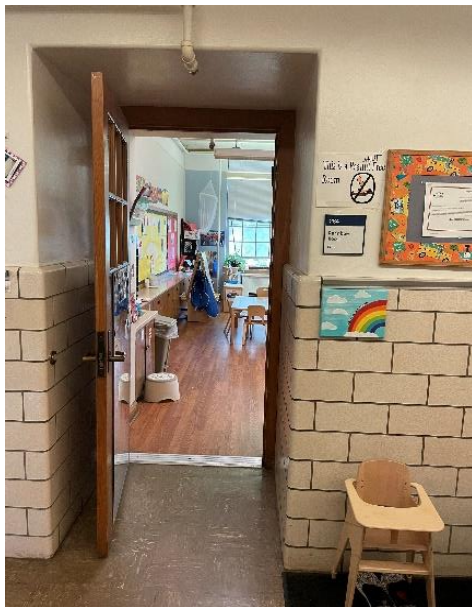
Non-ADA Compliant Clearances

- Provide ADA-compliant signage, power assist door opener, locksets, toilets, lavatories and mirrors.
- See Item J for replacement of toilet partitions and toilet accessories.

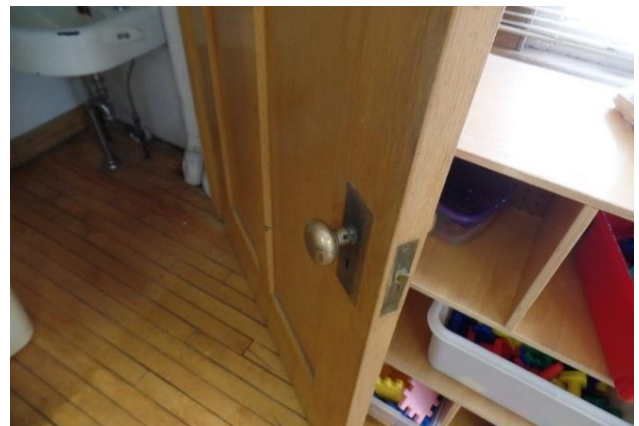
Non-Compliant Lockset

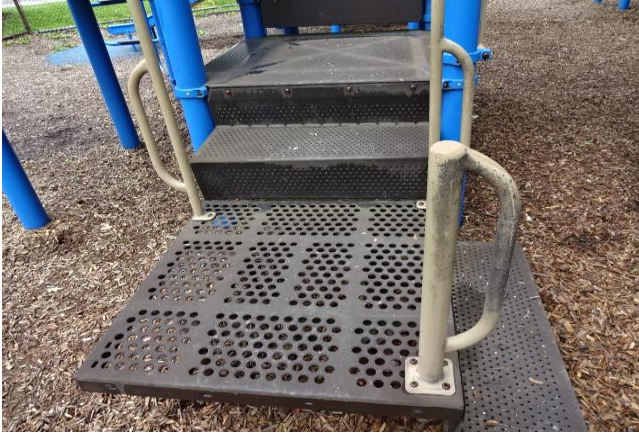
- The playground equipment is primarily constructed of wood, coated steel and high density plastic, and is in fair condition. Playground equipment is placed to provide compliant fall zones, and on a compliant wood fiber of sufficient depth. The playground area is equipped with tables and benches in fair condition.

Playground Equipment to be Replaced

- Provide crack sealing of parking lot, with work recommended within 0-2 years.
- Replace broken sidewalks.
- Replace asphalt inside dumpster enclosure with concrete.
- Replace wood fence.
- Update playground equipment and add partial ADA fall zones.

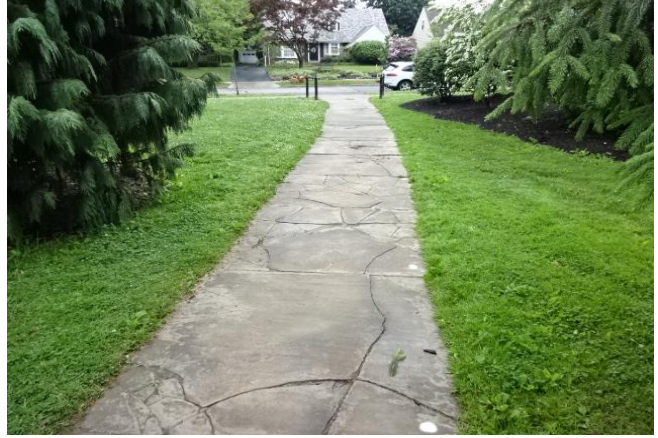
Sidewalk to be Replaced

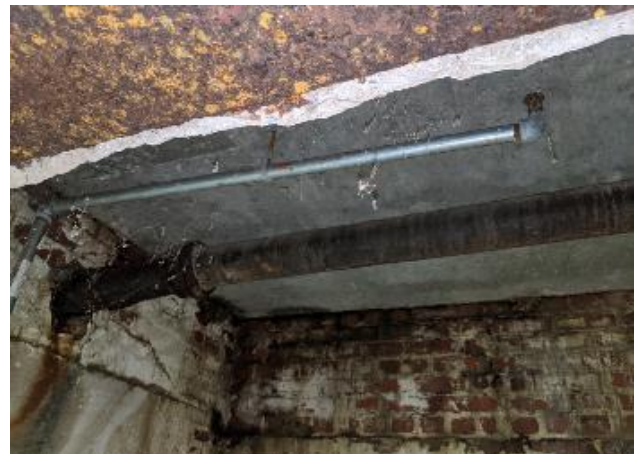
- The 3-compartment sink in the kitchen is connected to the grease interceptor.
- The sanitary line in the Coal Storage Room is rusty and should be replaced.
- The majority of the sanitary systems are cast iron and original to the building. No major issues have been identified.

Sanitary Pipe in Coal Storage Room

- Repair sanitary piping in Coal Storage Room.

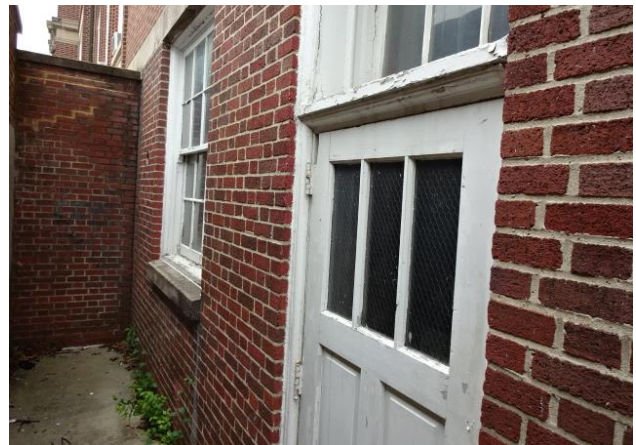
- Typical exterior doors to the west basement level, southeast first floor and the outbuilding doors are wood type construction, installed on wood frames, and are in poor condition. The southeast exterior doors feature single glazed vision panels, all doors have appropriate hardware.
- Entrance doors in the overall facility are hollow metal type construction, installed on hollow metal frames, and in poor condition. Entrance doors feature single glazed vision panels, transoms, sidelights, and appropriate hardware.
- The facility is not equipped with any roof access doors. There are no overhead doors in the facility.

Wood Door to Basement Level

- Replace 4 exterior doors with hollow metal doors, frames and locks.
- Replace 11 entrance doors, frames, locks, panic hardware, closers and glazing.

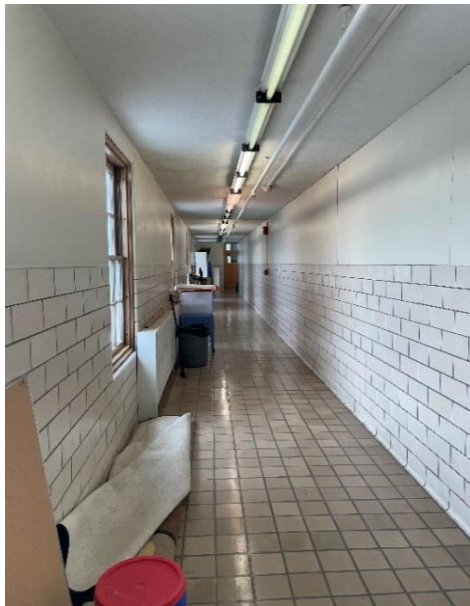
Fluorescent Lighting

- Provide for disposal of fluorescent lighting.
- Remove 9"x9" floor tile and mastic. Flooring replacement is in Item J.

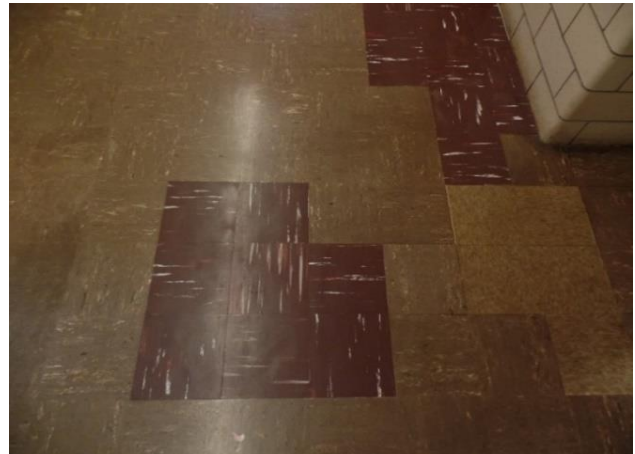
- There was no previous Asbestos Inspection Report provided. However, given the date of original construction and building methods, it is assumed that Asbestos Containing Building Materials (ACBM) were used. A Hazardous Materials Inspection should be performed to accurately determine the presence and condition of any ACBM within the building.
- Removal and replacement of fluorescent lighting in Item K will require special disposal.
- 9"x 9" floor tile in Corridors of the Addition may contain asbestos and may have been set in asbestos containing adhesive. Replacement of flooring is in Item J.

9"x9" Floor Tile

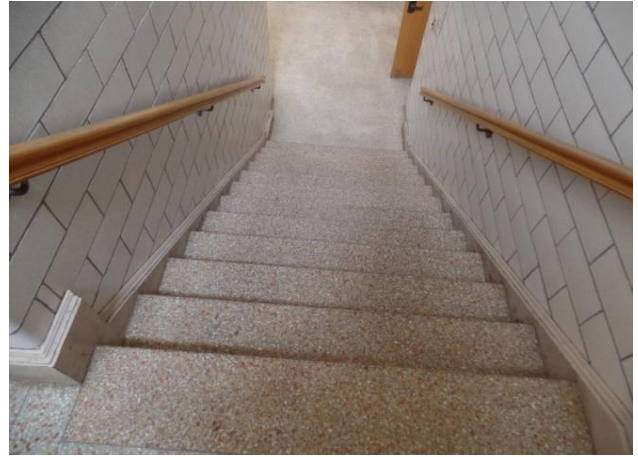
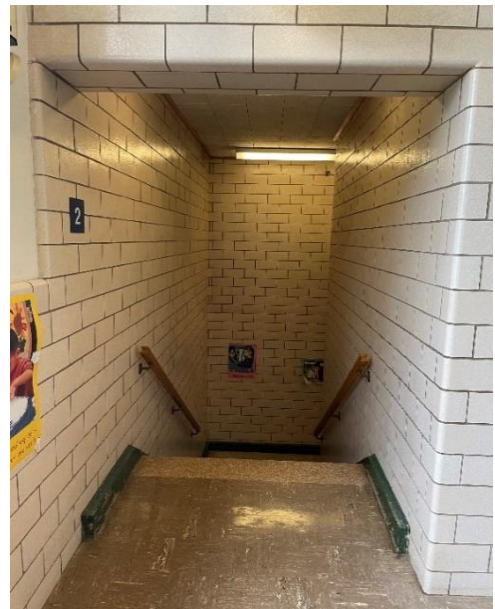
Handrails to be Replaced

- Provide new handrails to meet the requirements of the Ohio Building Code, with work recommended as soon as practicable.
