**Building Information - Shaker Heights City (44750) - Fernway Elem**

Program Type	Classroom Facilities Assistance Program (CFAP) - Regular
Setting	Urban
Assessment Name	Fernway ES Assessment - Shaker Heights CSD - HPG 2021 with 11-3-21 update
Assessment Date (on-site; non-EEA)	2021-08-13
Kitchen Type	No Kitchen
Cost Set:	2021
Building Name	Fernway Elem
Building IRN	11536
Building Address	17420 Fernway Rd
Building City	Shaker Heights
Building Zipcode	44120
Building Phone	(216) 295-4040
Acreage	2.39
Current Grades:	K-4
Teaching Stations	21
Number of Floors	3
Student Capacity	342
Current Enrollment	266
Enrollment Date	2021-08-23
Enrollment Date is the date in which the current enrollment was taken.	
Number of Classrooms	17
Historical Register	<b>NO</b>
Building's Principal	Christopher C. Hayward
Building Type	Elementary

**Building Pictures - Shaker Heights City(44750) - Fernway Elem(11536)**

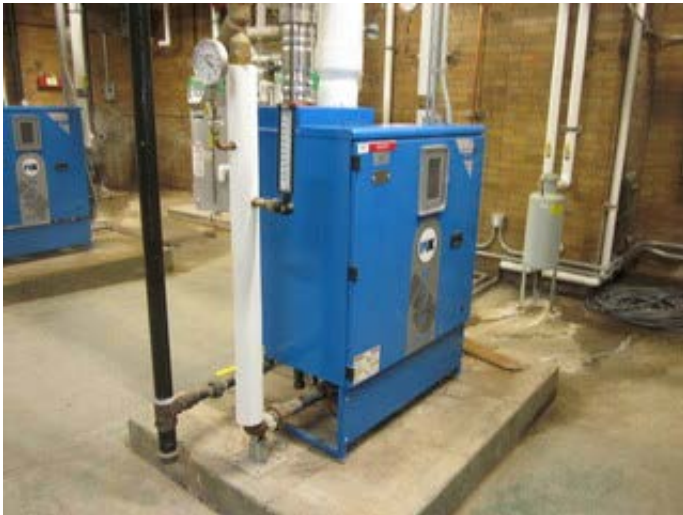
**Description:** The existing heating system for the overall facility is a natural gas-fired hot water system with rooftop mounted air-handlers. The 2 boilers, manufactured by P.K. Mach were installed in 2019 during the renovation/rebuild of the facility and are in excellent condition and are in the lower-level mechanical room of the 1927 original construction. The boilers are rated at 460,000 BTU/hr. each for a total output of 920,000 BTU/hr. Heating water is distributed to terminal units consisting of roof mounted air-handlers. The controls are digital and installed in 2019 with the complete HVAC system installation. The existing overall facility does contain a central air conditioning system as well as multiple split system units. The overall facility does not contain window air conditioners. The existing cooling system for the overall facility is a pad mounted chiller. The pad mounted chiller was installed in 2019 during the renovation/rebuild of the facility and is in excellent condition. Chilled water is distributed to roof mounted air-handlers. The system does feature individual temperature controls in all spaces required by the OSDM. The overall system does not feature any central energy recovery systems. The ventilation system in the overall facility consists of air handlers, mixing boxes, and exhaust fans to provide outside air into interior spaces. The overall facility contains transfer grilles for relief air venting. The system is capable of providing the 15 CFM per person outdoor air requirements of the Ohio Building Code and Ohio School Design Manual. The existing clear plenum space will allow for the installation of ductwork or ductwork reconfiguration, if required. According to school officials, the site does not contain underground fuel tanks.

Gas fired boiler

**Recommendations:** No work required. 11-2-21 Update: Correction to note above: The building's two DOAS air handlers are equipped with energy recovery wheels.

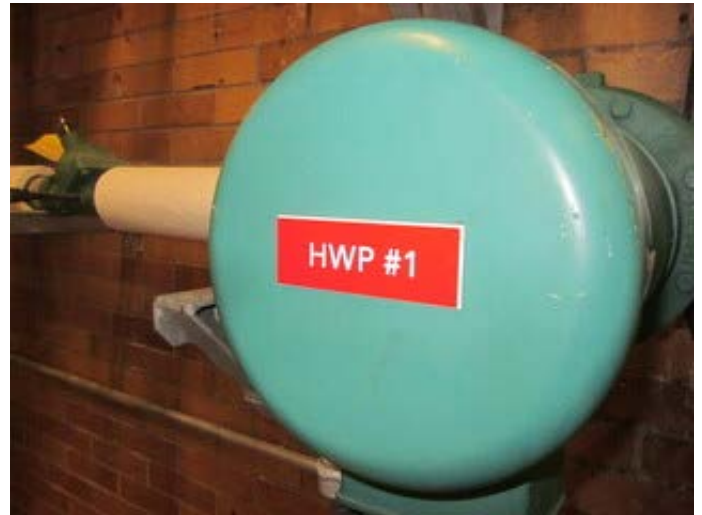
Hot water circulating pump

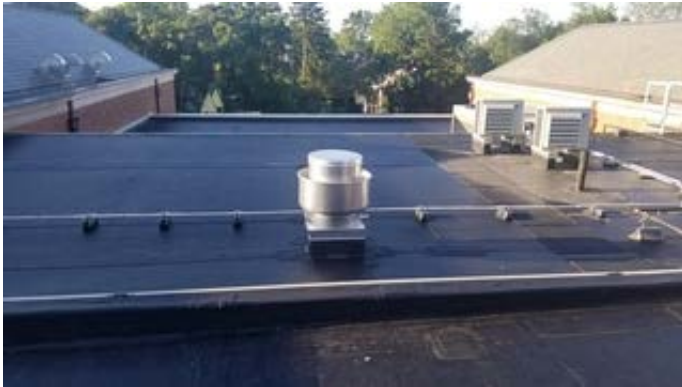
**Description:** The roof over the overall facility is primarily a slate shingle system that was installed in 2020, and is in good condition. Portions of the facility that have a flat roof system consist of a rubber membrane system that was installed in 2020, and is in good condition. There are no District reports of current leaking. No Signs of past leaking were observed during the physical assessment. Access to the roof was gained by access ladder and hatch that is in good condition. Fall safety protection cages are not required at the access. There were no observations of standing water on the roof. Metal cap flashings and stone copings are in good condition. Roof storm drainage is addressed through a system of copper gutters and downspouts, which are properly located, and in good condition. The roof is equipped with overflow roof drains in sufficient quantity and in good condition. No problems requiring attention were encountered with any roof penetrations. There are no covered walkways attached to this structure.

Flat roofs over 1927 original construction and 2020 addition

**Recommendations:** Existing conditions require no renovation or replacement at the present time.

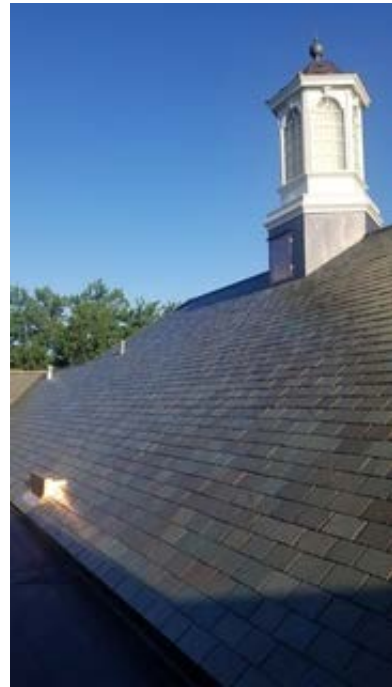
Slate roof at 1927 original construction

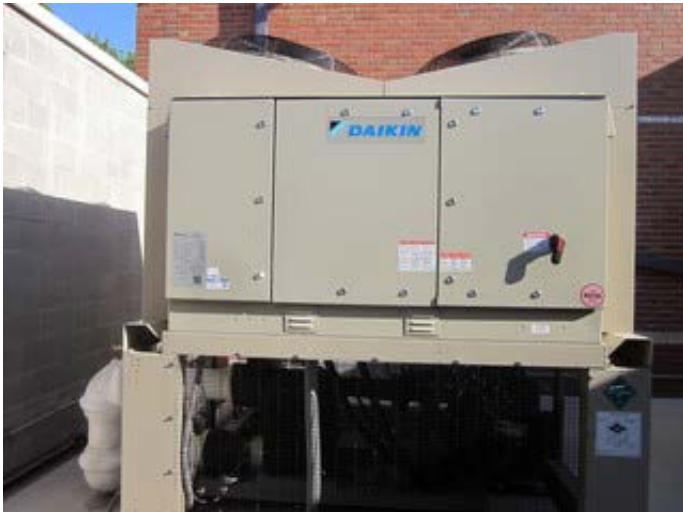
Pad mounted chiller

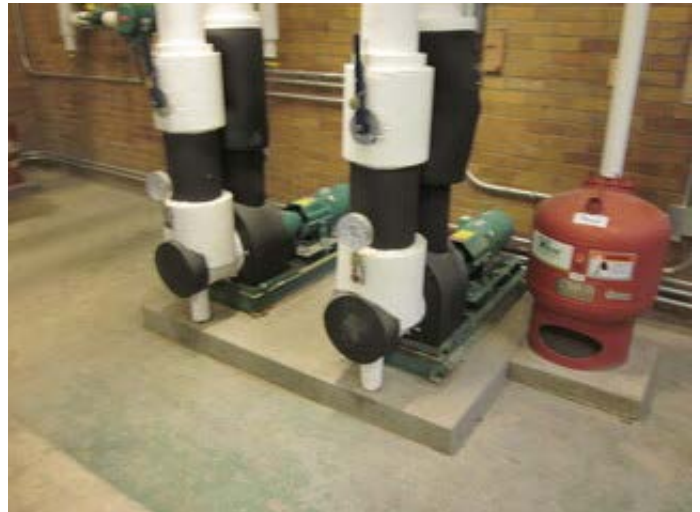
Cold water circulating pumps

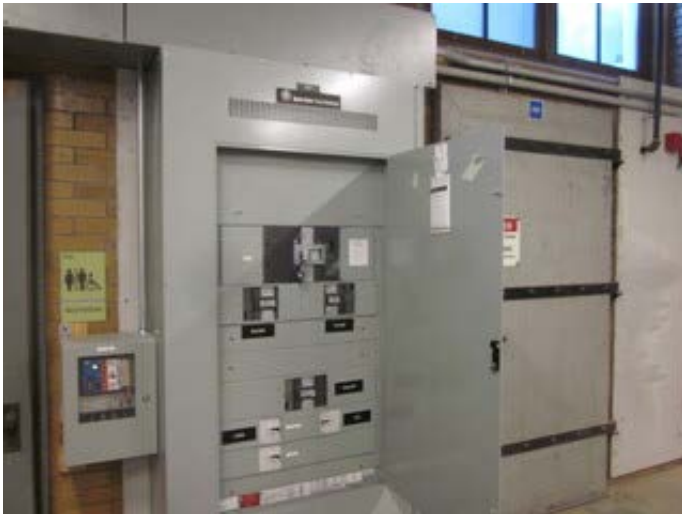
**Description:** The electrical system for the overall facility is a 480/277-volt, 800-amp, 3-phase, 4-wire system in excellent condition. The electrical system was installed during the 2019 renovation/rebuild of the facility. The main distribution equipment is General Electric. The panel system is in excellent condition. The panel system was installed during the 2019 renovation/rebuild of the facility and can be expanded for additional capacity. The facility contains an emergency generator. The emergency generator was installed during the 2019 renovation/rebuild of the facility. The pole mounted transformers are owned by the utility company. Classrooms are equipped with adequate electrical outlets. Corridors and the exterior of the building are equipped with adequate electrical outlets for building maintenance. The facility does not contain lightning protection with grounding.

**Rating:** 2 Needs Repair

Main distribution panel

**Recommendations:** Provide building lightning protection and grounding.

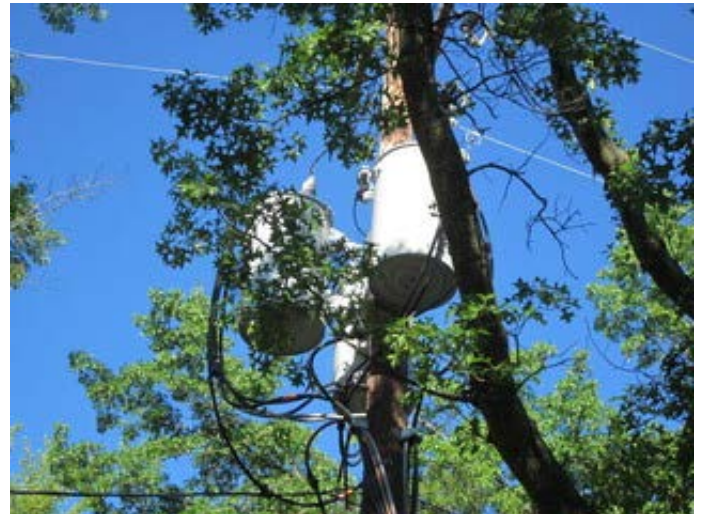
Pole mounted transformers

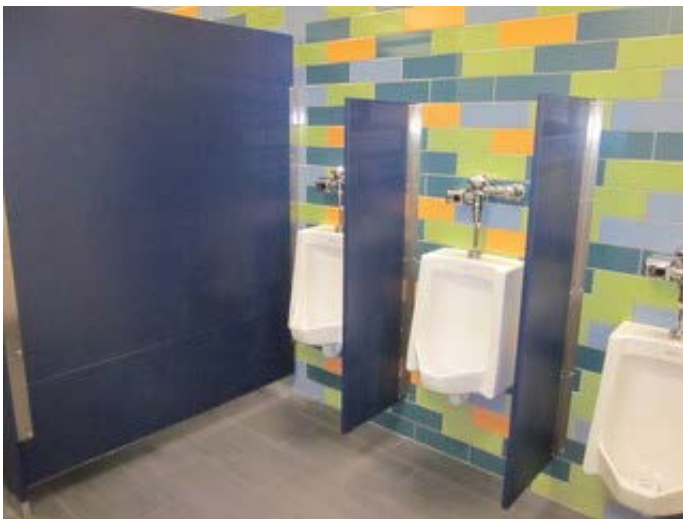
Wall mounted restroom fixtures

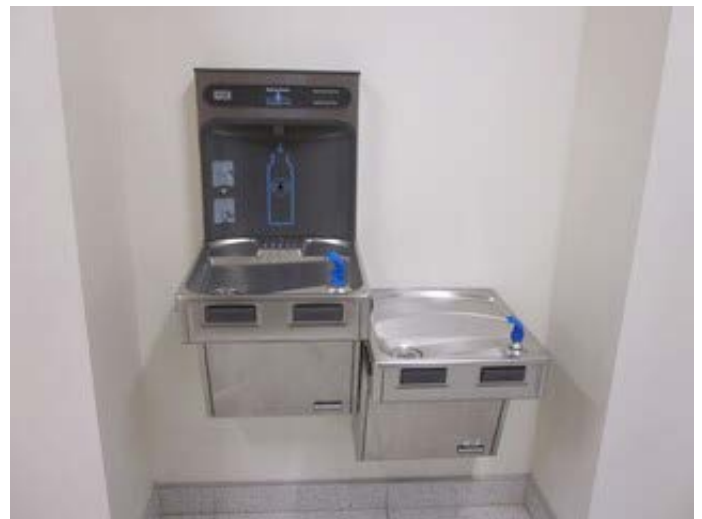
Electric water coolers with bottle fillers

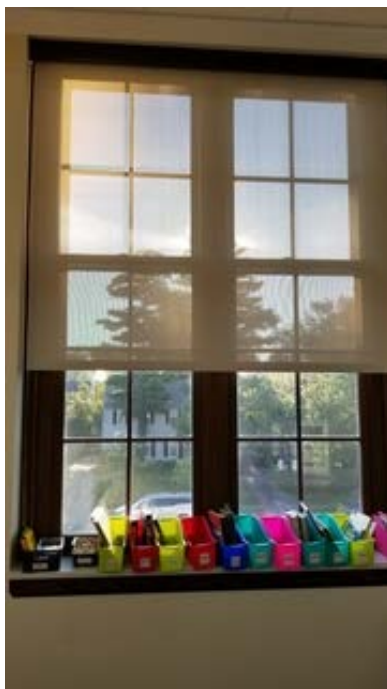
Window with surface mounted blind

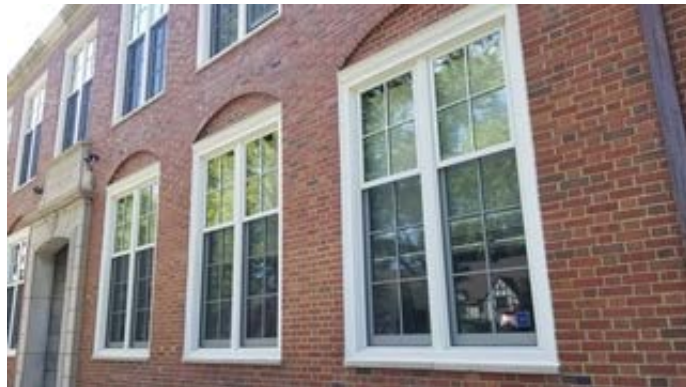
Windows in 1927 original construction

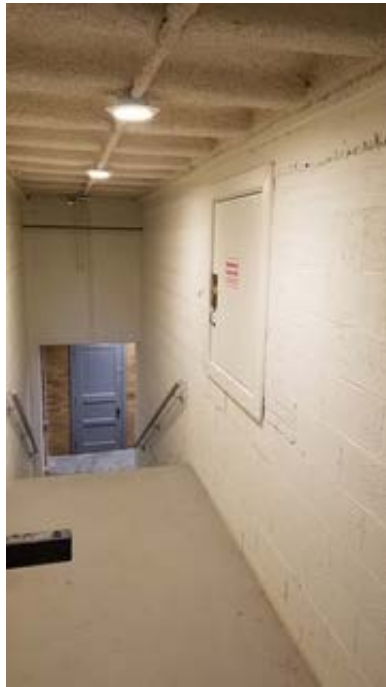
Masonry block foundation walls

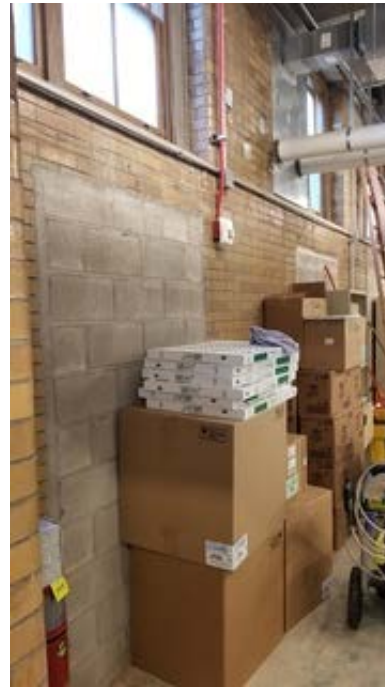
Masonry block and brick foundation walls

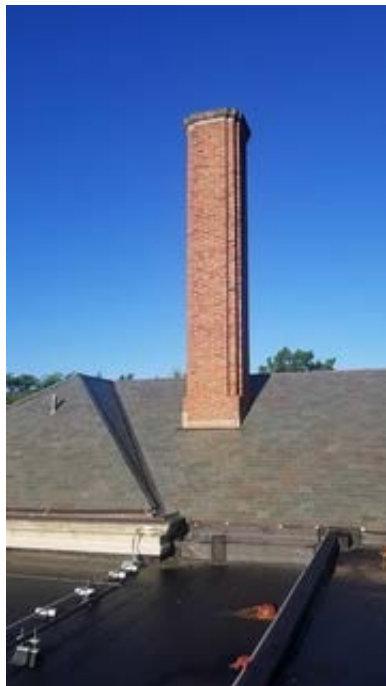
Original chimney restored in 2020 renovation

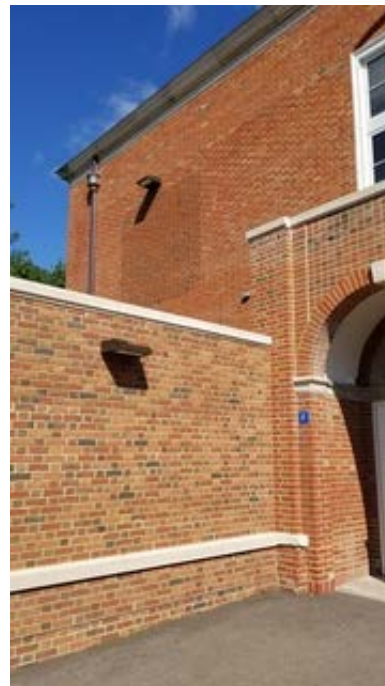
Masonry brick exterior walls

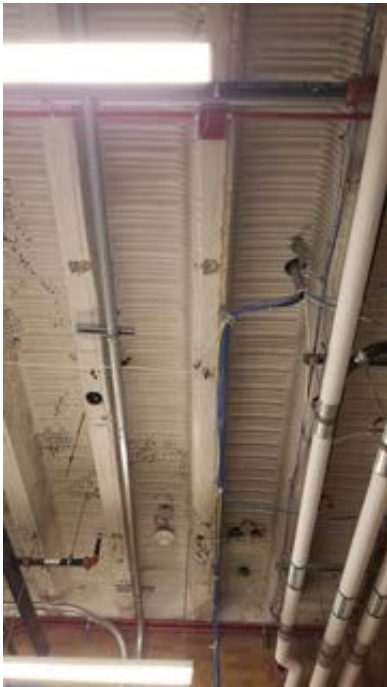
Cast in place concrete floor structure

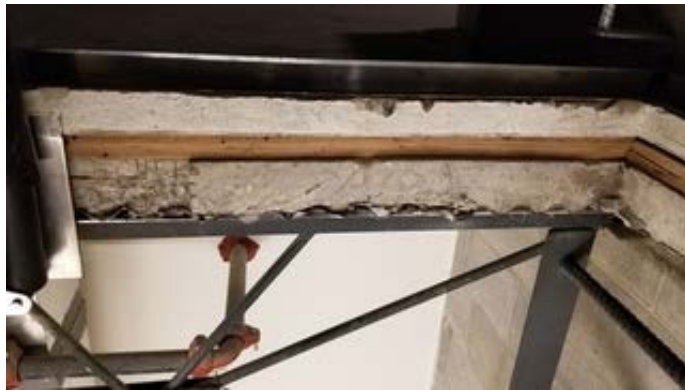
Cast concrete on metal deck at roof structure of 1927 original construction

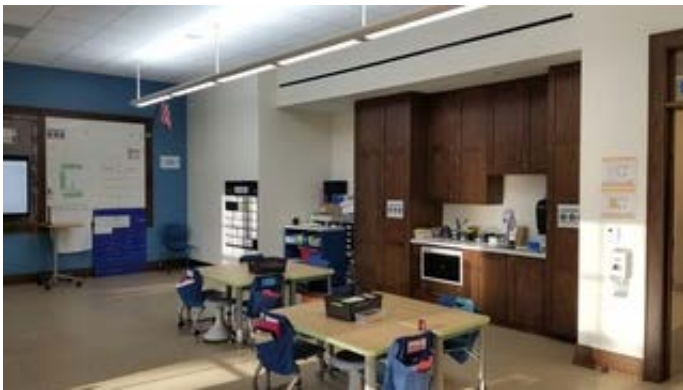
Typical classroom finishes

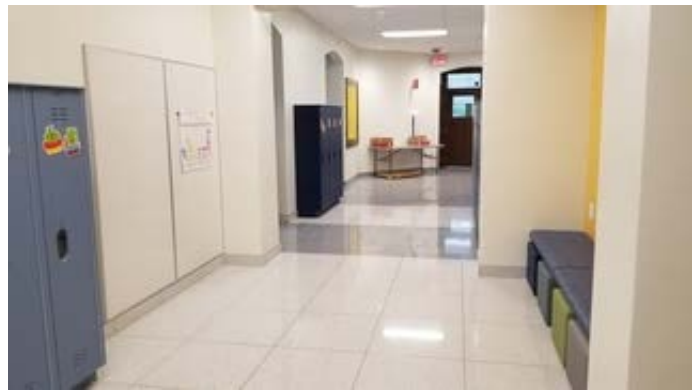
Typical corridor finishes

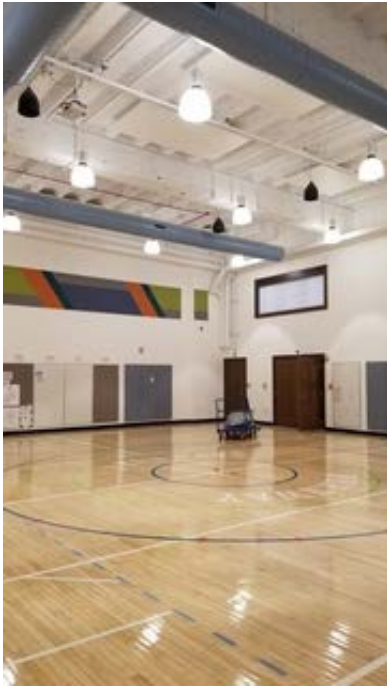
**Description:** Typical classrooms in the overall facility are equipped with LED lay-in trough type fixtures with dual level switching. Classroom fixtures are in good condition, providing an average illumination of 62 FC, thus complying with the 50 FC recommended by the OSDM. The typical corridors in the overall facility are equipped with LED lay-in trough type fixtures with dual level switching. Corridor fixtures are in good condition, providing an average illumination of 45 FC, thus complying with the 20 FC recommended by the OSDM. The primary gymnasium space is equipped with LED pendant fixture type lighting, in good condition, providing an average illumination of 35 FC, which is less than the 50 FC recommended by the OSDM. The media center is equipped with LED lay-in trough type fixtures, as well as LED ring type fixtures in good condition, providing an average illumination of 89 FC, thus complying with the 50 FC recommended by the OSDM. The student dining space is equipped with LED lay-in trough type fixtures with multi-level switching. Student dining fixtures are in good condition, providing an average illumination of 55 FC, thus complying with the 50 FC recommended by the OSDM. No dedicated kitchen space or serving area is provided in the facility. The typical administrative spaces in the overall facility are equipped with LED lay-in trough type fixtures in good condition, providing adequate illumination based on OSDM requirements. The overall lighting systems of the facility are compliant with Ohio School Design Manual guidelines, except for the gymnasium space that has inadequate lighting levels.

Lighting in gymnasium

**Recommendations:** Provide for replacement of lighting system in the gymnasium space due to inadequate lighting levels. 11-3-21 Update: After further investigation; light level in Gym is acceptable.

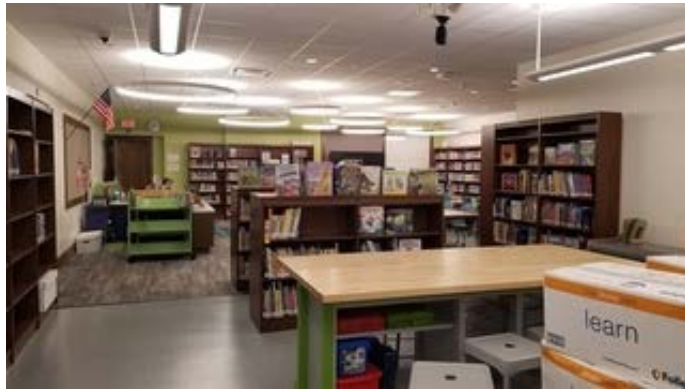
Lighting in media center

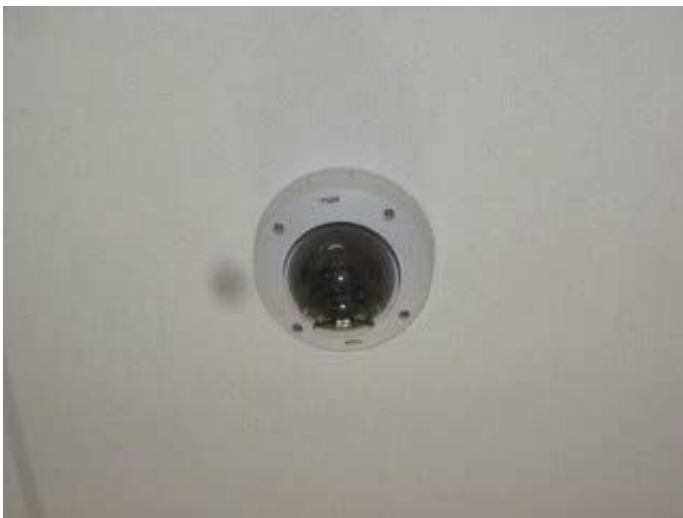
Ceiling mounted security camera

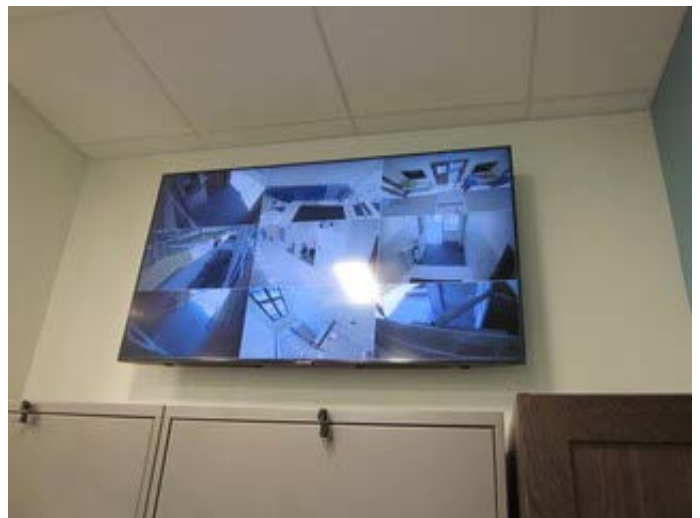
Security camera monitor in main office

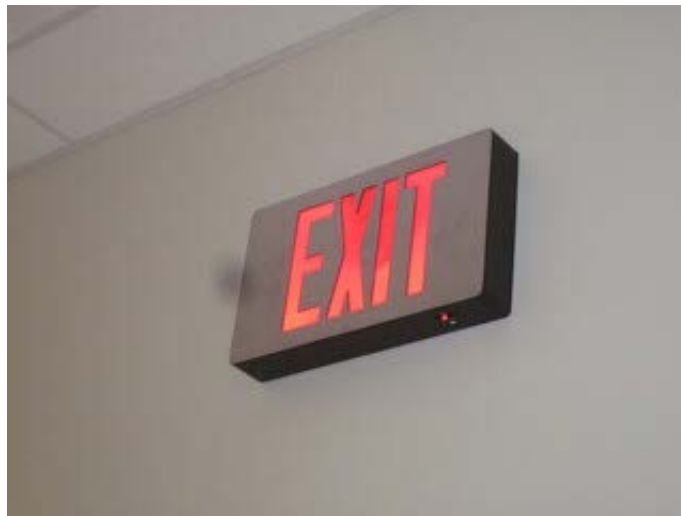
Wall mounted exit signage

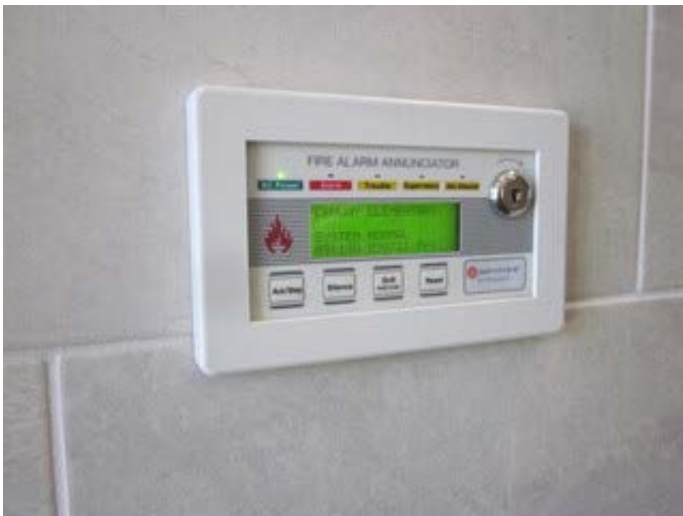
Fire alarm annunciator panel

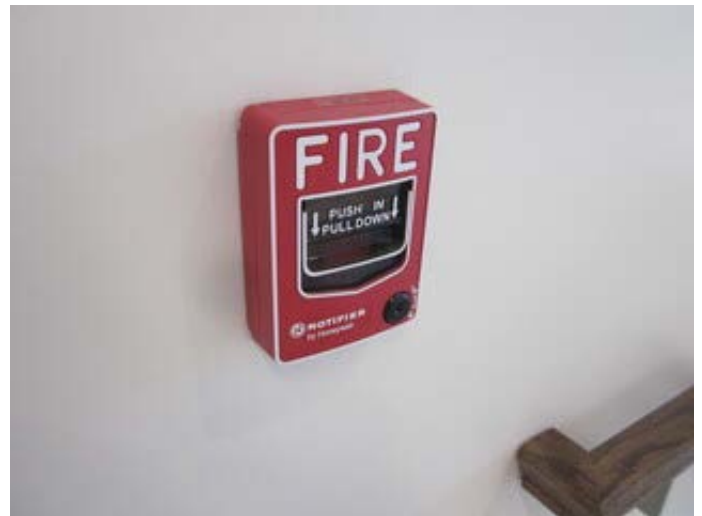
Fire alarm pull station

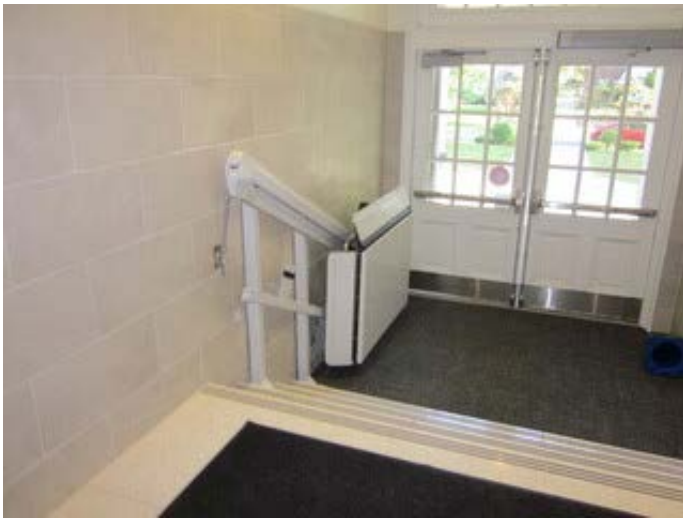
Chair lift at main entry in 1927 original construction

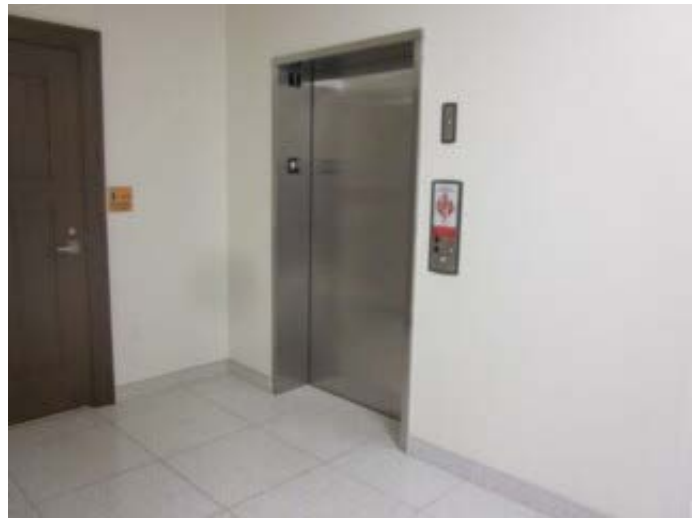
Elevator in 2020 SE and 2nd Floor Media Addition

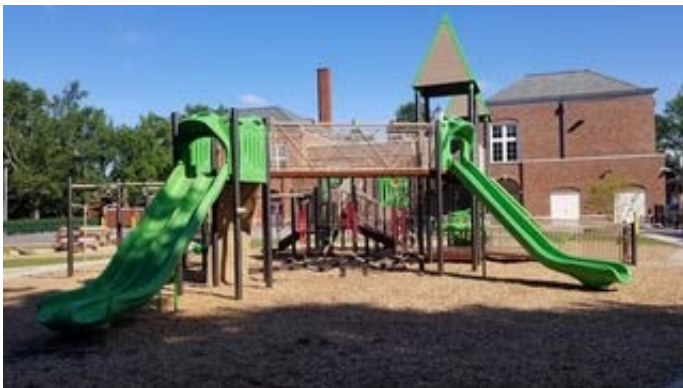
Playground equipment

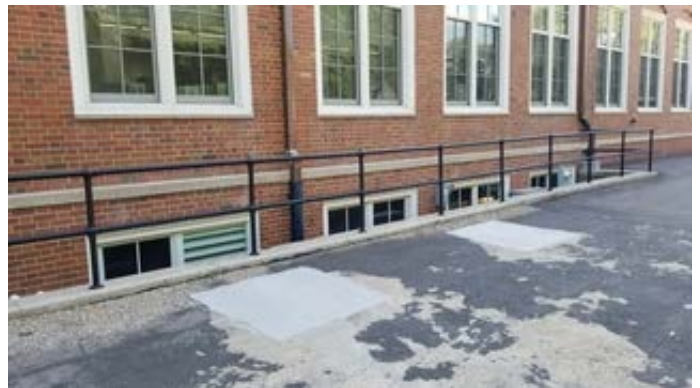
**Rating:** 2 Needs Repair

Exterior railings at 1927 original construction

**Recommendations:** Provide for replacement of railings to meet code requirements. Provide site contingency allowances for unforeseen conditions. Provide for separated bus drop-off for elementary school.

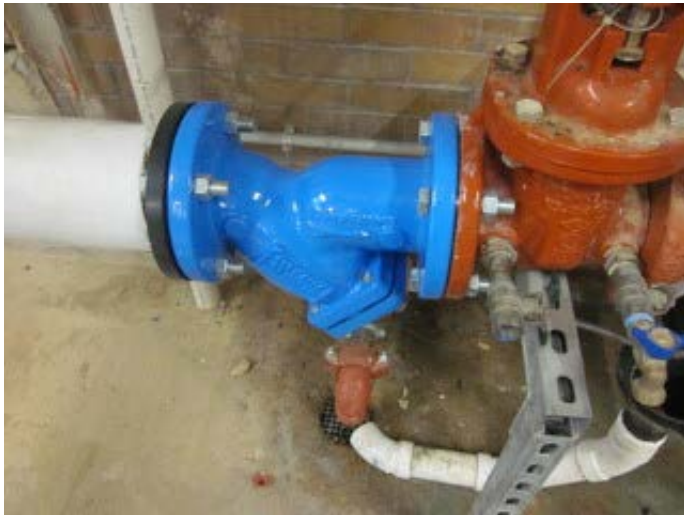
Water service back-flow preventor

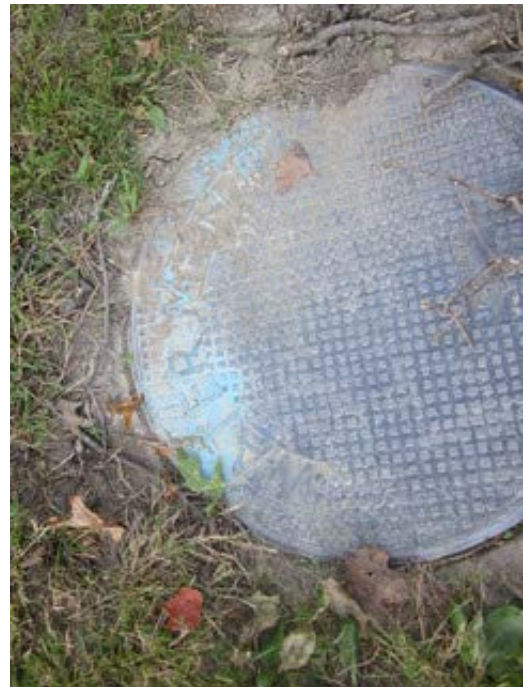
Water service meter pit

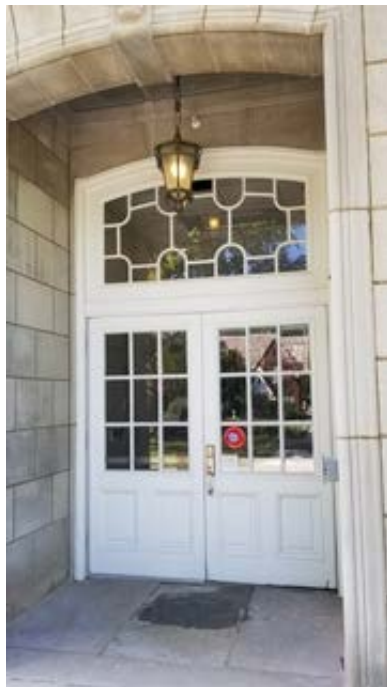
Main entrance doors at 1927 original construction

**Recommendations:** Existing conditions require no renovation or replacement at the present time. Main entrance doors are not being replaced due to historical significance of exterior door and glazing system.

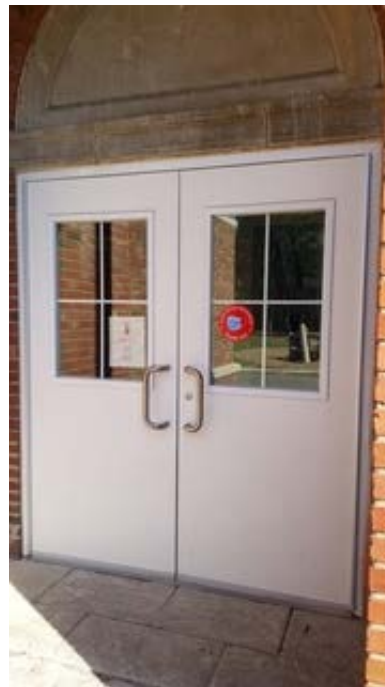
Typical entrance doors

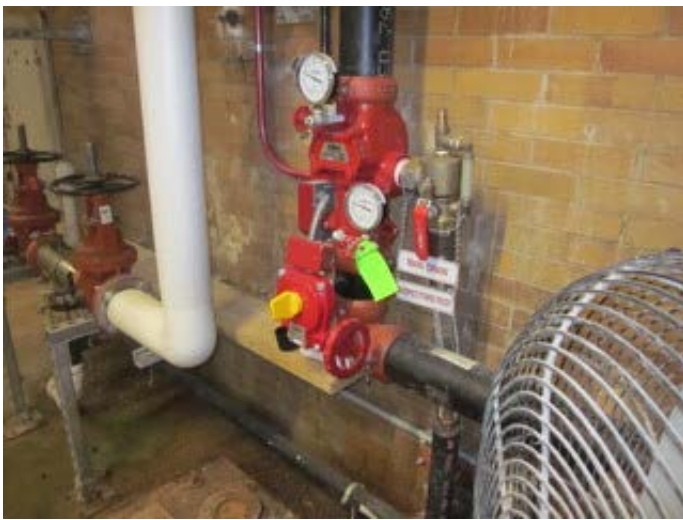
Fire suppression supply piping

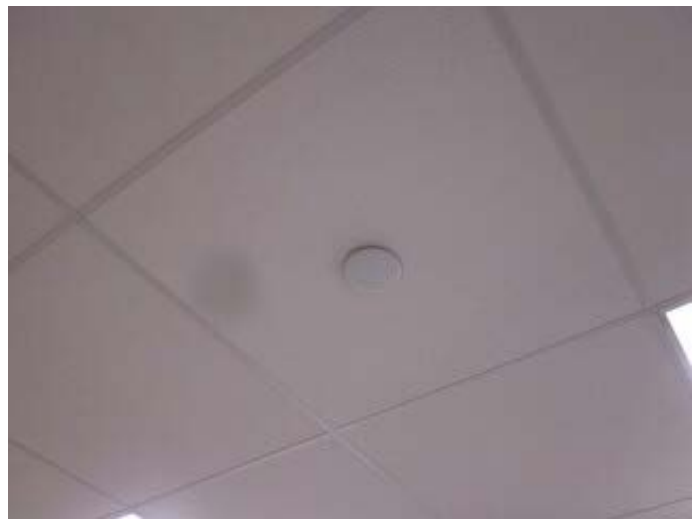
Recessed ceiling mounted sprinkler head

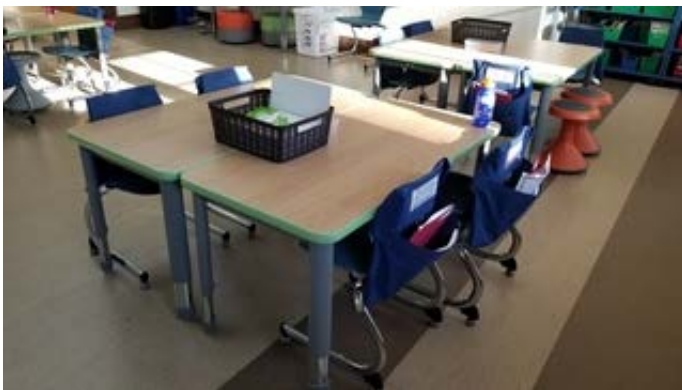
Typical classroom furnishings

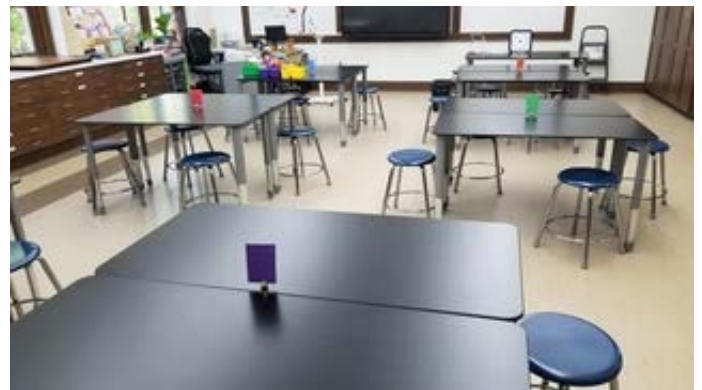
Furnishings in art room

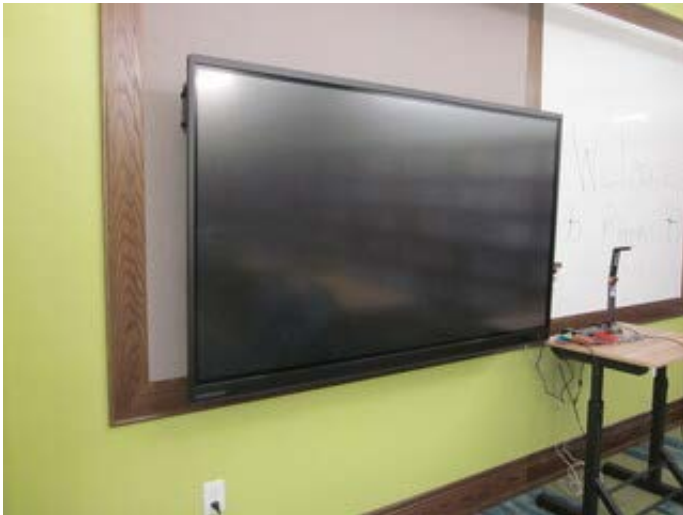
Interactive classroom monitors

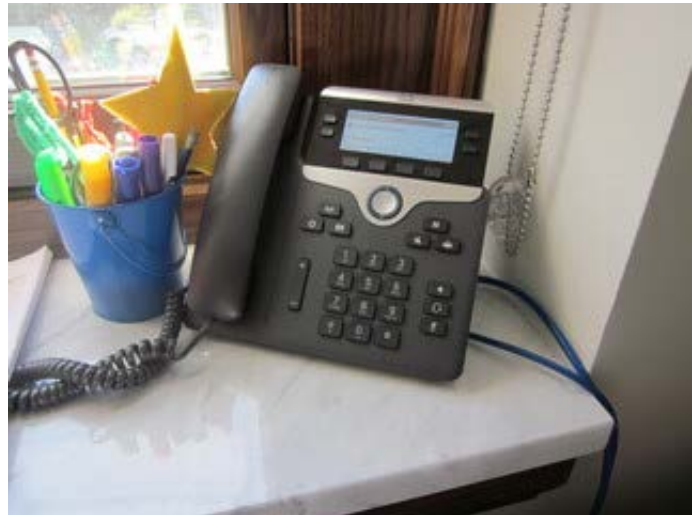
Classroom telephone sets
