SHAKER HEIGHTS

FACILITY ASSESSMENT

Stephanie Tubbs Jones Community Building

December 15, 2021

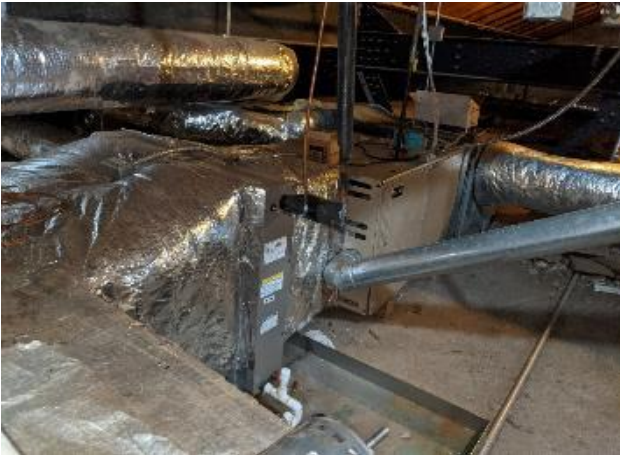
- The Basement is served by 2 gas fired furnaces twinned together.
- The First Floor is served by heating hot water from a boiler located in the basement installed in 1996.
- The Second Floor is served by 3 gas fired furnaces located in the attic with condensing units on the roof.

Gas Fired Furnace in Attic

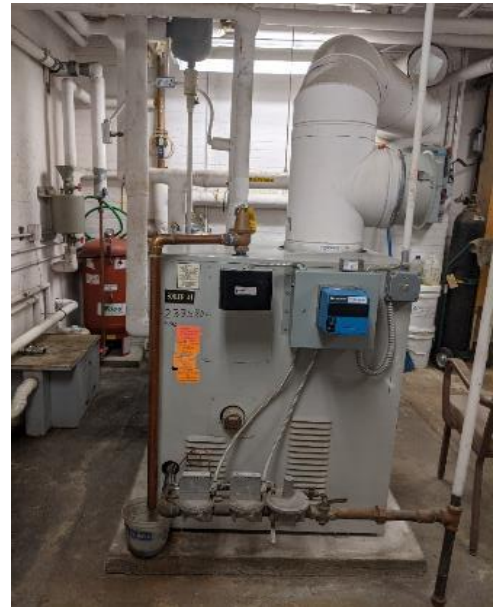
2 Needs Repairs

Boiler

- Replace Boiler serving the First Floor.

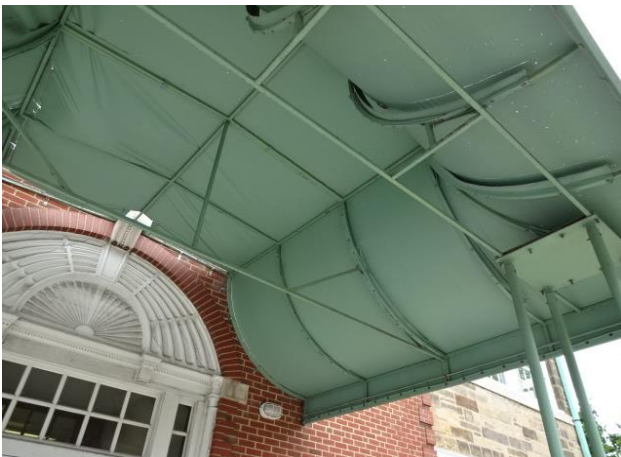
- The roof over the overall facility is asphalt shingles on the sloped roof and a spray applied roofing system on the flat roof areas, and is in good condition. There are no reports of current leaking. Access to the roof was gained by an access door that is in good condition. There were no observations of standing water on the roof. Metal cap flashings are in good condition. Roof storm drainage is addressed through a system of gutters and downspouts, which are properly located, and in good condition.
- No problems requiring attention were encountered with any roof penetrations.
- The entrance canopy is fabric in poor condition over a metal tube framing type system in fair condition. It is supported by steel posts on concrete pedestal that are in poor condition.

Entrance Canopy

- Remove canopy fabric and frame, repaint the metal tube framing, replace the concrete support post, replace concrete bases, and reinstall.

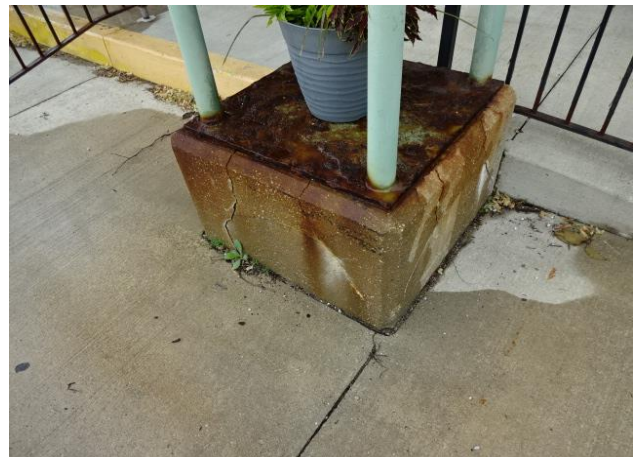
Entrance Canopy Foundation

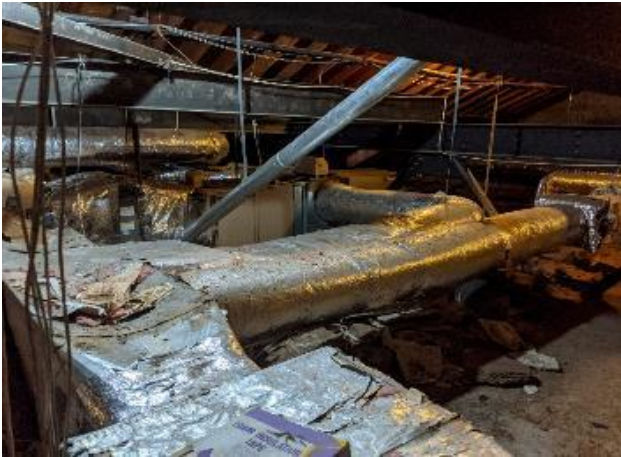
- Insulation on ductwork in Attic is falling off and ductwork is leaking. Rework ductwork so it is at a different elevation.
- There are 3 furnaces in the Attic with remote condensing units on the roof that serve offices on the Second Floor. Duct branches have a terminal unit with area thermostat.

Furnace and Dented Ductwork

- Provide selective replacement of insulation and ductwork.

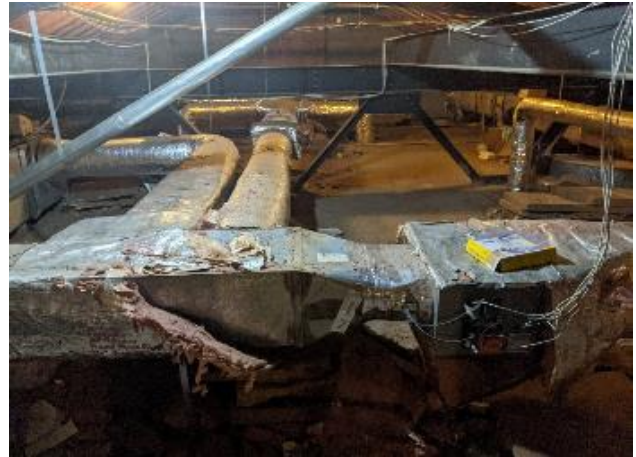
Terminal Unit and Missing Insulation

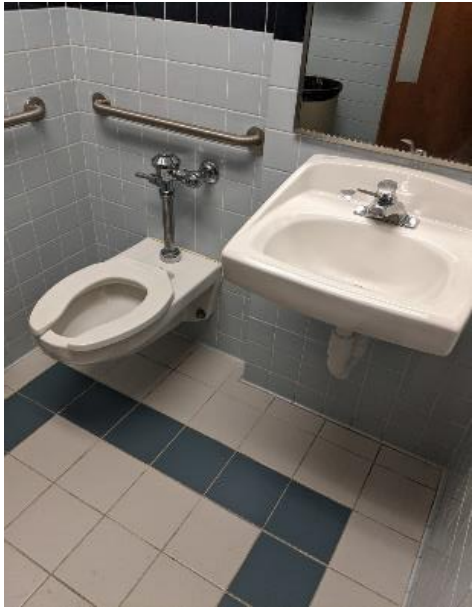
- The public restrooms are ADA-compliant, the Staff Restrooms and Unisex Restrooms are not.
- Condition of fixtures is good. All fixtures are manual style.

Manual Style Plumbing Fixtures

- Update manual fixtures with electronic sensors and flush valves.
- Refer to Section O for Plumbing related costs.

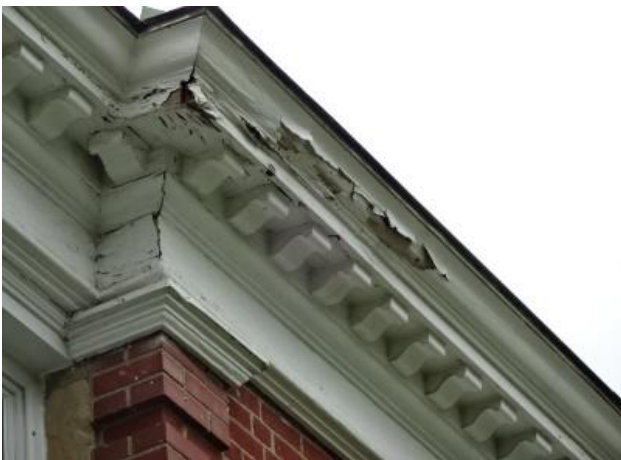
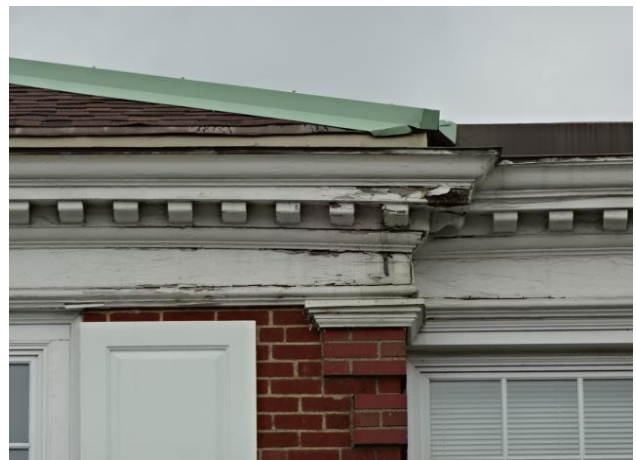
- The cornice is wood construction and there are areas with separation of boards, peeling paint, wood rot and decay. These areas are primarily where the brick and stone veneer meet and create jogs in the cornice. The cornice is made up 10 separate wood mouldings plus the blocking behind the mouldings.

Wood Cornice

- Replace wood cornice sections that have decay. Paint cornice and trim.

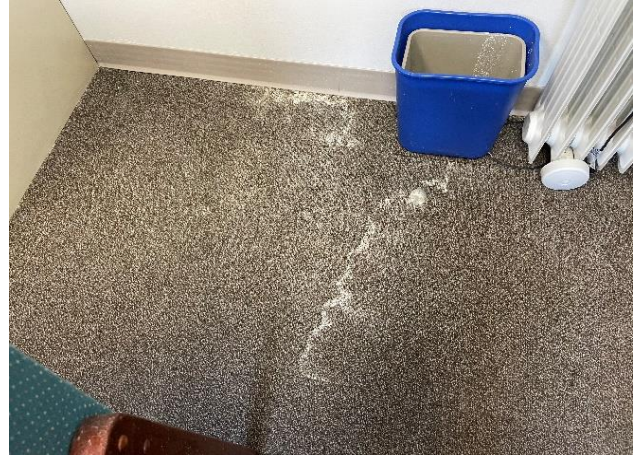
Carpet (Second Floor)

- Provide replacement of finishes on the first and second floors due to age and wear of finishes, with work recommended within 4 – 7 years.
- Provide replacement of carpet on the basement level due to age of the product, with work recommended in 4-7 years.
- Funding for replacement of interior doors is provided in Item O, including doors that are in poor condition.

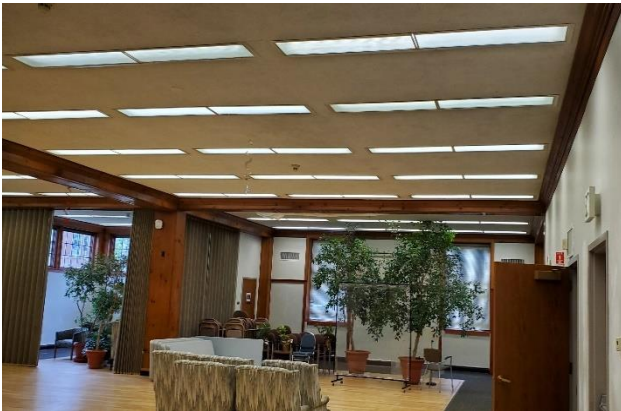
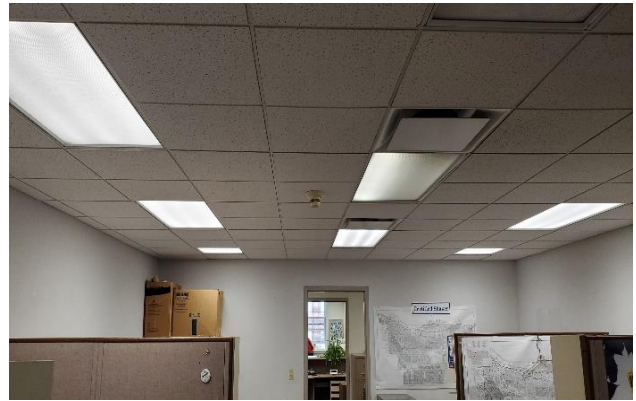
- The building contains 2- or 3-lamp fluorescent recessed fixtures in fair condition.
- The building does not have lighting controls that conform to energy code.

1st Floor Assembly Lighting

- Replace fluorescent fixtures with new LED fixtures.
- Provide new lighting controls to meet energy code requirements.

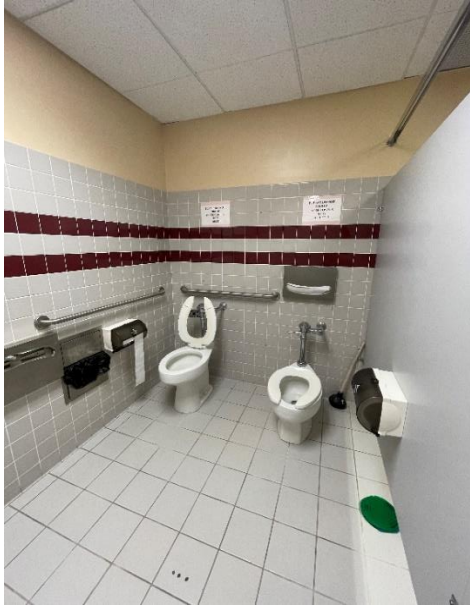
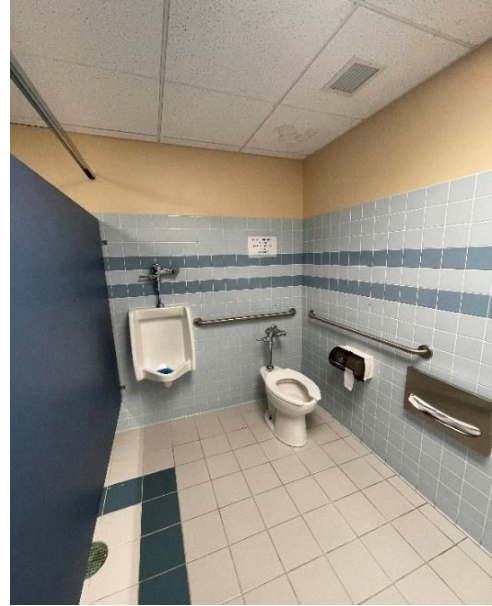
- Staff Restrooms on the second floor are not ADA compliant.
- ADA-compliant toilet partitions, accessories, and mirrors are provided in the public restrooms in the lower level. However, an additional fixture (1 toilet, 1 urinal) is still present in each of the ADA stalls which encroaches on the required clear space.

Basement Level Restroom with Extra Fixture

- Provide ADA-compliant toilets, sinks, toilet partitions, and toilet accessories in the second floor staff area to facilitate the building's meeting of ADA requirements, with work recommended as soon as practicable.
- Provide ADA-compliant door hardware in the overall facility where knob handles still occur to facilitate the building's meeting of ADA requirements, with work recommended as soon as practicable.

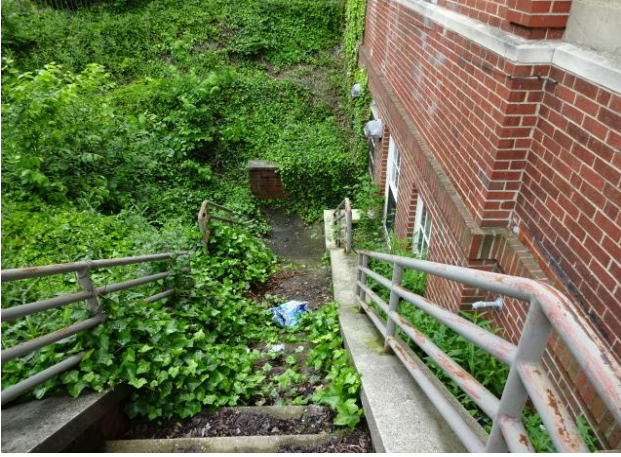
- The steel guardrails at the main entrance and the lower level are in fair condition.
- The dumpster enclosure fence is in fair condition.
- The landscaping at the garden terrace leading to the lower level and shrubs around the building are overgrown.

Overgrown Landscaping and Railings

- Replace concrete sidewalk.
- Replace concrete curb.
- Clean and paint wood dumpster enclosure fence.
- Paint railing to basement level and at main entrance area.
- Replace overgrown landscaping.
- Clean stone pavers and replace grout in joints.

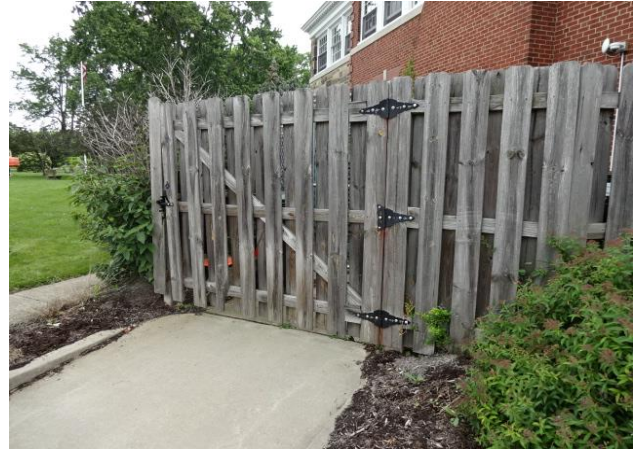
Dumpster Enclosure Fence

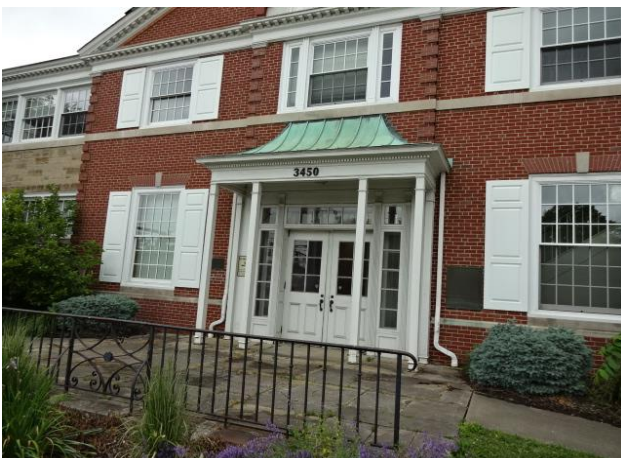
Wood Doors on East Side

- Replace the rusting door lite frame in the hollow metal door, with work recommended within 0-2 years.
- Replace painted wood doors, transom and sidelights with insulated doors and insulated glazing, with work recommended within 3-4 years.
- Painted wood doors, transom and sidelights, with work recommended within 0-2 years.
- Refinish wood doors at basement level, with work recommended within 0-2 years

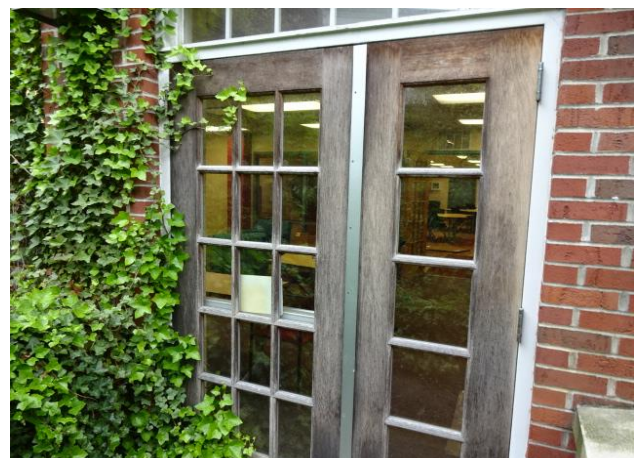
Wood Doors at Basement Level

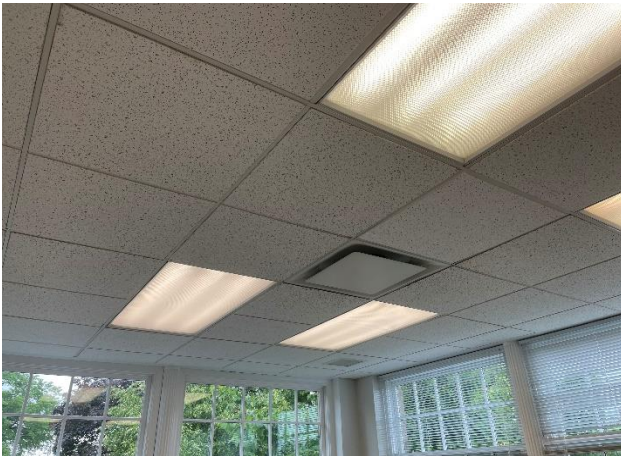
- There was no previous Asbestos Inspection Report provided. However, given the date of original construction and building methods, it is assumed that Asbestos Containing Building Materials (ACBM) were used. A Hazardous Materials Inspection should be performed to accurately determine the presence and condition of any ACBM within the building.
- Removal and replacement of fluorescent lighting in Item K will require special disposal.

Fluorescent Lighting

- Provide for disposal of fluorescent lighting.

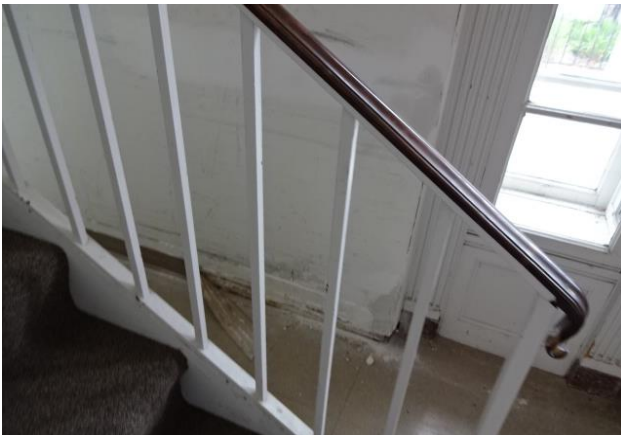
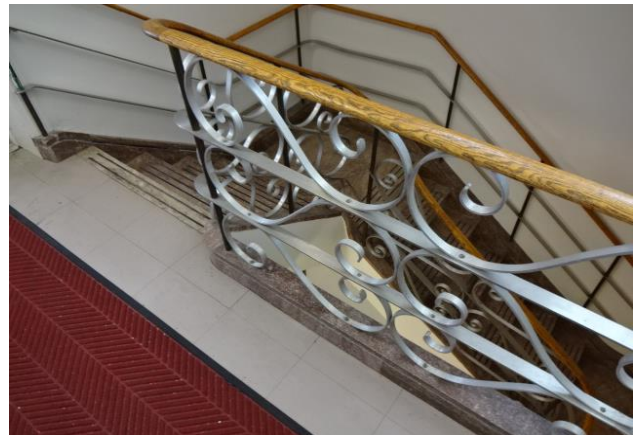
Handrail to be Replaced

- Consider sprinkling remainder of the building.
- Provide new handrails to meet the requirements of the Ohio Building Code, with work recommended as soon as practicable.

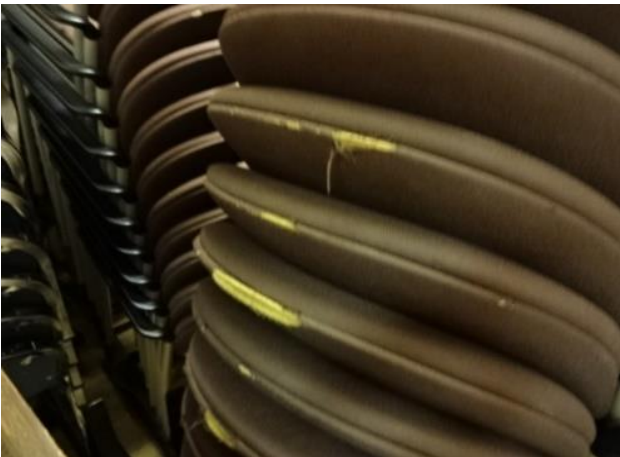
- The typical public space furniture is of consistent design, and in generally poor condition, consisting of tables, chairs, and lounge furniture. The facility's furniture and loose equipment were evaluated, and on a scale of 1 to 10 the overall facility received a rating of 3 due to observed conditions.

Meeting room chairs

- Provide for replacement of outdated or inadequate furnishings, with work recommended within 0-2 years.

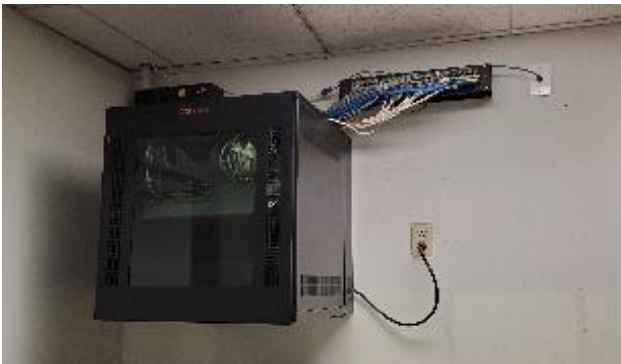
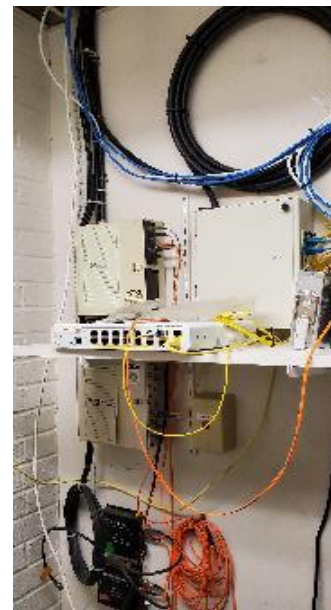
Telecom Equipment

- Replace outdated telecom system.
