**Building Information - Shaker Heights City (44750) - Lomond Elem**

**Building Pictures - Shaker Heights City(44750) - Lomond Elem(21279)**

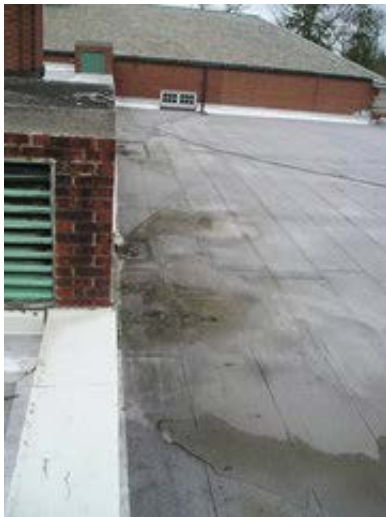
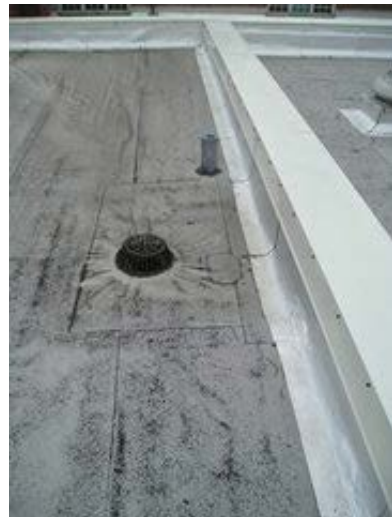
**Description:** Low sloped roof areas are covered with built-up roof with a granular top sheet. Some stained ceiling tiles were observed on the top floor. Metal copings are present around the perimeter. Drainage is facilitated by curb type inlets along the north edge of the roof. Drainage for the largest areas of this roof is supported by only 2 of these drains. The granules have worn off in several areas around the roof. Indications of ponding were observed at many areas of the low-sloped roof. Some parts of the roof are remote from the roof drainings. Efflorescence from leakage was observed near the north wall of the gymnasium. Areas of pitched roof are covered by original slate shingles. Water fall is collected by metal gutters at concealed areas, metal lined box gutters at areas visible from grade, and metal downspouts. Water collection features appear to be original to the 1926 building and are past their service life.

Evidence of ponding taking place several feet from point of drainage. Worn away top ply granules are collecting around this roof drain.

**Recommendations:** Provide a new built-up roof with adequate slope to ensure unimpeded drainage of the roof. Provide adequate overflow drains drains for evacuation of water from the roof. Provide new downspouts to replace the original water collection items. 01-27-16 UPDATE: REPLACE SLATE ROOF WITH ASPHALT SHINGLES ON ORIGINAL 1928 ORIGINAL BUILDING AND 1954 ADDITION. REPLACE BATT INSULATION ON SLOPED ROOFS ON 1928 ORIGINAL BUILDING AND 1954 ADDITION. PROVIDE FOR DECK REPLACEMENT ON SLOPED ROOF AREAS OF 1928 ORIGINAL BUILDING AND 1954 ADDITIONS. REPLACE GUTTERS AND DOWNSPOUTS ON SLOPED ROOF AREAS OF 1928 ORIGINAL BUILDING AND 1954 ADDITIONS. PROVIDE FOR TAPERED INSULATION TO CORRECT WATER PONDING ON LOW SLOPE ROOFS AREA OF 1928 ORIGINAL BUILDING AND 1954 ADDITION. PROVIDE BUDGET FOR REPAIRS TO SAGGING SLOPED ROOF TRUSSES ON 1928 ORIGINAL BUILDING. REPAIR LIGHTENING PROTECTION CABLE. 11-2-21 Update: Remove scope completed in 2019 & 2021. Slate repairs; adjust remaining replacement areas to match district's study/plan.

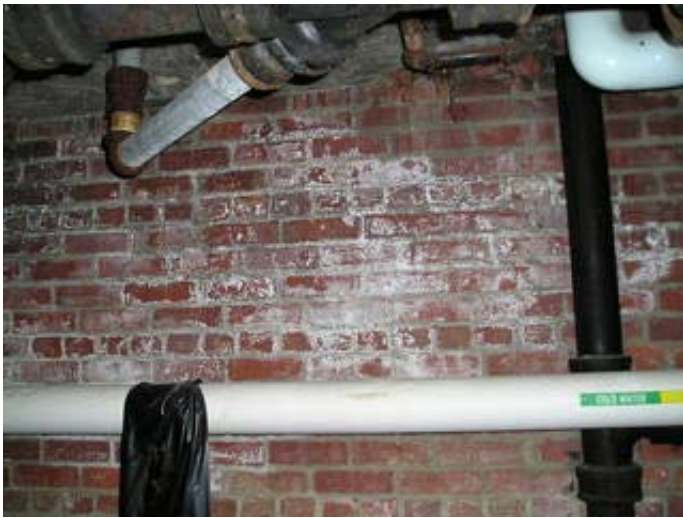
**Description:** Masonry foundation walls and piers were observed in the mechanical areas. Efflorescence and other indications of water breach were observed in these areas.

Efflorescence was observed on this tunnel wall

**Recommendations:** Provide sump pumps as necessary to evacuate ground water from areas adjacent to the basement mechanical spaces. 01-27-16 UPDATE: PROVIDE BUDGET TO DEMOLISH EXISTING COAL ROOM AT 1928 ORIGINAL BUILDING. INSTALL VAPOR BARRIER AND MUD SLAB IN CRAWLSPACE OF 1928 ORIGINAL BUILDING. PROVIDE WATERPROOFING MEMBRANE AND DRAINAGE TILE SYSTEM FOR FOUNDATION WALLS AT 1928 ORIGINAL BUILDING AND 1954 ADDITION. PROVIDE WATERPROOFING MEMBRANE AT CRAWLSPACE WALLS IN 1928 ORIGINAL BUILDING AND 1954 ADDITION. DELETE SUMP PUMP AT 1971 ADDITION. 11-2-21 Update: Remove all work completed in 2020.

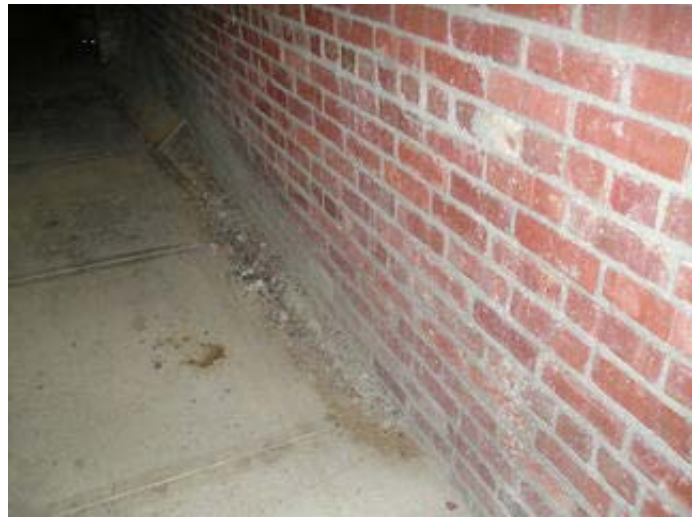
Moisture was observed on the floor near this tunnel wall

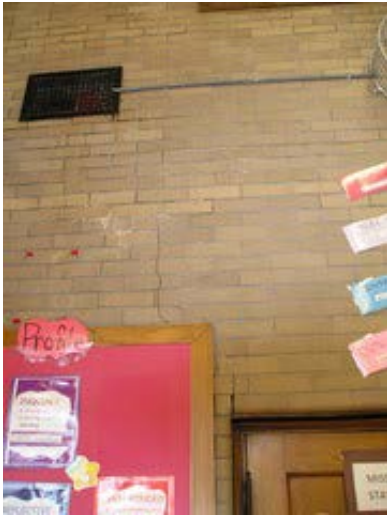
A crack leads from the upper left corner of this door

**Recommendations:** Provide expansion joints around the interior masonry walls as necessary to alleviate stress induced cracks. Clean and seal the masonry at the mechanical stacks to minimize water penetration through the brick veneer. 01-27-16 UPDATE: REPLACE SANDSTONE CORNICE ON 1928 ORIGINAL BUILDING. REPLACE CAULK AROUND WINDOWS AND DOORS IN 1928 ORIGINAL BUILDING. ADD WEEPS ABOVE WINDOW LINTELS ON ORIGINAL 1928 BUILDING AND 1954 ADDITION. REBUILD AREA WELL MASONRY WALLS IN 1928 ORIGINAL BUILDING. PROVIDE TUCKPOINTING ON 1928 ORIGINAL BUILDING. PROVIDE FOR REPLACEMENT OF SANDSTONE CORNICE. CAULK JOINTS IN SANDSTONE. PROVIDE FOR EXTERIOR MASONRY CLEANING AND SEALING ON 1928 ORIGINAL BUILDING, 1954 ADDITION AND 1971 ADDITION. REPLACE CRAWLSPACE VENTS WITH LOUVERED VENTS WITH VERMIM PROOF SCREENS. 11-2-21 Update: Remove all work completed in 2019 & 2020; cleaning & sealing, tuckpointing, masonry repair & caulking.

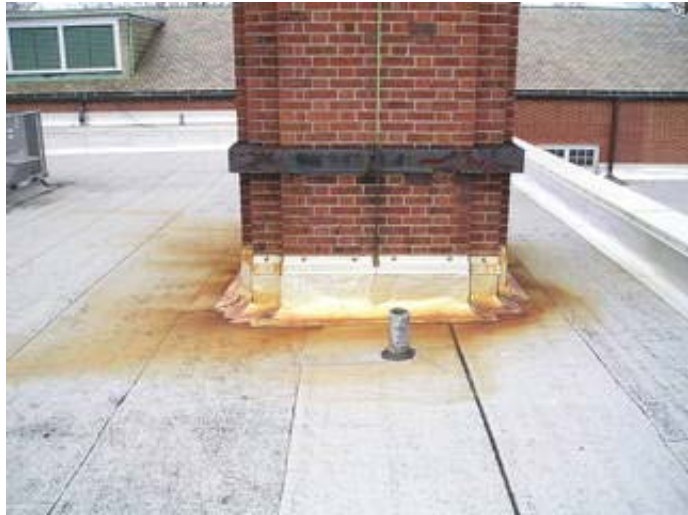
**Description:** Load bearing masonry walls are present throughout the building. m Exterior load bearing walls are brick clad. Some damaged mortar joints were observed. However, the mortar joints has been repaired. Cracking related to movement was observed on the interior wall of the gymnasium. A large stack on the roof has been braced by structural steel straps. The straps are corroding and the corrosion is has stained the roof and flashings.

Steel straps are corroding and stack stability could be compromised.

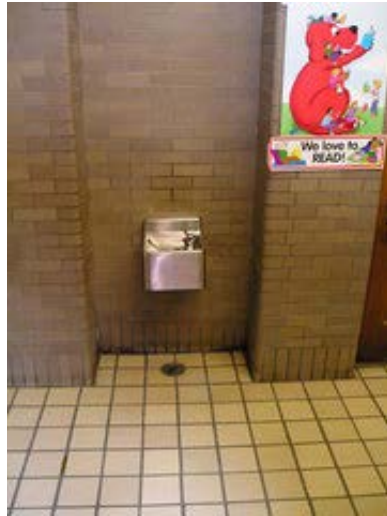
Drinking fountain not wheelchair accessible

**Recommendations:** The following should be provided to ensure accessibility throughout the building. - Elevator for 1st and 2nd levels - High contrast braille embossed signage - Lever style door operators - Wheelchair lift at the stage - Wheelchair accessible drinking fountains - wheelchair accessible toilet fixtures and stalls - ADA assist at main entrance and playground access door. 01-27-16 UPDATE: REVISE NUMBER OF STOPS FOR ELEVATOR TO 3 IN 1928 ORIGINAL BUILDING. PROVIDE POWER ASSIST DOOR OPERATOR FOR 1954 ADDITION. REWORK INTERIOR DOOR OPENINGS IN 1928 ORIGINAL BUILDING AND 1954 ADDITION TO MEET ADA.

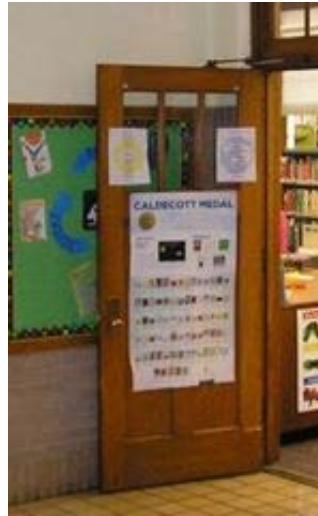
Door hardware is not ADA compliant

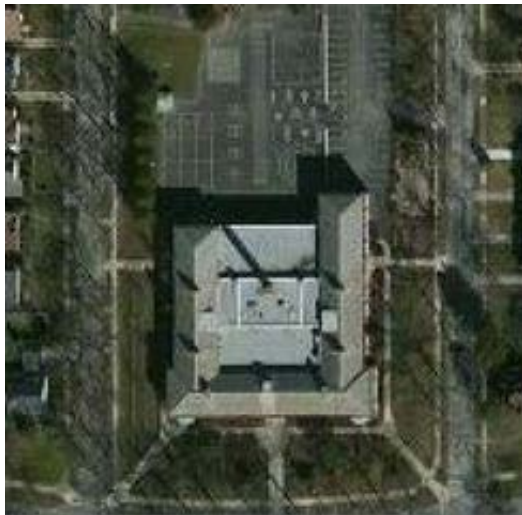
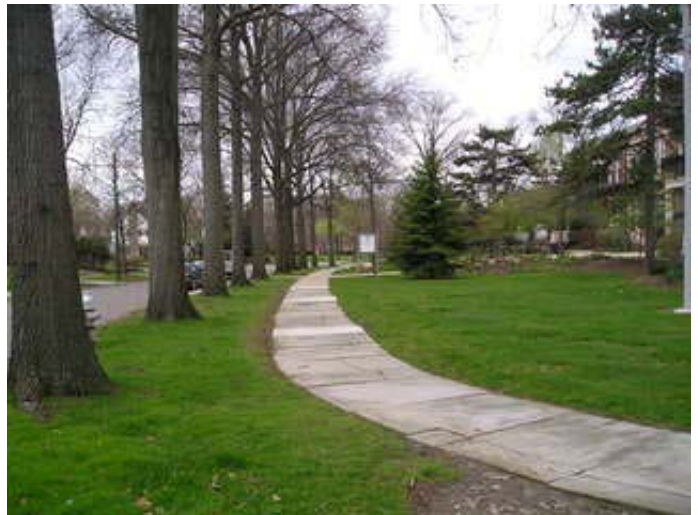
**Description:** The site performs well overall. Recent model playground equipment was observed for recreation of the students. Asphalt paved parking lots and playgrounds show some cracking, but no major damage, tripping or driving hazards were observed. Separate areas for bus and vehicular drop-off were not observed. A suitable concrete dumpster pad was not observed.

No physical provisions are there to separate bus from vehicular drop-off.

**Recommendations:** Provide paved areas which separate bus drop-off from vehicular drop-off. 01-27-16 UPDATE: PROVIDE FOR ADDITIONAL PARKING SPACES. STABILIZE HILLSIDE AND REPLACE STAIRS AND HANDRAILS @ MAIN ENTRANCE OF 1928 ORIGINAL BUILDING. REPLACE STAIRS, RAMPS, SIDEWALKS AND LANDSCAPING AT 1928 ORIGINAL BUILDING, DUE TO EXCAVATION FOR WATERPROOFING OF FOUNDATION WALLS. REPLACE SIDEWALKS AT 1928 ORIGINAL BUILDING. REPAINT HANDRAILS AT 1928 ORIGINAL BUILDING. PROVIDE FOR SOFT SURFACE PLAYGROUND AND HANDICAP SWING. 11-2-21 Update: Remove work completed in 2020: Concrete stair replacement and partial sidewalk replacement.

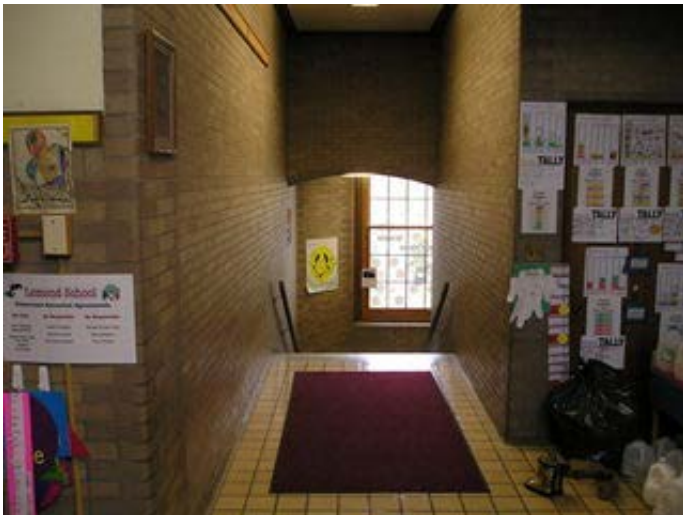
**Description:** The building is not equipped with an automatic fire suppression system. No provision for preventing the vertical spread of fire through the stairways was observed. The facility is NOT equipped with an emergency generator.

This stair will foster vertical fire spread.

**Recommendations:** Provide an automatic fire suppression system. Provide increase water service of a capacity sufficient to support the fire suppression system, funding included in Water Service section R for new water service for fire suppression. Provide an emergency generator to meet the needs for this building. Provide a fire rated enclosure around the stairs to prevent vertical fire spread. Provide a means of fire stopping at the borrowed lights in the 2nd floor. 01-27-16 UPDATE: REPLACE STAIR TOWER HANDRAILS IN 1928 ORIGINAL BUILDING. PROVIDE FOR PRE-ACTION FIRE SUPPRESSION SYSTEM IN ATTIC SPACE OF 1928 ORIGINAL BUILDING AND 1954 ADDITION.

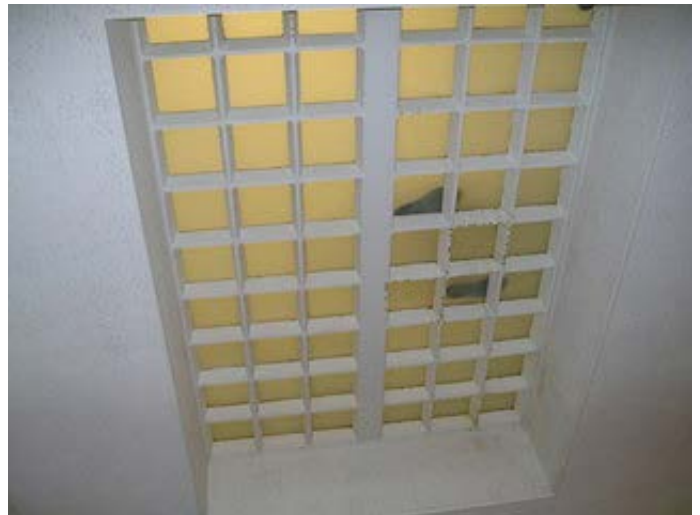
Glass block block in the floor may foster vertical fire spread
