# SHAKER HEIGHTS

## FACILITY ASSESSMENT

Bertram Woods Branch Library

January 19, 2022 - Revision 1

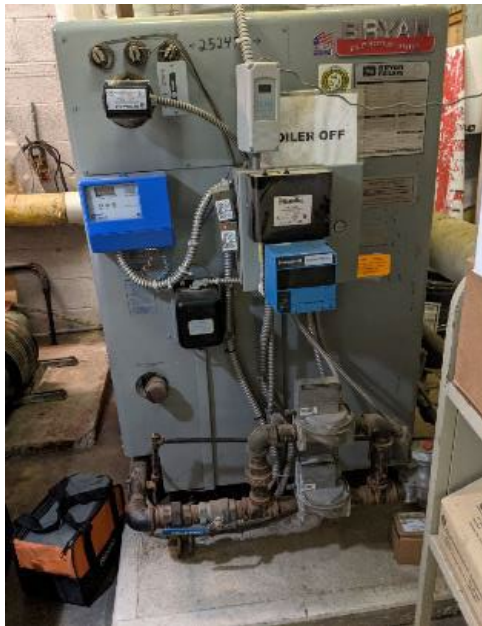
- The heating hot water boiler installed in 1999 serves hot water coils at AHUs, FCUs and radiant finned tube.
- Boiler pumps and piping are rusting.

- Recommend replacing boiler as it is nearing the end of its life expectancy.
- Recommend replacing pumps and accessory equipment prior to failing.

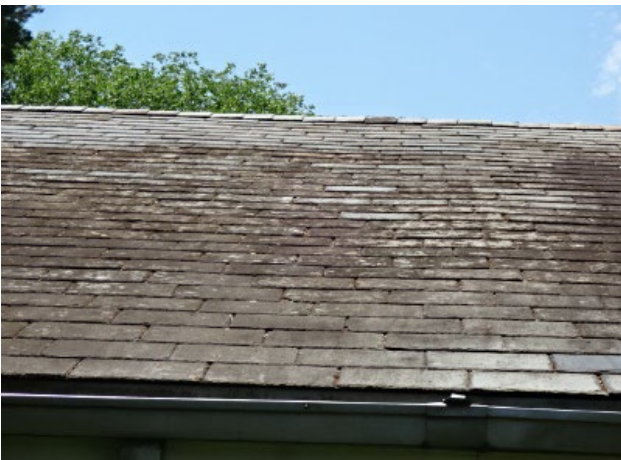
Slate Roof

- The roof on the overall facility is a slate roof system that is in fair condition. There is a small area of standing seam metal roof that is in fair condition. There are no reports of current leaking. There are a few cracked, chipped, and missing slate that should be replaced as part of routine slate roof maintenance. No signs of past leaking were observed during the physical assessment.
- Roof observations on the single story building were made from the ground. The building does not have access hatches or fixed ladders.
- There were no observations of standing water on the roof. Roof storm drainage is addressed through a system of stainless steel gutters and downspouts, which are properly located, and in fair condition.
- No problems requiring attention were encountered with any roof penetrations.

- The slate roof over the overall facility requires replacement.
- The metal roof requires replacement due to condition and age of system.

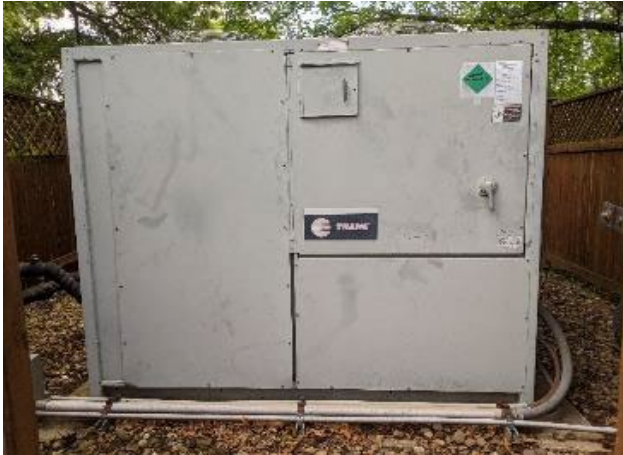
Outdoor Air-Cooled Chiller

- The AHU serving the children's area has DX refrigerant cooling with a condensing unit mounted outdoors.
- An outdoor air cooled chiller installed in 1999 serves the AHU serving remainder of building.
- Chilled water also serves FCUs around the perimeter of the building.

- The outside air cooled chiller is nearing the end of its life expectancy and should be replaced.

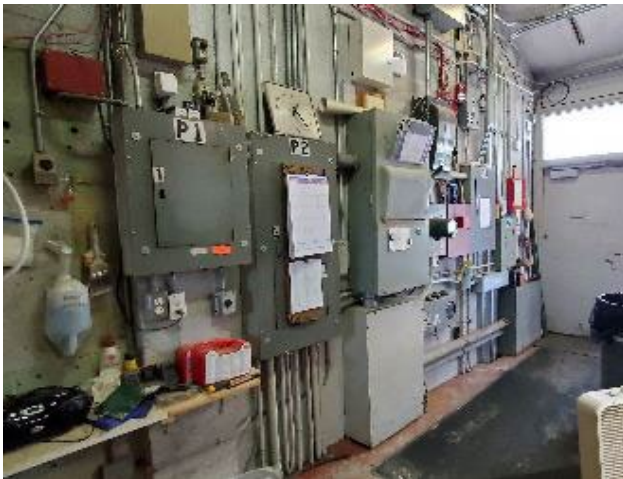
Main Electrical Equipment

- The building contains two electrical services: a 400A, 208/120V, 3-phase service and a 200A, 208/120V, 3-phase service. The building does not have an emergency generator.
- Most of the electrical equipment is old and in poor condition.
- Three panelboards were installed in 2002. These are in good condition and do not need replacement.

- Replace the two electric services with a single service.
- Replace all old electrical equipment in the main electrical room.

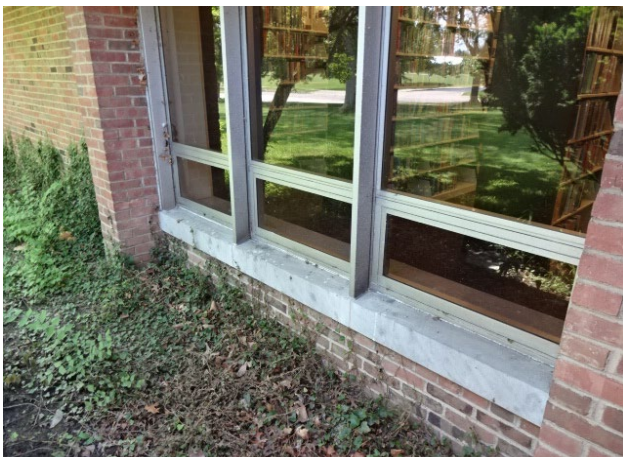
Window System

- Most of the facility is equipped with aluminum frame window systems with single glazed type windows, which are in fair condition. The older window system features operable windows in most areas of the building, and the operable windows are not equipped with insect screens. Window system seals are in fair condition, with minimal air and water infiltration being experienced. Window system hardware is in fair condition. The window system features surface mounted blinds, which are in good condition.
- The bay window is newer and equipped with aluminum frame windows with insulated glazing in good condition.
- The building does contain 12'x15' polycarbonate panel skylights in poor condition and showing deterioration on the outside.

- Due to age and condition, replace the existing non-insulated window system with a new insulated window system to match the existing insulated system, with work recommended within 4 years.
- Due to age and condition, replace the existing polycarbonate skylight panels. Work recommended within 4 years.

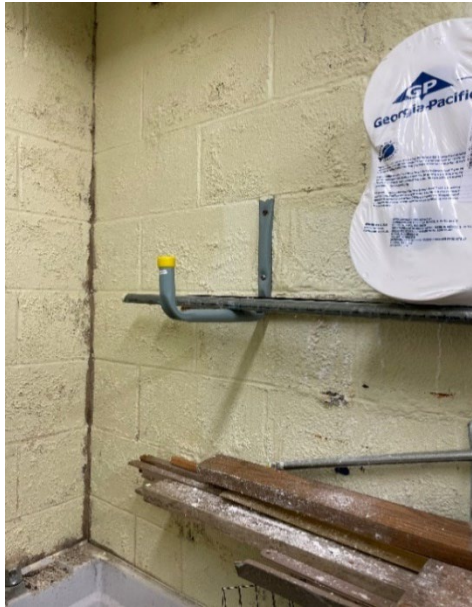
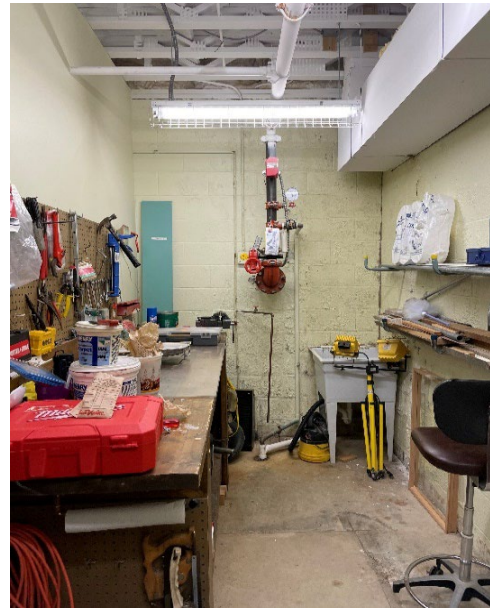
- The overall facility is equipped with concrete masonry unit foundation walls, which displayed no significant differential settlement or cracking, and are in good condition. No significant issues related to foundation cracking or spalling were encountered. No grading or site drainage deficiencies were noted around the perimeter of the structure that are contributing or could contribute to foundation / wall structural deterioration. There is a section of the basement where the paint is peeling off the the wall, which indicates wall dampness.

Peeling Paint at Foundation Wall

- Excavate the exterior side of the basement wall where paint is peeling and waterproof the wall.

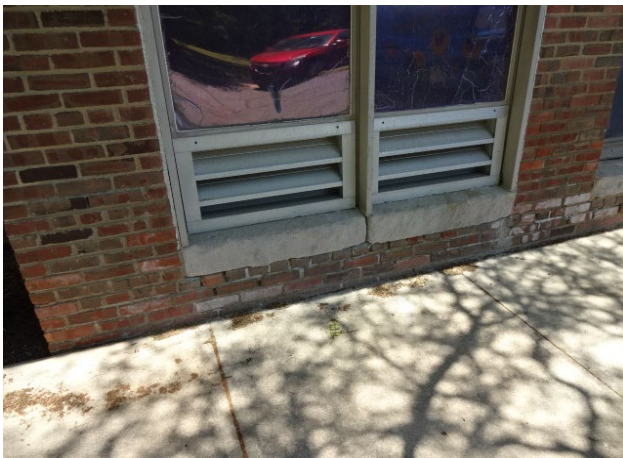
Stone Sills

- The overall facility has a brick veneer on load bearing masonry wall system and steel framing, and is in good condition. There is a small amount of deterioration near the mechanical room. The brick chimney is in good condition.
- Lower level walls are concrete masonry units and are in good condition.
- Interior corridor and demising walls are metal stud with gypsum board, project full height from floor to bottom of deck, and are in good condition. Interior masonry appears in good condition.
- The window sills are stone, and most are in good condition. Three stone sills at the Mechanical Room are deteriorating. The exterior lintels are steel, and are in good condition. Exterior soffits and fascia are of wood type construction, and in good condition.

- Replace 3 stone window sills near the Mechanical Room, with work recommended within 4 years.

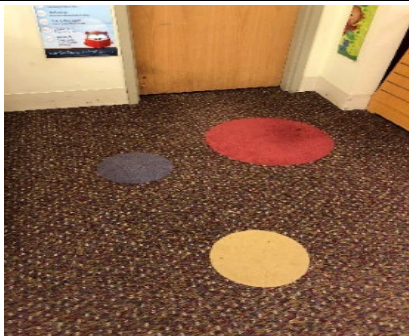
Existing Library Carpet

- The overall facility features conventionally partitioned rooms and open library space. The library and offices have carpet flooring, ACT and gypsum board ceilings, and painted plaster and exposed brick walls. The carpet is dated and in fair condition, and the ceilings and walls are in good condition.

- Provide complete replacement of all flooring and repairing of damaged wall finishes on the main level due to the age and condition. Casework should be replaced as practicable due to the age. Provide replacement of all toilet accessories.
- Per Library direction, provide alterations to interior wall layout, additional casework, visual display boards, wall and door protection and window treatments.
- Funding for replacement of interior doors is provided in Item O, including doors here noted as being in deficient condition.

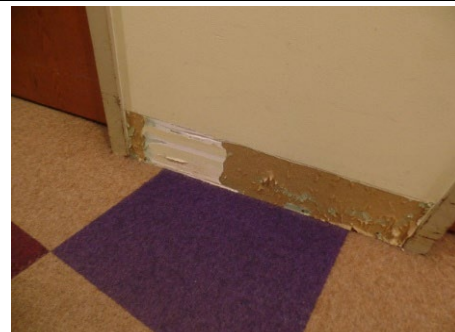
Corridor Wall Base Condition

- The corridors have carpet, ACT ceilings, and painted plaster walls. The wall base is missing from all corridor walls. Similar to the rest of the facility, the carpet is in fair condition but is dated. The overall facility has restrooms with 12x12 ceramic tile type flooring, ACT ceilings, as well as gypsum board type wall finishes. The ceiling and floors are in fair condition and the walls are in poor condition. Toilet partitions are laminate and are in fair condition. Casework in the overall facility is wood type construction with plastic laminate (or other) tops and is dated but in good condition. Wood library casework (circulation desks) are in poor condition.

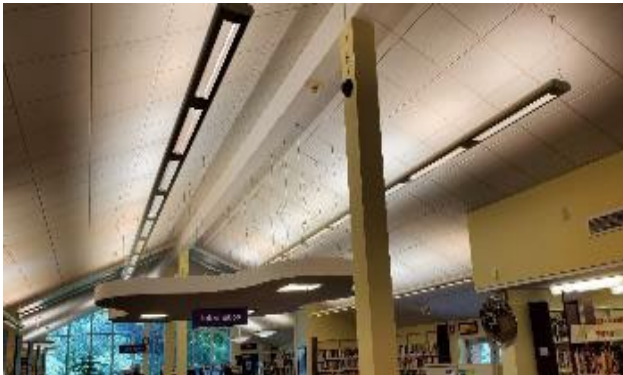
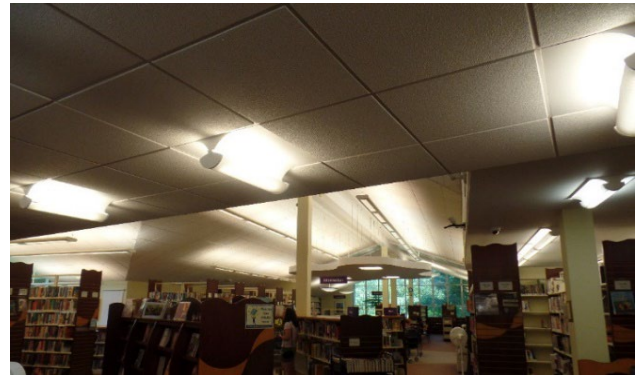
- The building contains T8 fluorescent fixtures and compact fluorescent downlights. Light fixtures are in good condition.
- The color temperatures of the fluorescent bulbs in not consistent throughout.

- Replace fluorescent fixtures with LED fixtures.

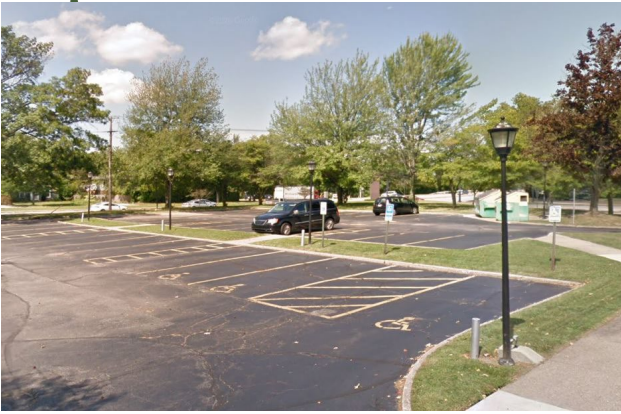
Handicapped Parking

- The exterior entrances are ADA accessible and are equipped with ADA-compliant hardware.
- Access from the parking/drop-off area to the building entries is not compromised by steps or steep ramps. Adequate handicapped parking is provided, however one space does not have an access aisle.

- Provide access aisle adjacent to handicap parking space.
- Provide an elevator.

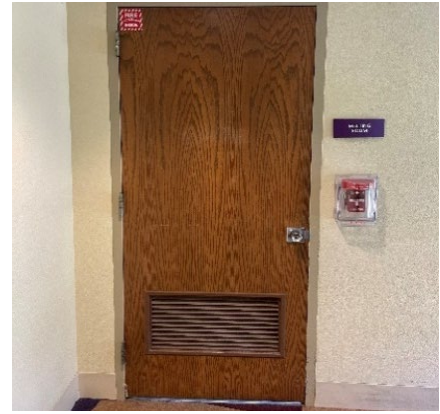
Non-Compliant Knob Hardware

- This multi-story building has does not have a compliant elevator.
- Interior doors are not recessed, some are not provided adequate clearances, and some do not have compliant hardware.

Item	Cost	Unit	Whole Building	Sum	Comments
Accessible Hardware	\$385.00	SET	11.00	\$4,235.00	(includes installation / hardware only)
Sum:				\$4,235.00

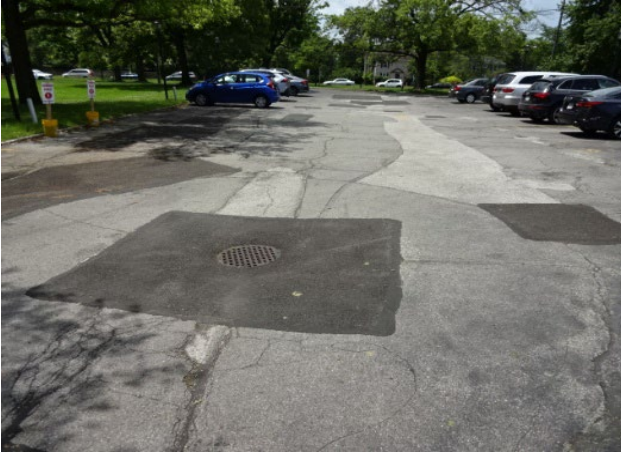
Asphalt Parking Lot

- Staff and visitor parking is facilitated by an asphalt parking lot in fair condition, containing 39 parking places for staff members, visitors, and the disabled. The site and parking lot drainage design, consisting of catch basins and storm sewers, provides adequate evacuation of storm water, and no problems with parking lot ponding were observed.

- Replace asphalt pavement with work recommended within 4-7 years.
- Replace damaged concrete curbs where rebar is exposed and rusting, with work recommended within 0-2 years.
- Replace fence gates and post caps, with work recommended within 0-2 years..
- Clean and stain fence, with work recommended within 0-2 years..

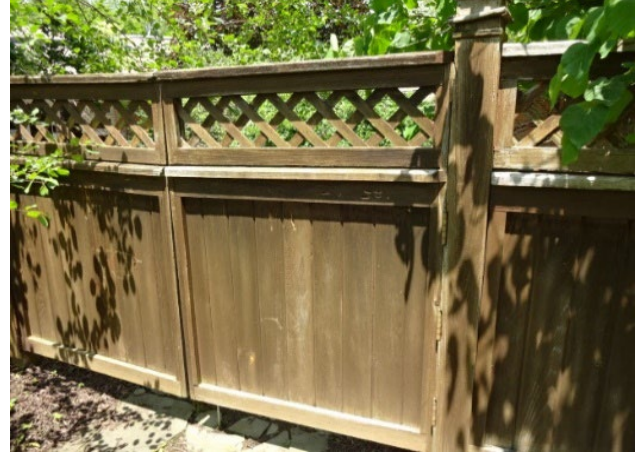
Cedar Fence

- A 6 foot tall lattice top cedar fence in fair condition surrounds an outdoor patio and garden area. The fence is in fair condition and the gates and post caps are in poor condition. A separate 6 foot tall lattice top cedar fence and gates in fair condition surrounds the chiller unit.

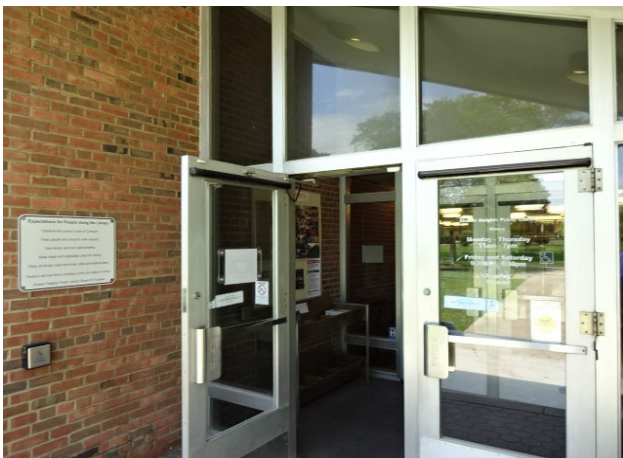
Aluminum Storefront Doors

- The entrance doors to the facility office areas are equipped with aluminum sidelights and transoms with tempered, single pane glazing, in fair condition
- The exterior doors in the patio and outdoor garden area are equipped with aluminum frame sidelights and transoms with tempered, insulated glazing, in good condition.
- The exterior doors to the maintenance area and lower level are equipped with hollow metal sidelights and transoms with tempered, single pane glazing, in poor condition.

- Due to age and condition, replace the existing non-insulated aluminum doors and window system at the main entrance with a new insulated storefront system to match existing system design, with work recommended within 4 years
- Due to age and condition, replace the existing non-insulated hollow metal doors and window system with new insulated FRP doors and insulated glass windows in an aluminum frame system to match existing system design, with work recommended within 2 years.

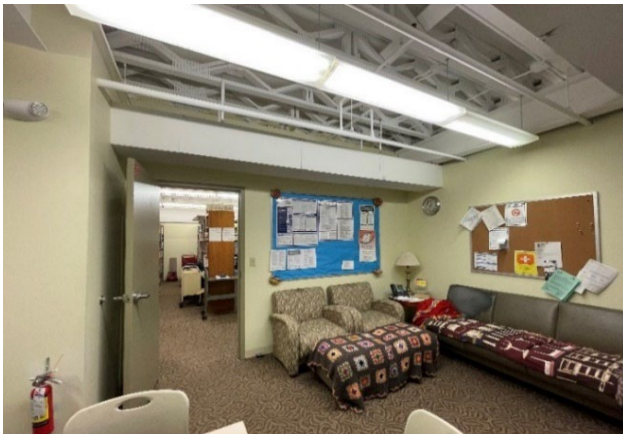
Fluorescent Lighting

- There was no previous Asbestos Inspection Report provided. However, given the date of original construction and building methods, it is assumed that Asbestos Containing Building Materials (ACBM) were used. A Hazardous Materials Inspection should be performed to accurately determine the presence and condition of any ACBM within the building.
- Removal and replacement of fluorescent lighting in Item K will require special disposal.

- Provide for disposal of fluorescent lighting.

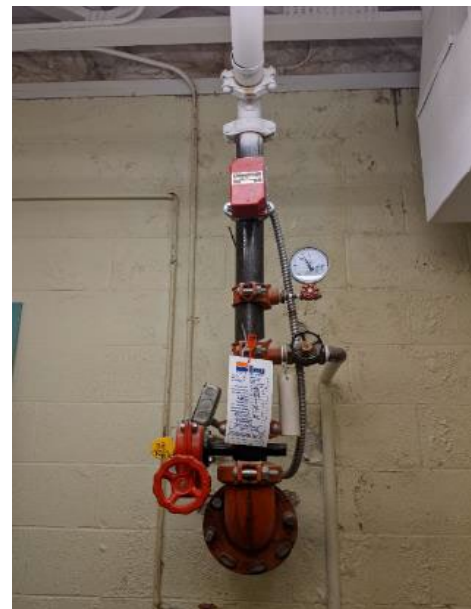
Fire Suppression System for Basement

- The facility is equipped with an automated fire suppression system in the basement level only.
- Exit Corridors are situated such that dead-end corridors are not present.
- The facility features one interior stair which is protected by compliant two-hour fire enclosure.
- The facility features one exterior concrete stair providing egress from the basement to grade, which is in good condition.
- Rooms with a capacity greater than 50 occupants are equipped with adequate egress.
- Fire extinguishers are provided in sufficient quantity and are adequately spaced.
- The facility is not equipped with an emergency generator.

- Extend fire suppression system to the main floor.

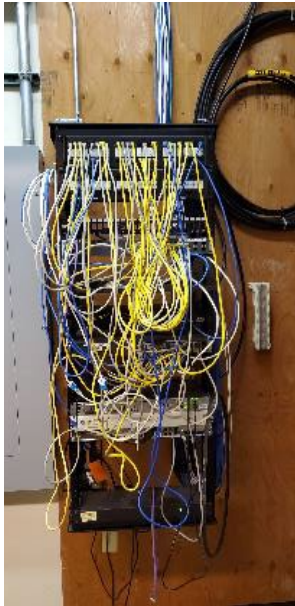
Main Telecom Rack

- The telecom equipment includes a single rack with CAT5e cabling. Cabling at the rack is lacking proper cable management.
- There is some older outdated telecom equipment installed, such as punch-down blocks for phone.
- The computers and phone systems appear to be in good condition.
- Wireless access points are provided throughout the building.

- Provide proper cable management at telecom rack.
- Remove or replace outdated telecom equipment.
