Building Information - Shaker Heights City (44750) - Mercer Elem

Building Pictures - Shaker Heights City(44750) - Mercer Elem(24307)

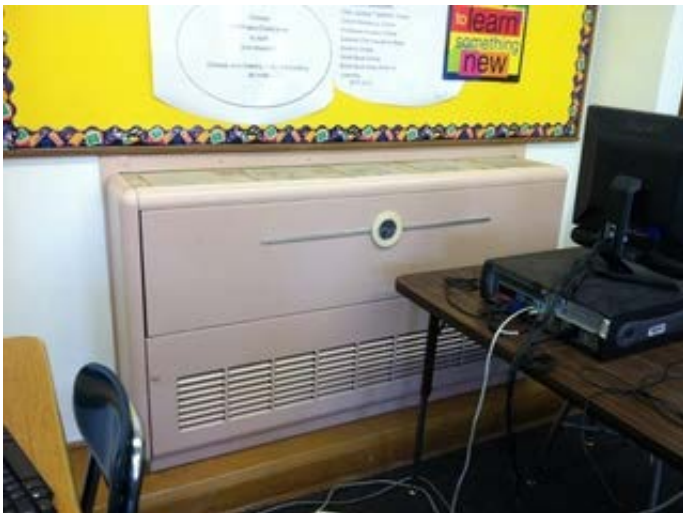
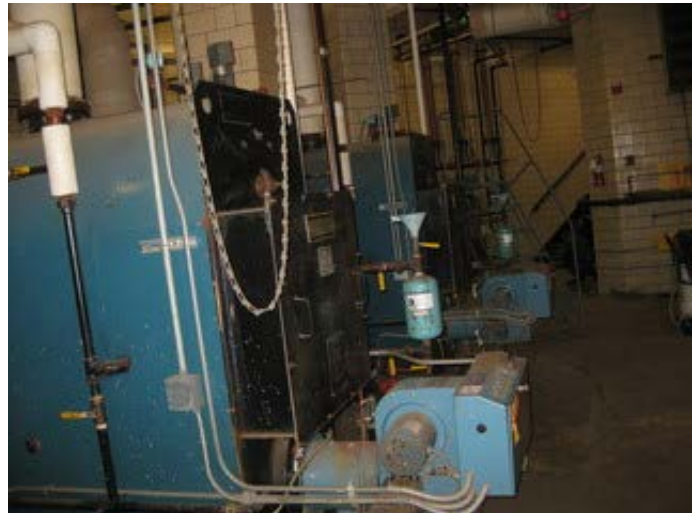
Description: The existing system for the building consists of two 1995, Burham steam boilers at 2821MBH gross out put each. The boilers appear to be in fair to good condition for nearly being 20 years old. Building is heated with steam heat to unit ventilators, fin tube or radiators. There are unit ventilators located on the inside of the classrooms with outside air ducted to each from the attic area. These classrooms have fin tube or radiators located on the exterior wall. There are air handling units with steam heat for the Boys Gym, Girls Gym, and Auditorium. The boilers and air handling units are controlled with DDC controls and the rest of the controls are pneumatic and in fair to poor condition due to the equipment age. Generally, all the equipment has been well maintained. Overall, the ventilators and the air handling units in the building do not provide the required outside air delivery to meet OBC mechanical code. The DDC controls were added two years ago under an energy performance contract. The steam system does not provide a capacity for simultaneous heating and cooling operation which is not compliant with the OSDM requirements. The staff indicated that the site does not contain underground fuel tanks.

Rating: 3 Needs Replacement

Recommendations: Provide a new overall heating ventilating and air conditioning system to achieve compliance with OBC and OSDM standards. Convert to ducted system to facilitate efficient exchange of conditioned air. Provide new DDC temperature controls with the new system. The new ducted system will likely require architectural soffits to accommodate the installation of the ductwork.

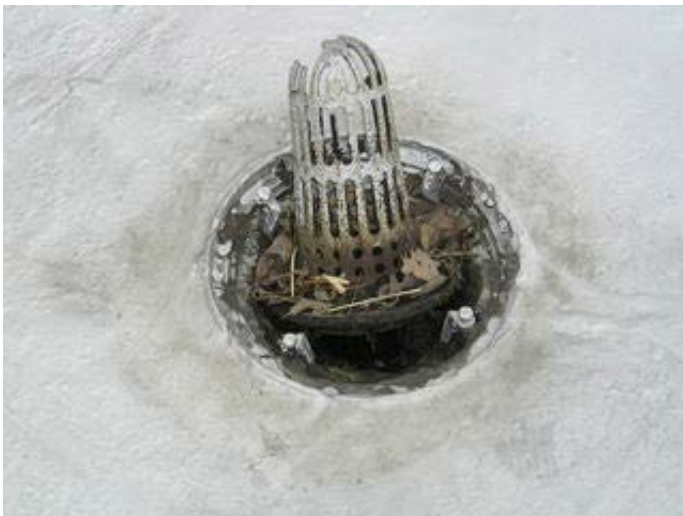
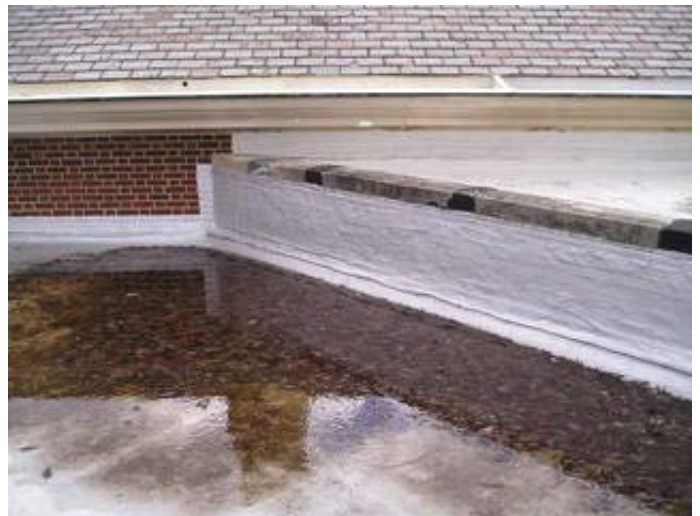
Description: Low sloped roof areas are covered with built-up roof with a reflective coating on top. These roofs have only 2 drains over the gymnasium and 3 drains over the cafeteria. This roof has passed its expected service life. Roof drains with broken or missing strainers were observed as well. Ponding water was observed. These areas are edged with a parapet wall capped with stone copings. The copings have an asphalt seal over the seams which is failing in some areas. The pitched areas of the roof are covered with original slate shingles and drain into metal lined box gutters and gutters which empty to the low slope roof below. The roof is accessed via a ladder and hatch.

Rating: 3 Needs Replacement

Recommendations: Provide new built-up roof, overflow drains, coping and tapered insulation at the low-sloped roof areas of the building. New gutters and downspouts should be provided at pitched roof areas as well. 01-27-16 UPDATE: REPLACE SLATE ROOF WITH ASPHALT SHINGLES AND DECK REPLACEMENTS ON SLOPED ROOF AREA OF 1952 ORIGINAL BUILDING. PROVIDE BATT INSULATION ON SLOPED ROOF AREAS OF 1952 ORIGINAL BUILDING AND 1957 ADDITION. 11-2-21 Update: Remove scope completed in 2017 & 2021: Slate replacement/repairs and built-up roof replacement.

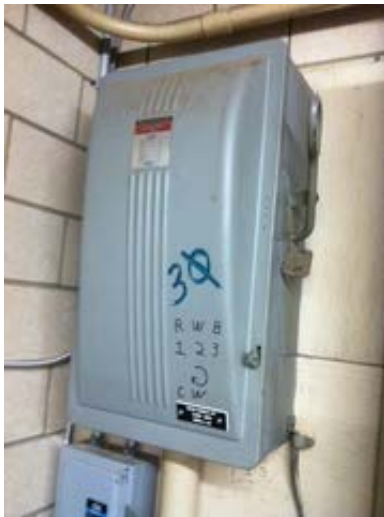
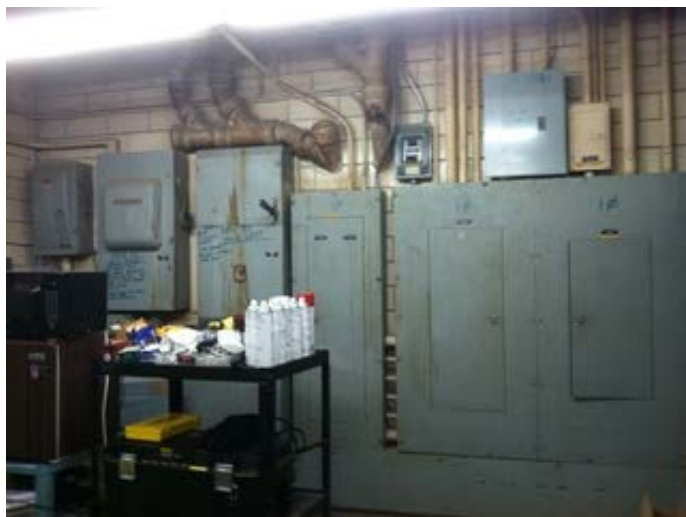
Description: The main power enters the building underground to a locked transformer vault. The transformers are owned by the utility. The service described is leaving the transformer vault to serve the building. There are three electric service mains with separate disconnects for this building: #1: 240V, 3 phase, 100 amps, #2: 120/240V, 1 phase, amperage capacity estimated 200 amps, #3: 120/240V, 1 phase, amperage capacity estimated 200 amps. This 1952 electrical gear is beyond its usable life and should be replaced. Three new switches has been recently added to manually transfer power to a portable generator. There are permanent lugs located outside that are tied to the main gear to back up the building. Three DDC power recording devices were installed 2 years ago to track the power used. The electrical system in the building has not been updated since the original construction date and should be replaced. Additional outlets have been added to the classrooms, but the classrooms are still not equipped with adequate electrical outlets. Adequate GFI protected exterior outlets are not provided around the perimeter of the building. There is no lightning protection. The overall electrical system does not meet OSDM requirements in supporting the current needs of the school and will be inadequate to meet the facility's future needs.

Rating: 3 Needs Replacement

Recommendations: The electrical system down stream of the main electrical gear requires replacement to meet Ohio School Design Manual guidelines for overall capacity due to poor condition and age.

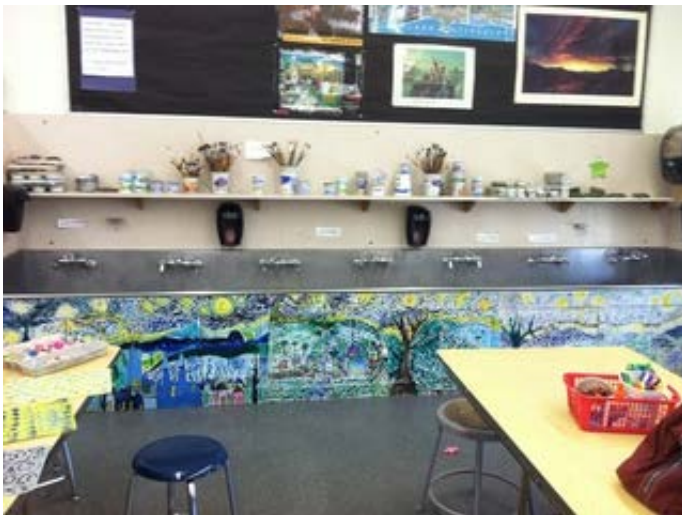
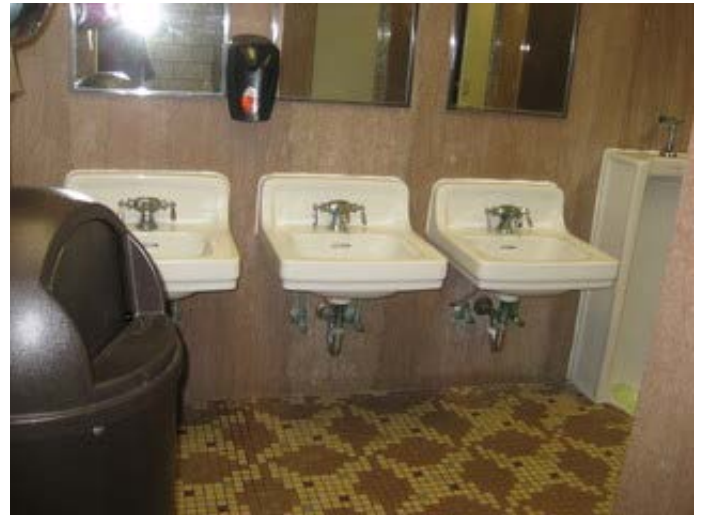
Description: The 4" domestic water supply piping in the original building is galvanized piping at the building entrance. The much of the water piping in the building is still galvanized and replaced for failure. There have been no major renovations for the plumbing piping. There is no pressure reducing valve and backflow preventer on the water service line. There were no water pressure issues indicated by the staff. A water treatment system is not required for the domestic water system. There is a small water softener for the boiler water make-up. A 2003, AO Smith 190 MBH water heater with storage tank provides the domestic hot water for the main building. There are no electronic sensor faucets and flush valves in the building. All of the toilets and urinals are floor mounted. The plumbing fixtures are generally in fair condition and showing age. The school contains 5 restrooms for boys, 5 restrooms for girls, and 7 restrooms for the staff. There are 27 LAVs, 12 ADA LAVs, 39 toilets, 9 ADA toilets, 17 urinals. There are 7 classroom sinks in good condition but the faucets are in fair condition. The LAVs have manual faucets in fair to poor condition and showing age. There are 4 electric water coolers and 1 drinking fountain in generally good condition. There is no kitchen in this school.

Rating: 3 Needs Replacement

Recommendations: Provide low flow fixtures with of the faucets and flush valves with sensors to meet OSFC requirements. A Three Station Modular Lavatory will replace the Lavatories in each of the boys and girls restrooms. The boys restrooms will require major renovation due to the floor mounted urinals. Replace galvanized piping throughout building. Replace 01-27-16 UPDATE: REPLACE SANITARY WASTE PIPING ON 1952 ORIGINAL BUILDING AND 1957 ADDITION. PROVIDE FOR LAVATORY MOUNTED DRINKING FOUNTAINS IN 1952 ORIGINAL BUILDING AND 1957 ADDITION.

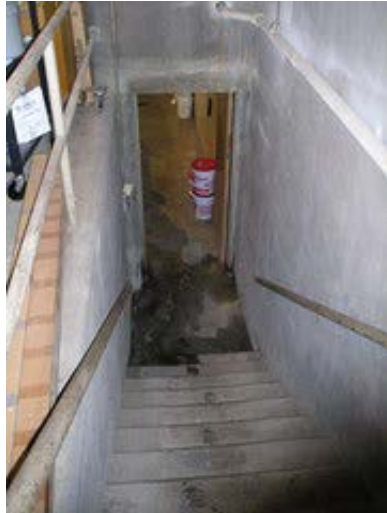
Description: Cracked piers were observed in the mechanical room. Steel reinforcing has been provided for reinforcement. Water was observed on some areas of the mechanical room floor. Cracks were also observed in some CMU foundation walls.

Water is breaching the foundation at the lowest levels.

Recommendations: Provide sump pumps as necessary to redirect water in the ground. 01-27-16 UPDATE: INSTALL VAPOR BARRIER AND MUD SLAB IN BASEMENT OF 1952 ORIGINAL BUILDING. PROVIDE WATERPROOFING MEMBRANE AND DRAINAGE TILE SYSTEM FOR BASEMENT AND CRAWLSPACE AT 1952 ORIGINAL BUILDING AND 1957 ADDITION. 11-2-21 Update: Remove scope completed in 2020: Partial waterproofing and drain tile.

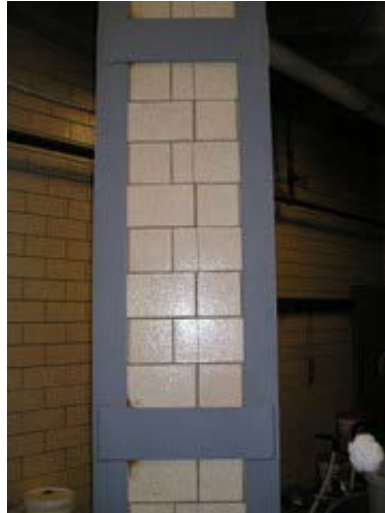
Vertical cracks were observed in this foundation pier.

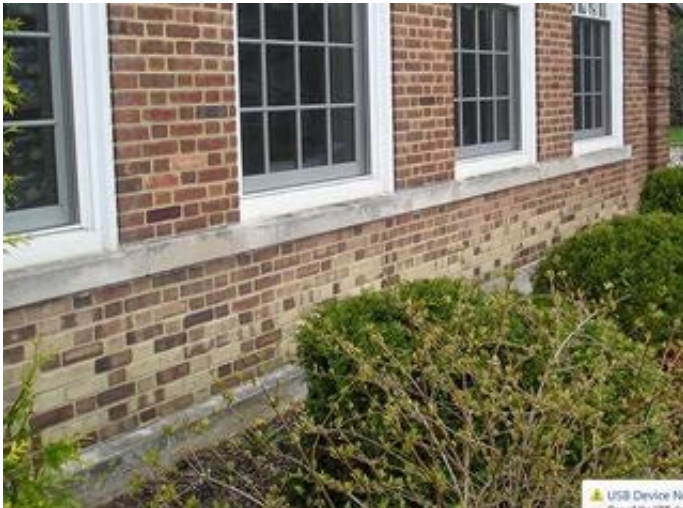
Surface damage to the face of this brick.

Recommendations: Provide masonry cleaning and sealer over spalled areas to stabilize the masonry in these conditions. 01-27-16 UPDATE: REPLACE SANDSTONE CORNICE ON 1952 ORIGINAL BUILDING AND 1957 ADDITION. ADD WEEPS AT LINTELS ABOVE WINDOWS IN 1952 ORIGINAL BUILDING AND 1957 ADDITION. REPLACE CAULK AROUND WINDOWS AND DOORS IN 1952 ORIGINAL BUILDING AND 1957 ADDITION. PROVIDE FOR CLEANING AND SEALING OF EXTERIOR MASONRY ON 1957 ADDITION. REBUILD WALLS SURROUNDING STORAGE ROOM B17 IN 1952 ORIGINAL BUILDING. REPLACE SPALLING FACE BRICK ON 1952 ORIGINAL BUILDING. PROVIDE CLEANING AND SEALING OF EXTERIOR MASONRY ON 1957 ADDITION. INSTALL CONTROL JOINTS ON 1952 ORIGINAL BUILDING. PROVIDE FOR TUCKPOINTING ON 1952 ORIGINAL BUILDING. 11-2-21 Update: Remove scope completed in 2019 & 2020: cleaning & sealing, tuckpointing; partial masonry infill & caulking.

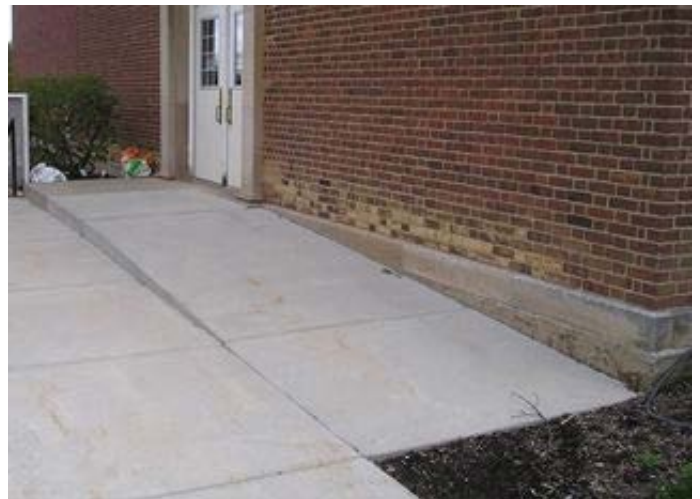
Surface damage to the face of this brick

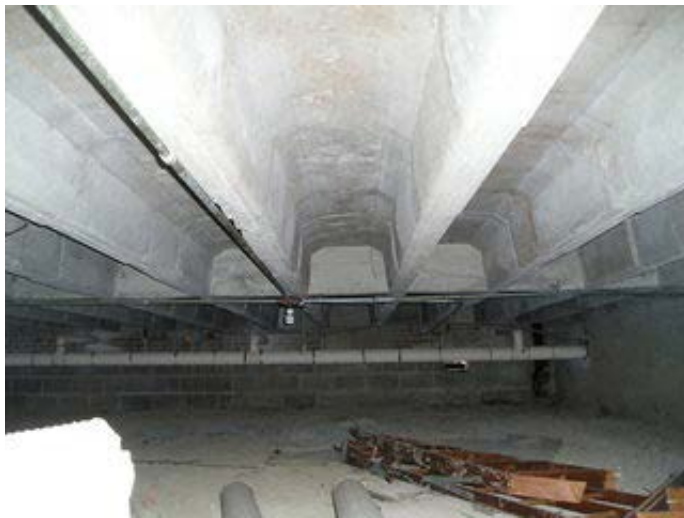
Concrete pan joists observed from crawl space

Recommendations: No work is recommended at this time. 01-27-16 UPDATE: REPAIR SPALLING CONCRETE PAN JOIST ON 1952 ORIGINAL BUILDING.

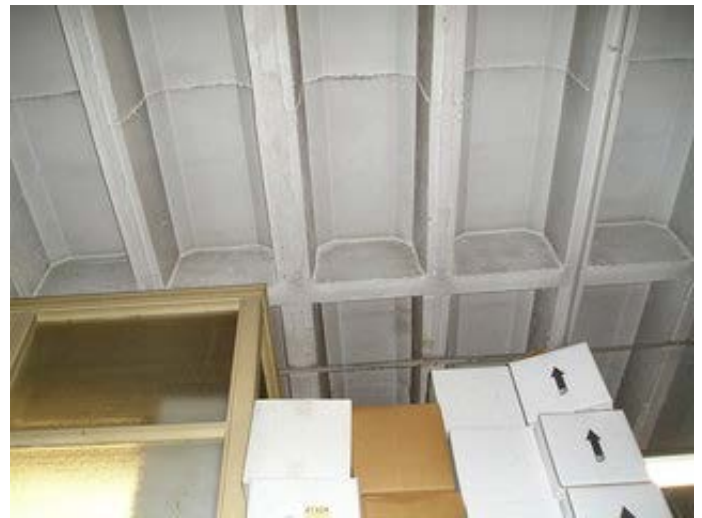
Concrete pan joists observed from mechanical room

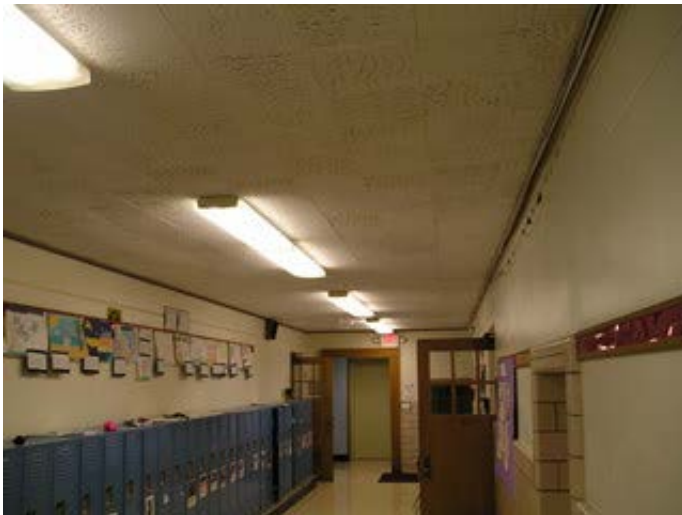
Finishes in a typical corridor

Recommendations: Most finishes and casework observed are past their expected service life and should be replaced. 01-27-16 UPDATE: DRYWALL REPLACEMENT FOR REMOVAL OF EXISTING DRYWALL TO ACCESS ACM BEHIND WALLS IN 1952 ORIGINAL BUILDING AND 1957 ADDITION NOTED UNDER ITEM T. PROVIDE ACOUSTICAL TREATMENT TO GYMNASIUM AND STUDENT DINING IN 1952 ORIGINAL BUILDING.

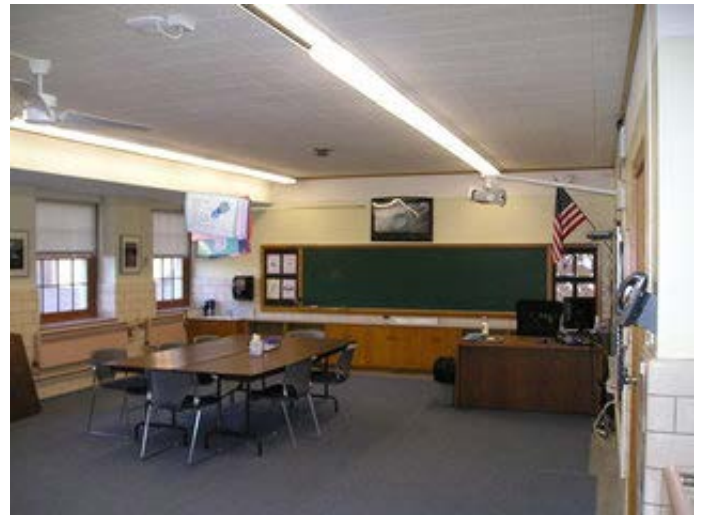
Finishes in a typical room

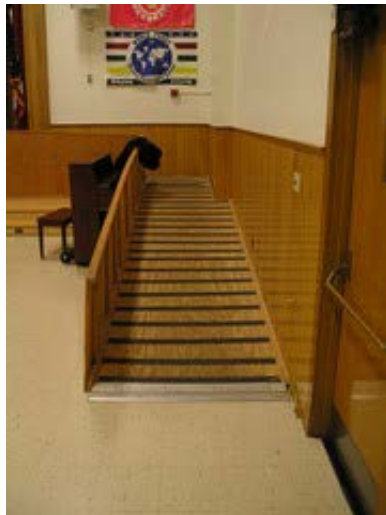
This ramp is steeper than 1:12

Recommendations: Provided ADA compliant signage and door hardware throughout the building. Replace the ramp at the stage with a 1:12 or less steep ramp. Provide a new ADA compliant water cooler. Widen door opening to the restroom in the library. Provide a new ramp to replace the temporary wood ramp at the main entrance. 01-27-16 UPDATE: PROVIDE FOR TOILET PARTITIONS, AND TOILET ROOM ACCESSORIES IN 1952 ORIGINAL BUILDING AND 1957 ADDITION. REWORK DOOR OPENINGS IN 1952 ORIGINAL BUILDING ADDITION TO PROVIDE ADA COMPLIANCE. REPLACE INTERIOR DOORS IN 1952 ORIGINAL BUILDING AND 1957 ADDITION. 01-27-16 UPDATE: PROVIDE FOR INSULATED PIPE WRAP PROTECTIONS ON PLUMBING PIPING UNDER LAVATORIES.

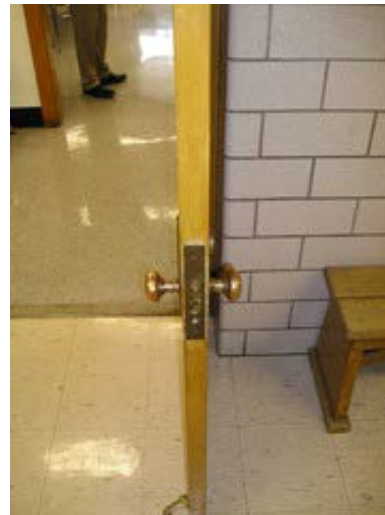
Door hardware is not ADA compliant

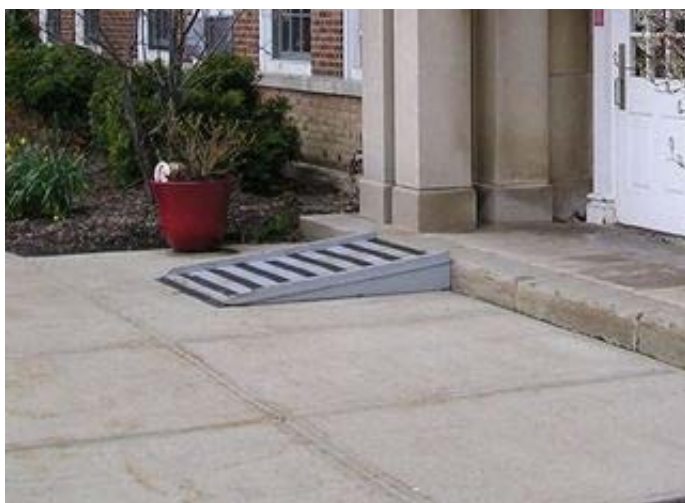
This temporary ramp should be replaced with concrete and rails

Recommendations: Provide ramp and rails at the main entrance. Replace damaged areas of concrete walks where water is ponding. Provide concrete pad for the dumpster. Add an off-street drop of area to adequately separate bus and non-bus circulation. A ramp should be provided under Section O. Handicapped Access. 01-27-16 UPDATE: PROVIDE FOR SOFT SURFACE PLAYGROUND AND SWING. REPLACE CONCRETE SIDEWALKS AT 1952 ORIGINAL BUILDING AND 1957 ADDITION. REMOVE EXISTING STONE SLAB AND REPLACE WITH FROST SLAB AT 1952 ORIGINAL BUILDING. REPLACE RETAINING WALL AT 1957 ADDITION. REPLACE STAIRS, RAMPS, SIDEWALKS AND LANDSCAPING AT 1952 ORIGINAL BUILDING AND 1957 ADDITION DUE TO EXCAVATION FOR WATERPROOFING OF FOUNDATION WALLS.

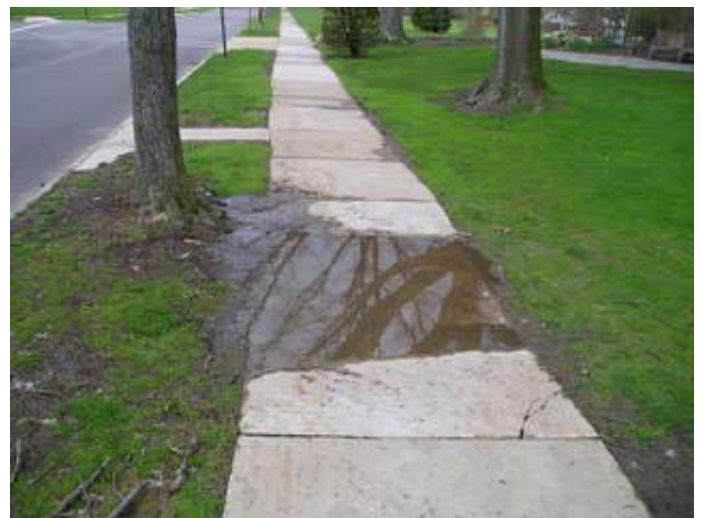
Standing water is present over this area of concrete walk.

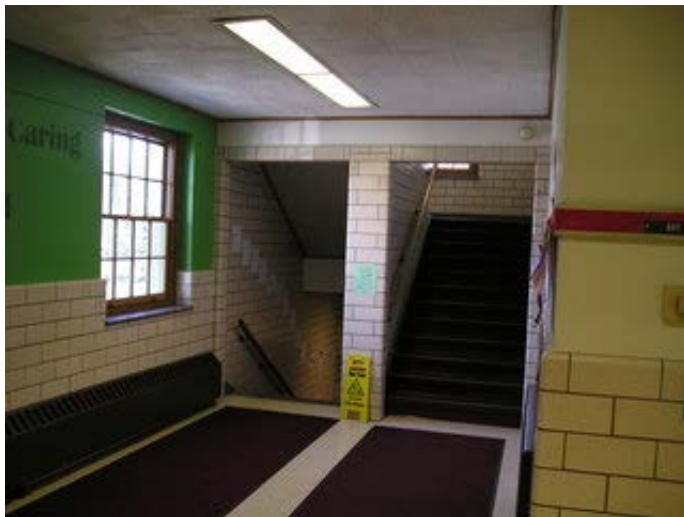
This stair will foster vertical fire spread.

Recommendations: Provide an automatic fire suppression system throughout the building. Add enclosures at stairs to prevent the vertical spread of fire. 01-27-16
 UPDATE: PROVIDE FOR PRE-ACTION FIRE SUPPRESSION SYSTEM IN ATTIC SPACE OF 1952 ORIGINAL BUILDING.

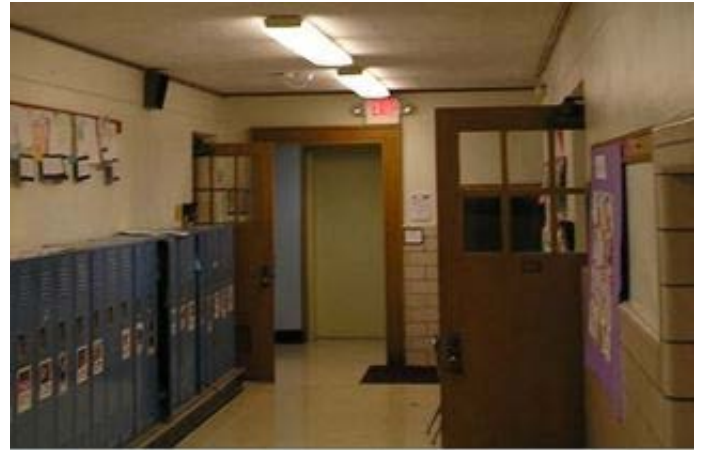
Doors open in to the corridor by up to 36".
