Building Information - Shaker Heights City (44750) - Onaway Elem

[Next Page](#)

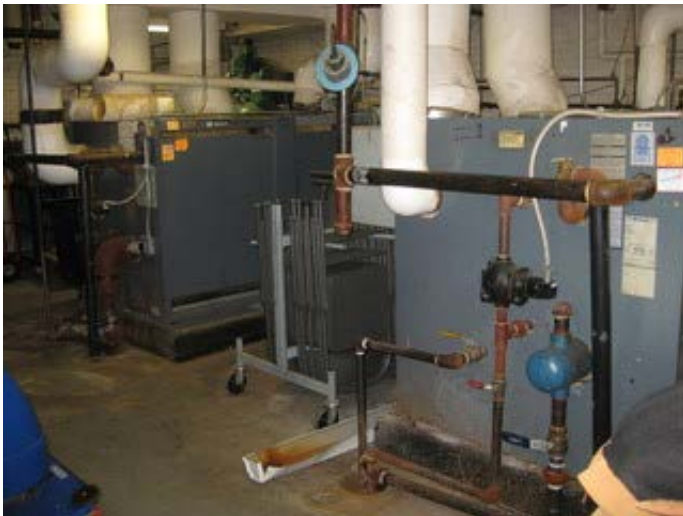
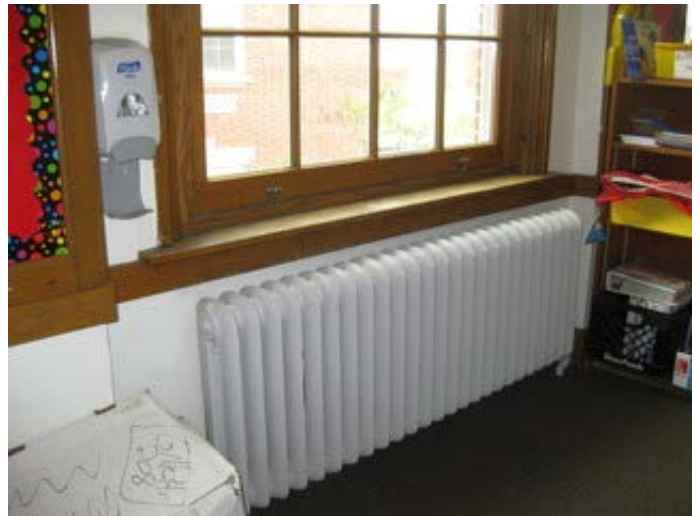
[Back to Assessment Summary](#)

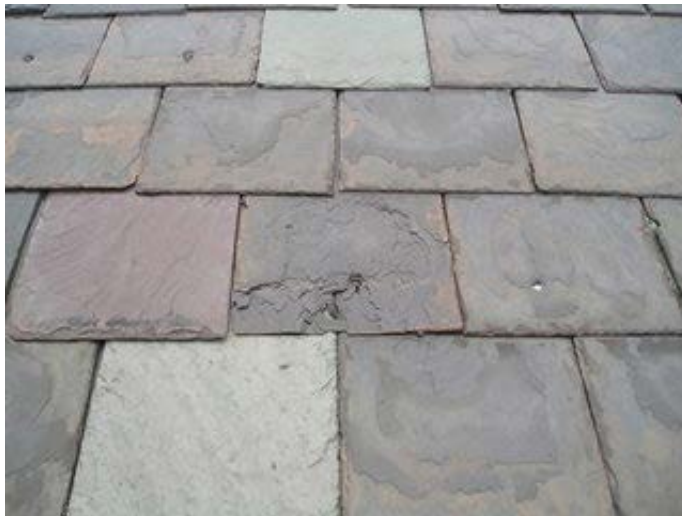
Damaged and replaced slate tile

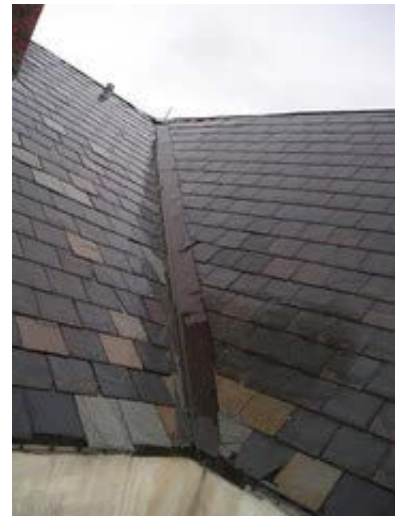
Damaged and replaced slate near valley

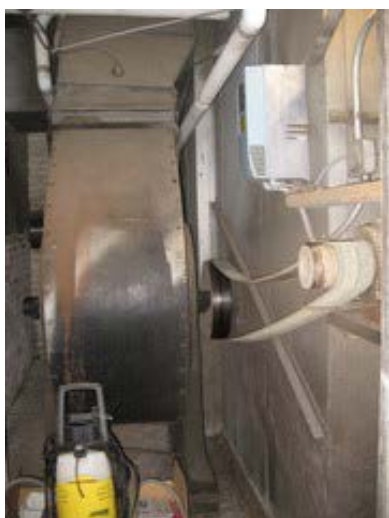
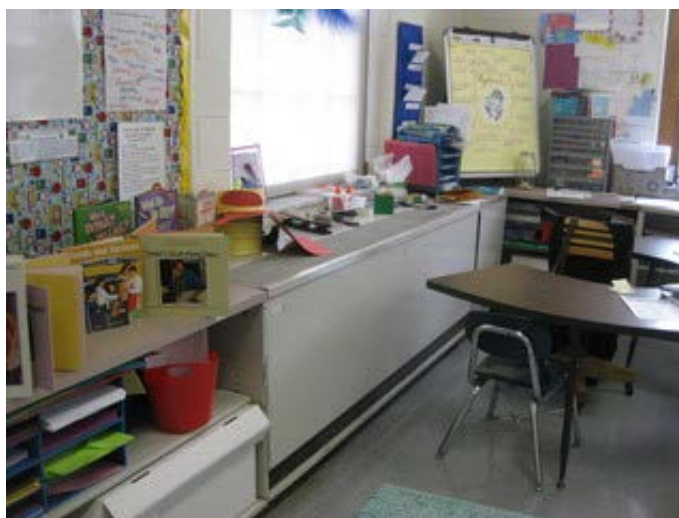
[Back to Assessment Summary](#)

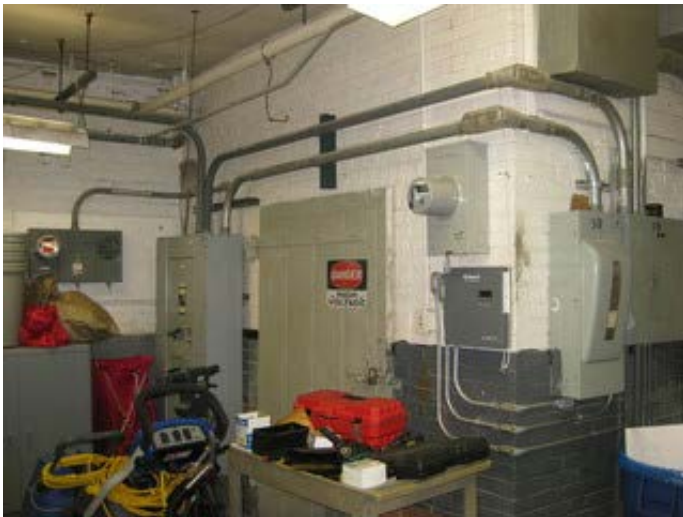
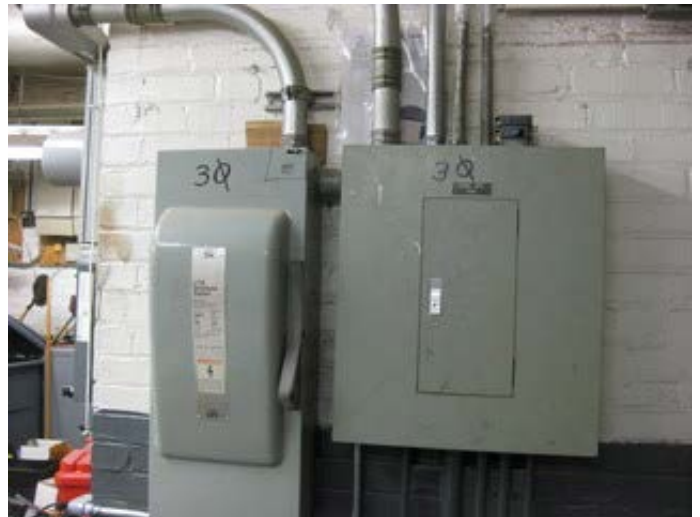
[Back to Assessment Summary](#)

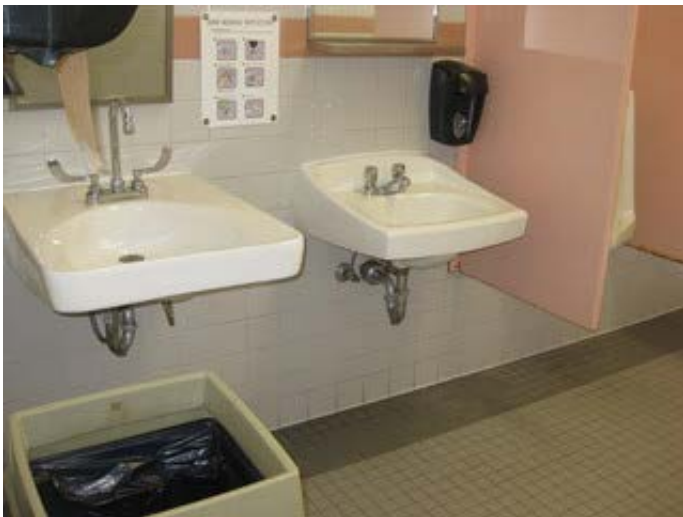
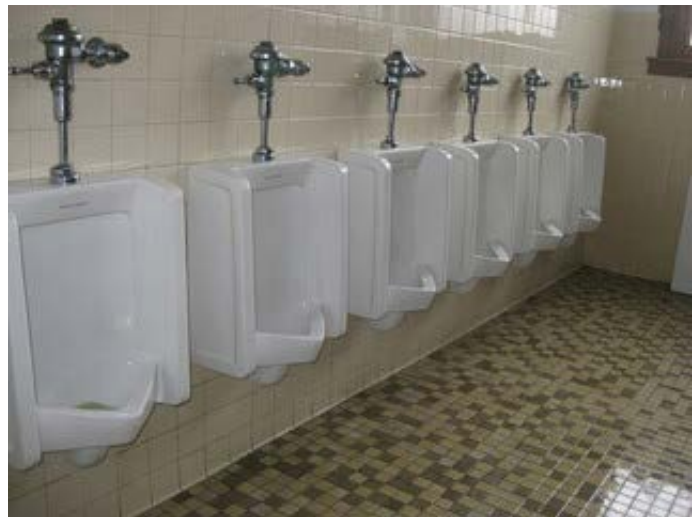
[Back to Assessment Summary](#)

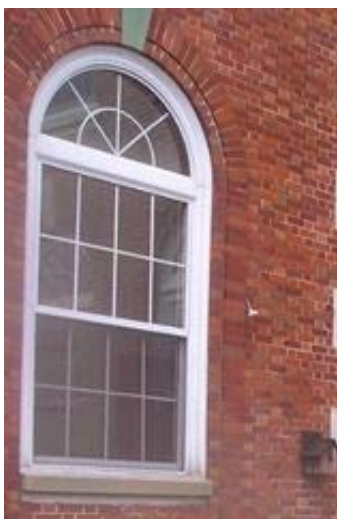
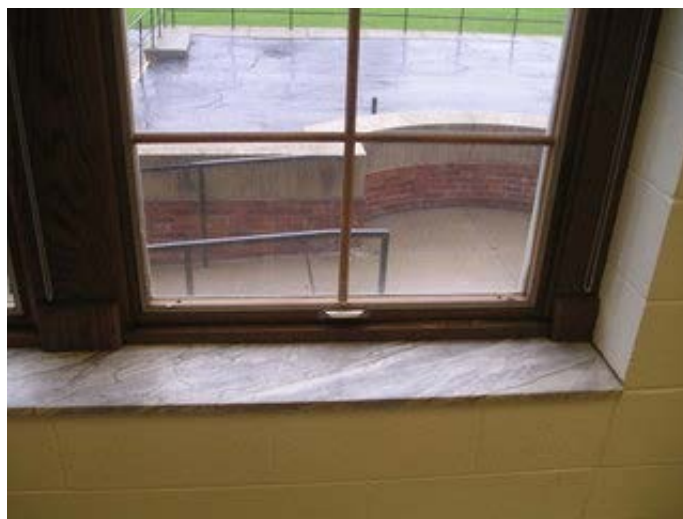
[Back to Assessment Summary](#)

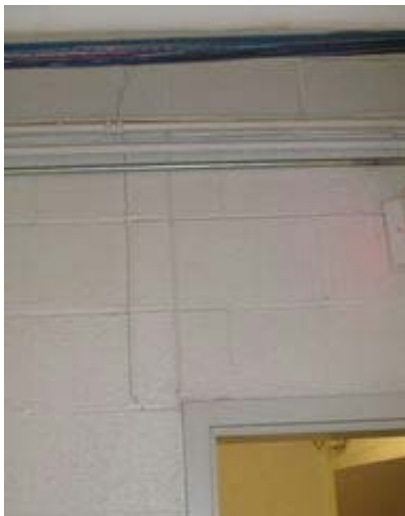
Cracking is present over this door frame in the basement.

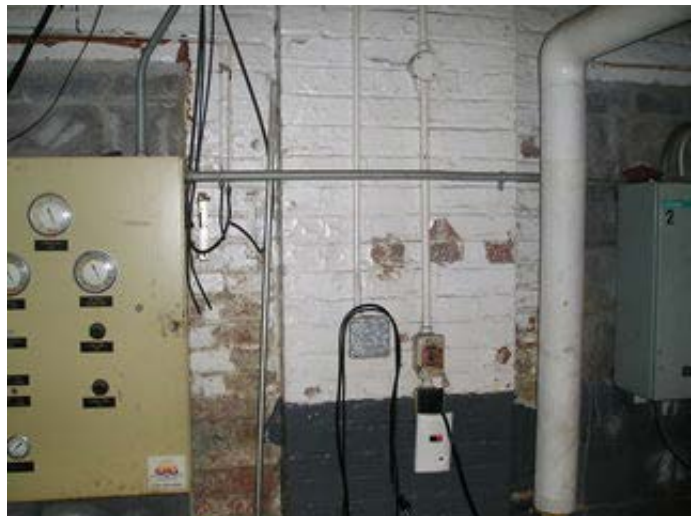
Evidence of water breach is seen at this basement wall.

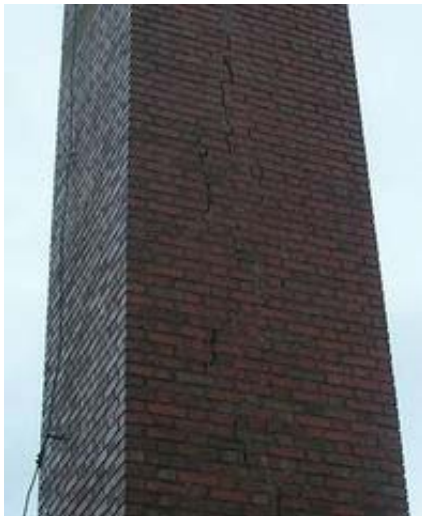
Cracks and mortar wash-out are visible on this chimney

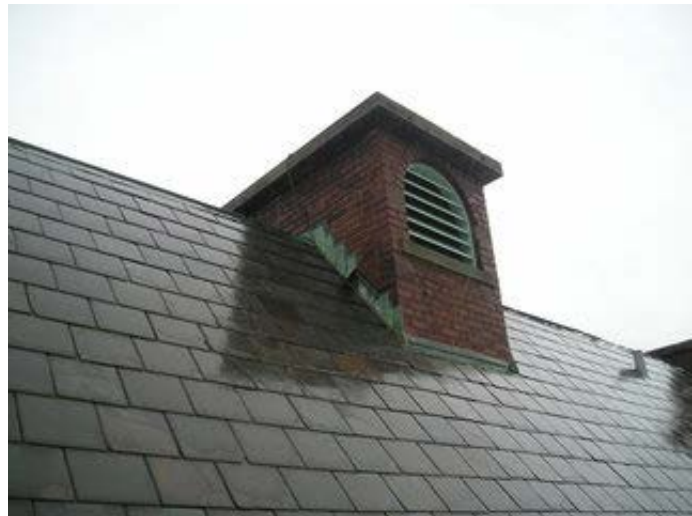
Flashing is damaged at this dormer

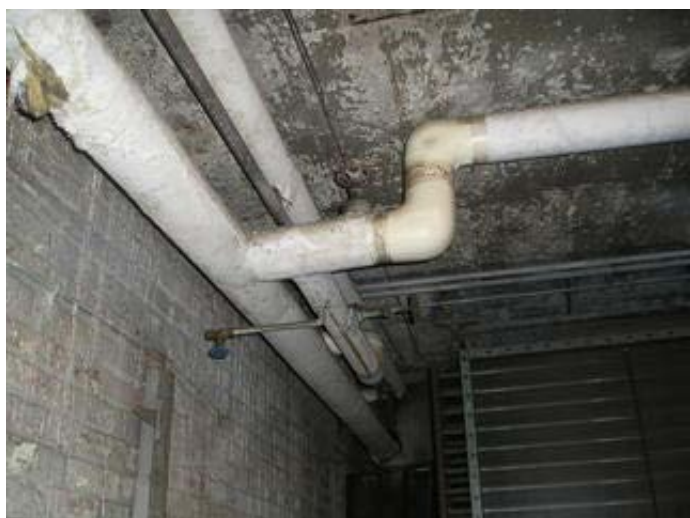
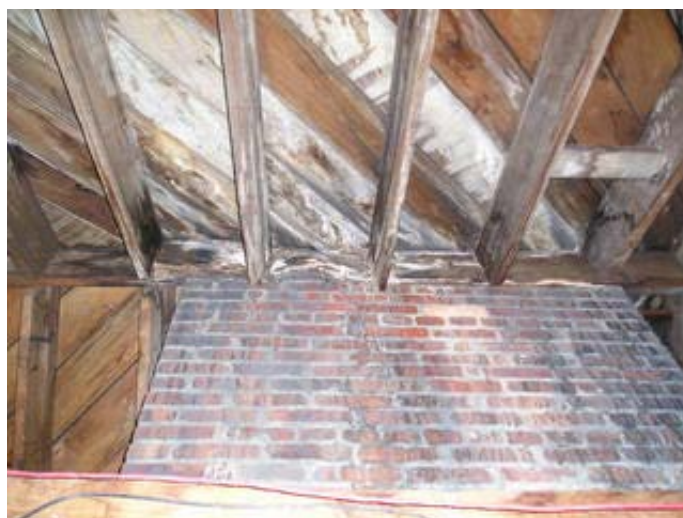
[Back to Assessment Summary](#)

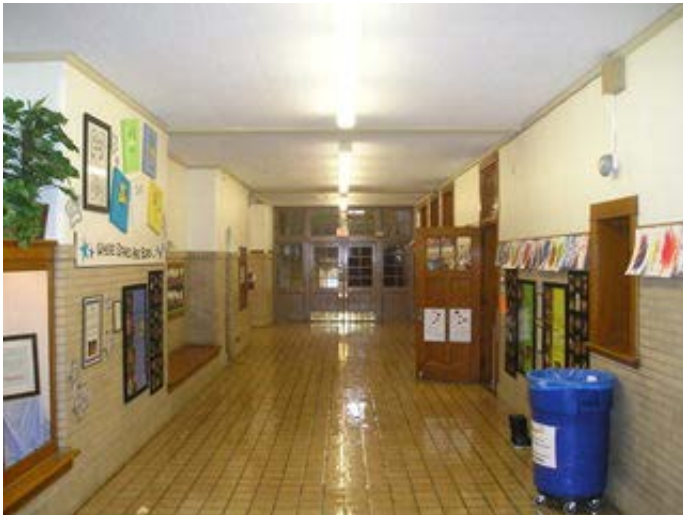
Item	Cost	Unit	Whole Building	Original Building (1922) 39,017 ft²	Addition (1991) 20,622 ft²	Sum	Comments
Complete Replacement of Finishes and Casework (Elementary):	\$15.90	sq.ft. (of entire building addition)		Required	Required	\$948,260.10	(elementary, per building area, with removal of existing)
Basketball Backboard Replacement	\$6,500.00	each		6 Required		\$39,000.00	(electric)
Gypsum Board Replacement	\$4.00	sq.ft. (Qty)		117,600 Required		\$470,400.00	(Hazardous Material Replacement Cost - See T.)
Other: Acoustical Treatment	\$30,000.00	allowance		Required		\$30,000.00	Acoustical Treatment for Student Dining
Other: Acoustical Treatment	\$30,000.00	allowance		Required		\$30,000.00	Acoustical Treatment for Gymnasium
Sum:			\$1,517,660.10	\$1,189,770.30	\$327,889.80

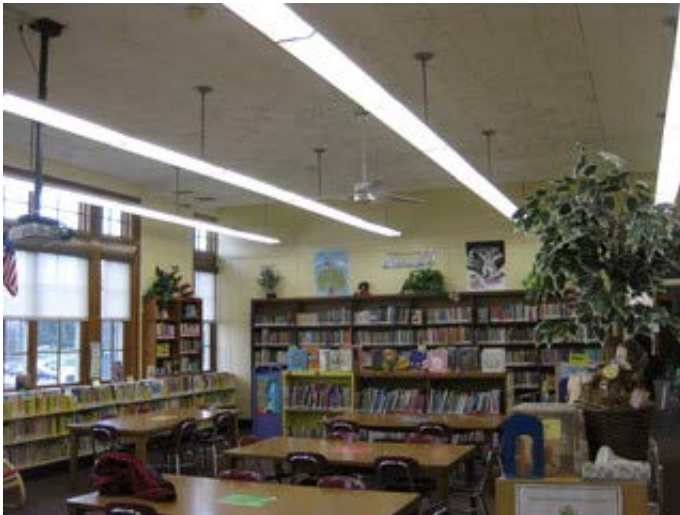
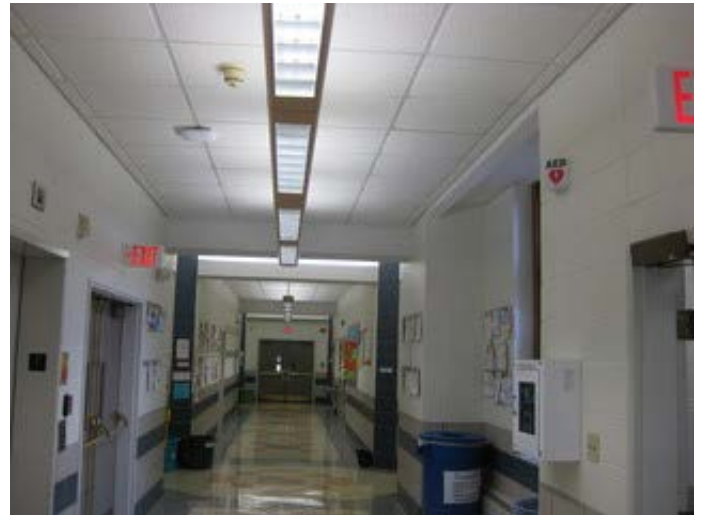
[Back to Assessment Summary](#)

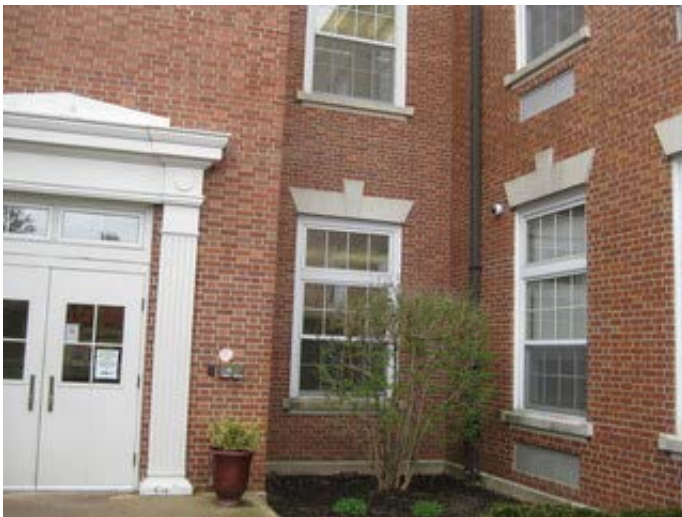
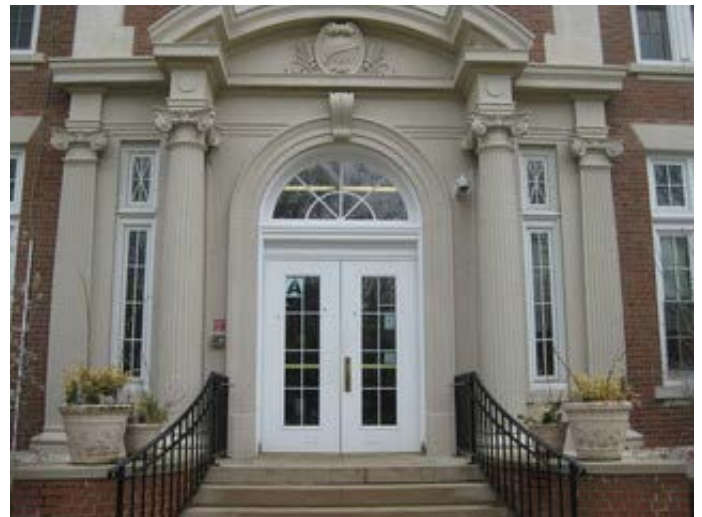
[Back to Assessment Summary](#)

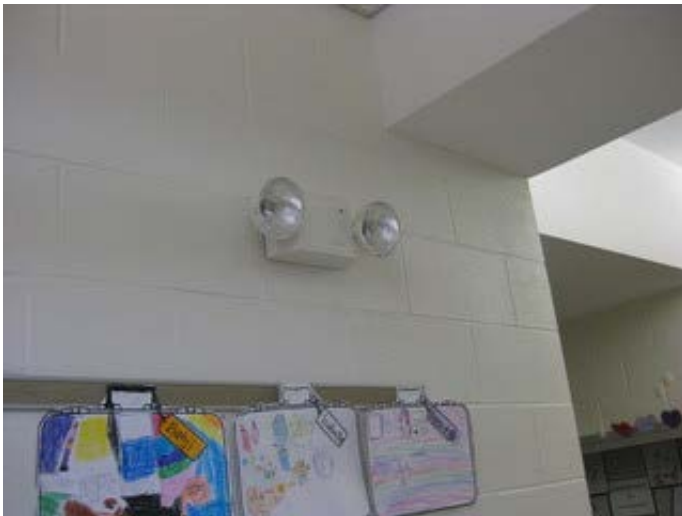
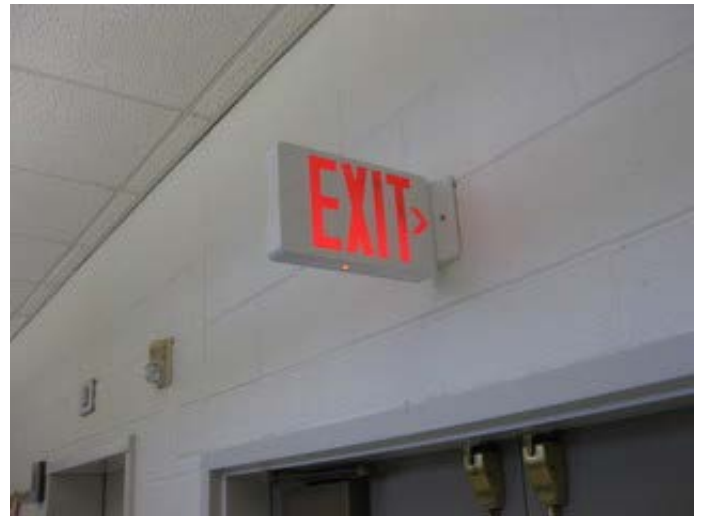
[Back to Assessment Summary](#)

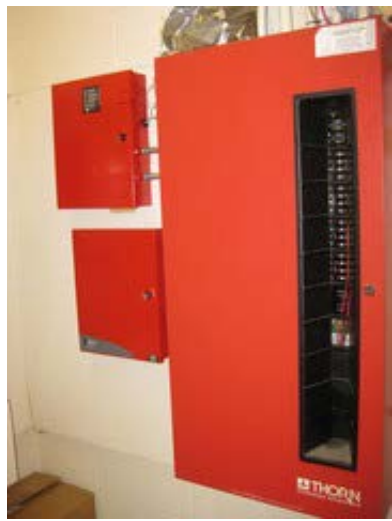
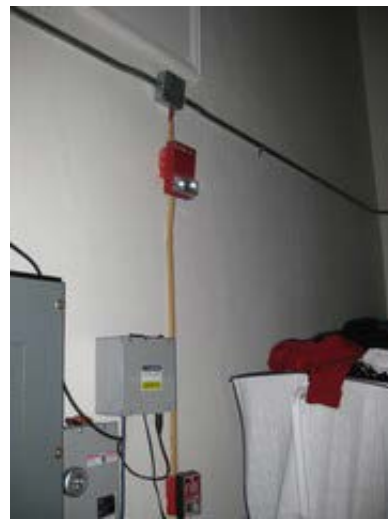
[Back to Assessment Summary](#)

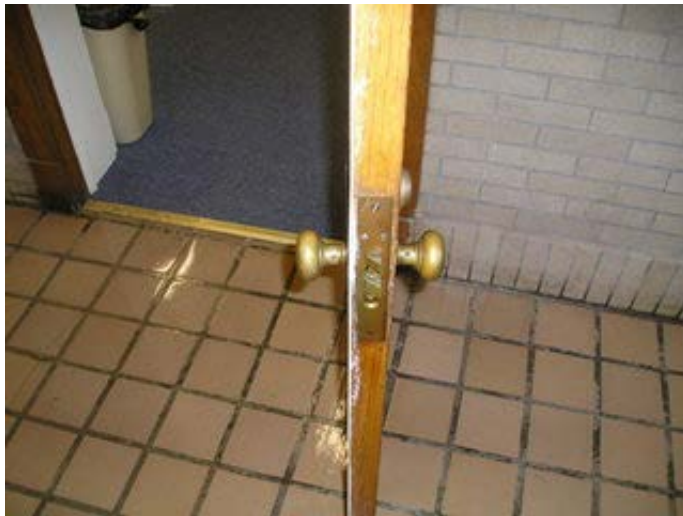
Replace with lever type hardware

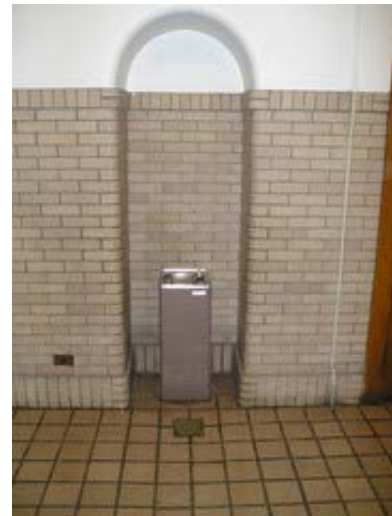
Non-accessible drinking fountain in original 1922 building.

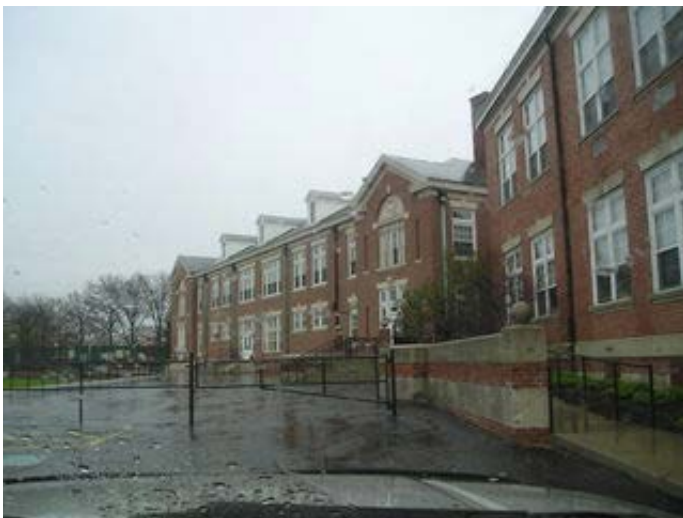
No vehicular drop-off

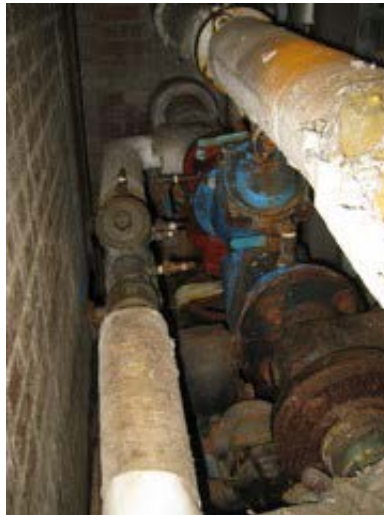
[Back to Assessment Summary](#)

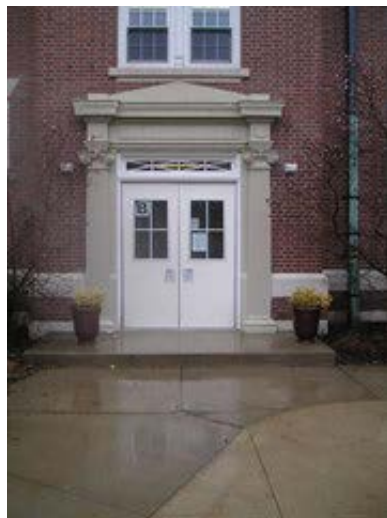
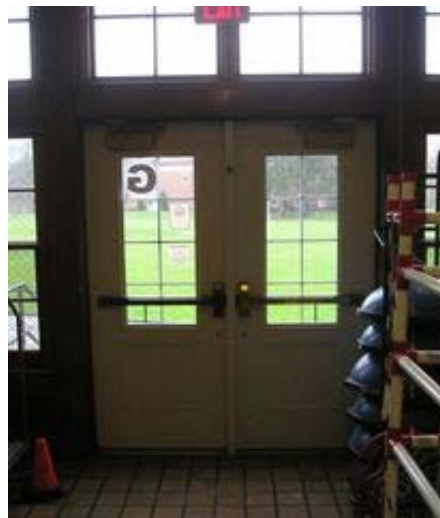
[Back to Assessment Summary](#)

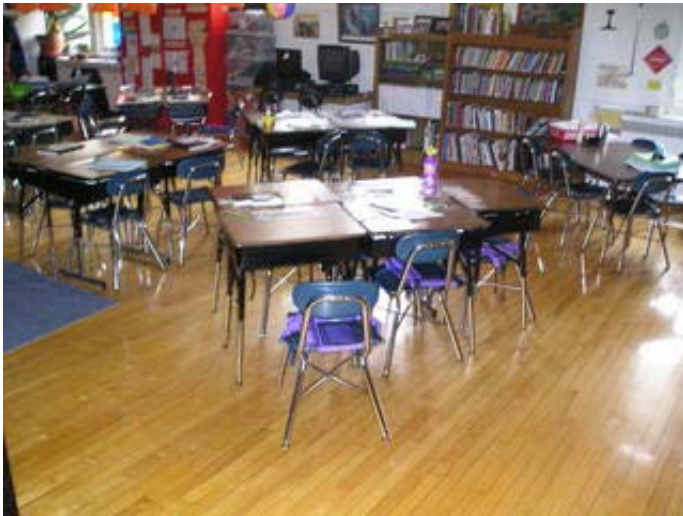
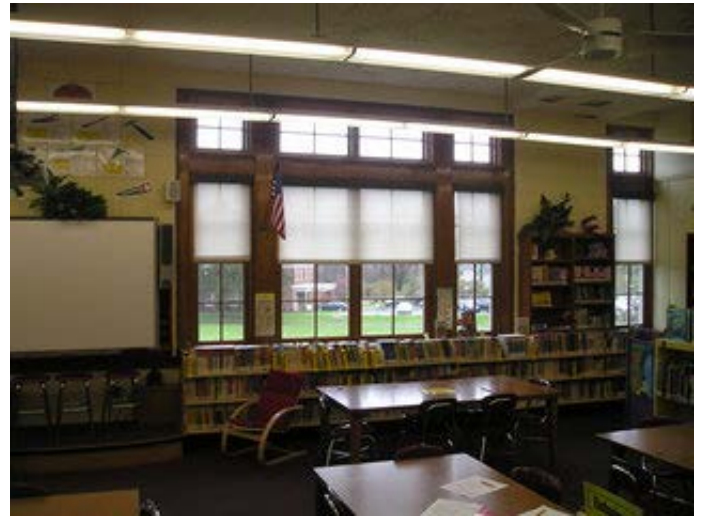
[Back to Assessment Summary](#)

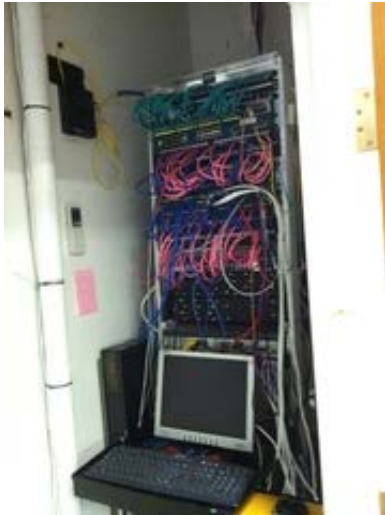
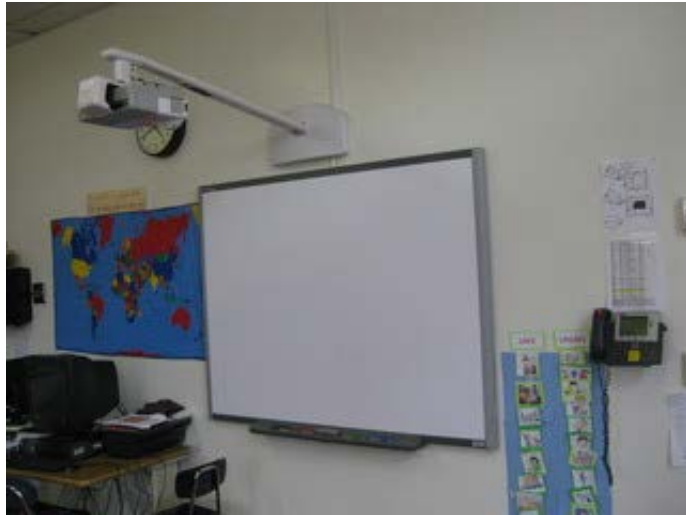
[Back to Assessment Summary](#)
