**Building Information - Shaker Heights City (44750) - Woodbury Elementary School**

**Building Pictures - Shaker Heights City(44750) - Woodbury Elementary School(41939)**

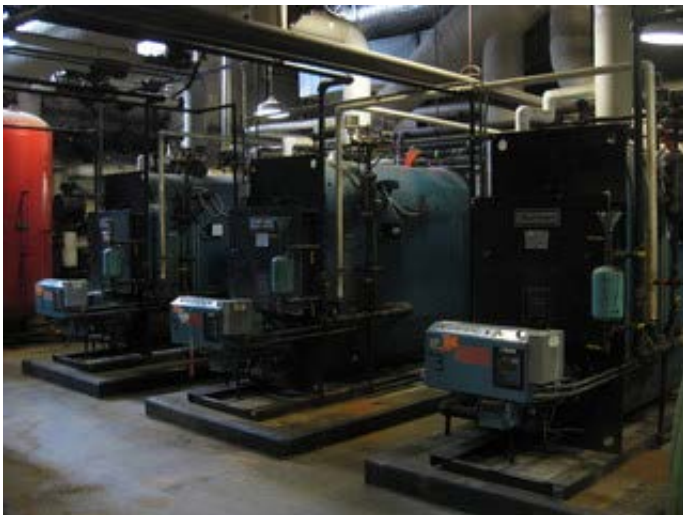
**Description:** The existing system for the main building and classroom areas consists of three Burnham steam boilers with 3475 MBH capacity installed 1995. The boilers appear to be in satisfactory condition for their age. There is a tube and shell steam to hot water heat exchanger in the mechanical room with two heating water building pumps that serve the unit ventilators and air handling units. The pumps are in poor condition. The boilers and air handling units are controlled with DDC controls and the rest of the controls are pneumatic and in fair to poor condition due to the equipment age. Generally, all the equipment has been well maintained. Each ventilator has an outside air grilled at the exterior wall or outside air is ducted from the attic to an interior ventilator. Overall, the ventilators and the air handling units do not provide the required outside air delivery to meet OBC mechanical code. The DDC controls were added two years ago under an energy performance contract. The staff indicates the controls do not always work and they turn off the boilers on mild temperature days to avoid over heating the school. 1969 Addition: The pool, locker rooms, band room, community room, and gym near the pool are served by three steam boilers: two Smith Cast Iron Boilers at 1,200 MBH each and one Weil-McLain boiler at 1690 MBH (estimated - no model number marked). There is a tube and shell steam to hot water heat exchanger providing heating water for the unit ventilators in this area. The air handling units are steam heat. The two-pipe system does not provide a capacity for simultaneous heating and cooling operation which is not compliant with the OSDM requirements. The staff indicated that the site does not contain underground fuel tanks.

**Rating:** 3 Needs Replacement

Main Mechanical Rm Steam boilers

**Recommendations:** Provide a new overall heating ventilating and air conditioning system to achieve compliance with OBC and OSDM standards. Convert to ducted system to facilitate efficient exchange of conditioned air. Provide new DDC temperature controls with the new system. The new ducted system will likely require architectural soffits to accommodate the installation of the ductwork.

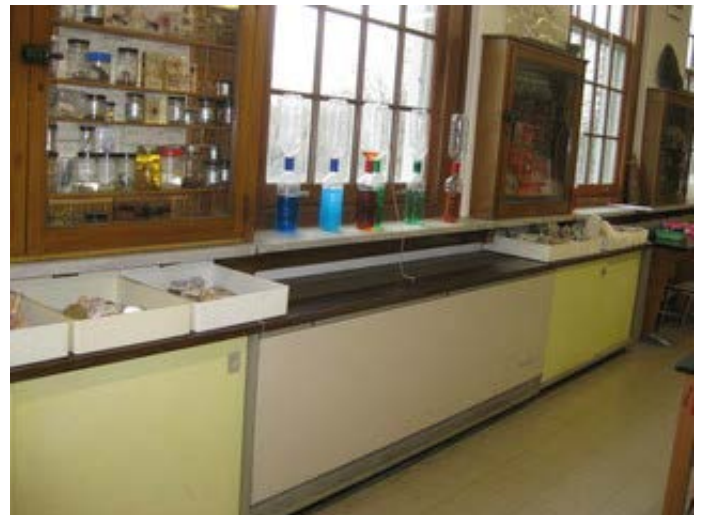
Unit ventilator

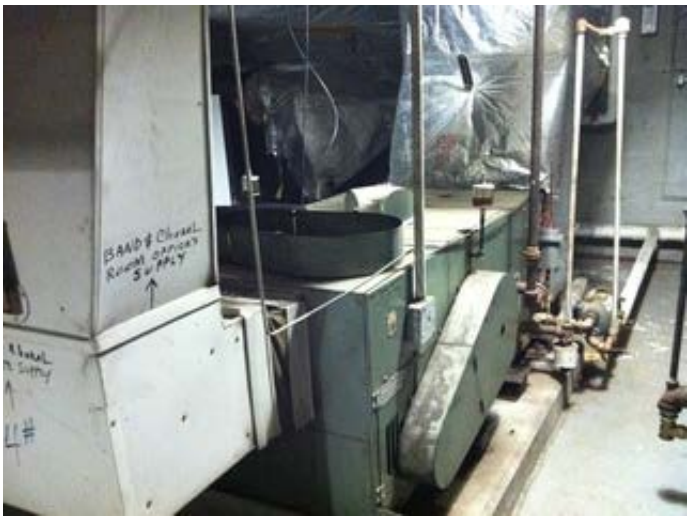
Band AHU

**Recommendations:** Provide an air conditioning system to meet OBC and OSDM requirements. Pricing included in Item A.

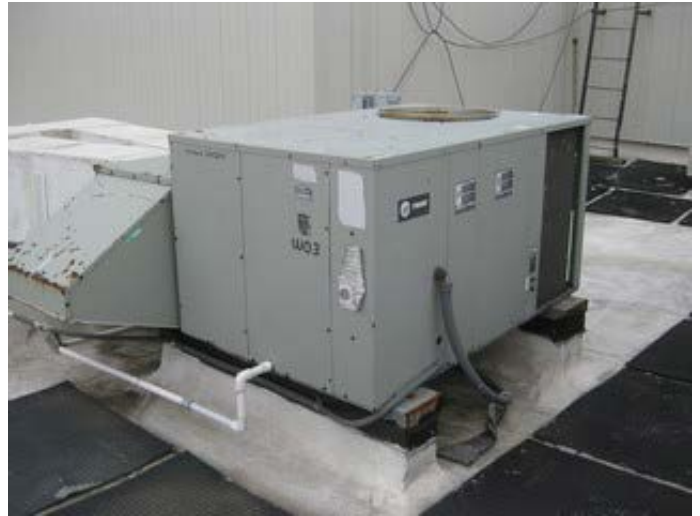
RTU

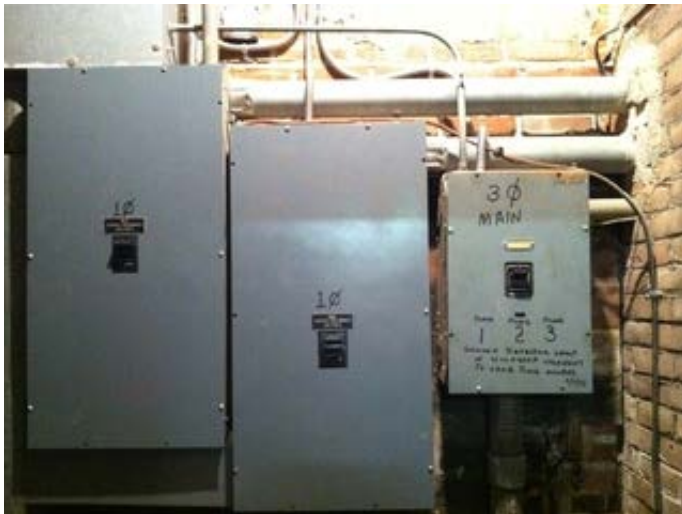
Main Electrical Switch Gear

**Recommendations:** The entire electrical system requires replacement to meet Ohio School Design Manual guidelines for overall capacity due to poor condition and age.

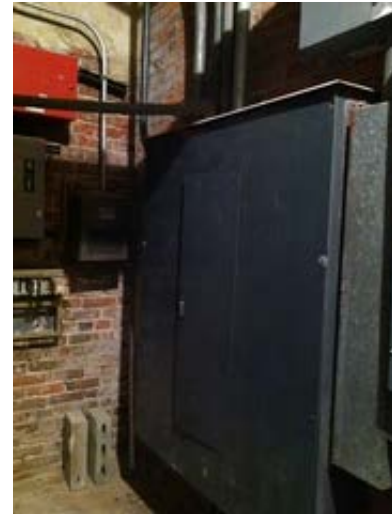
Distribution Panel

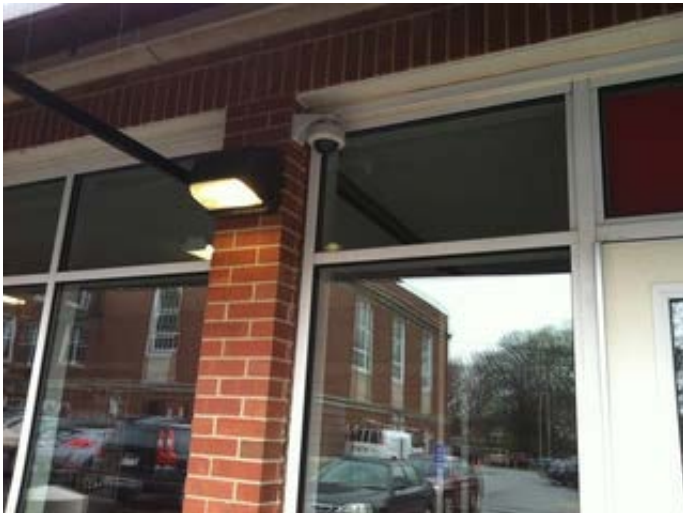
Camera at entrance

**Recommendations:** Provide new security system to meet OSFC design manual guidelines and upgrade the exterior lighting.

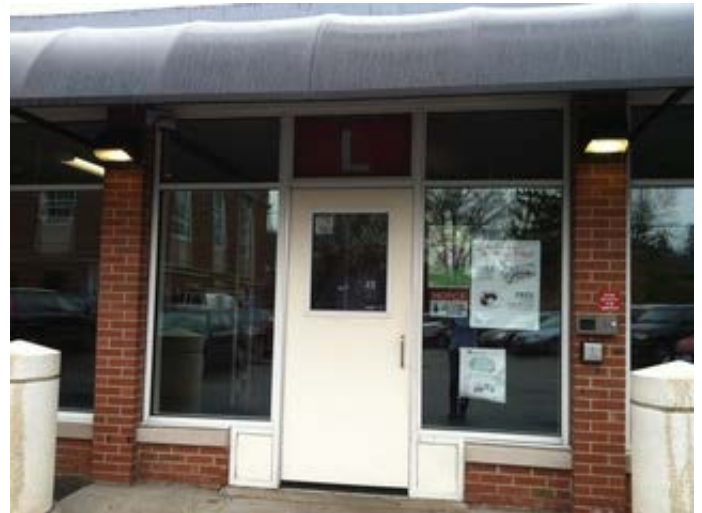
Front Entrance door

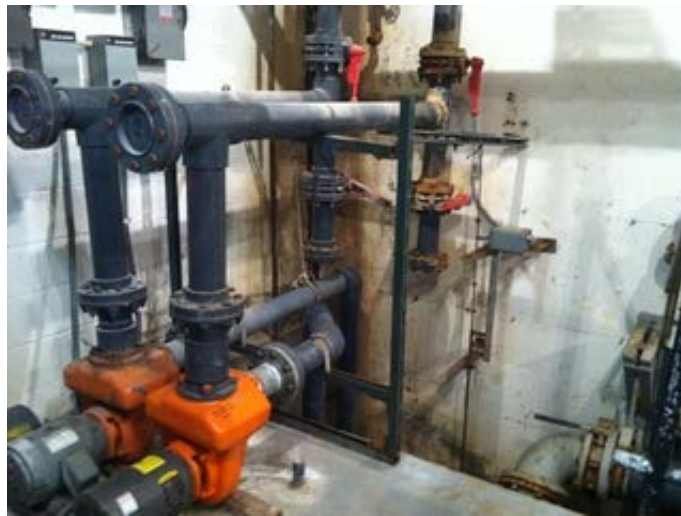
Storm water sump pump

**Recommendations:** Replace the sewer system due to age.

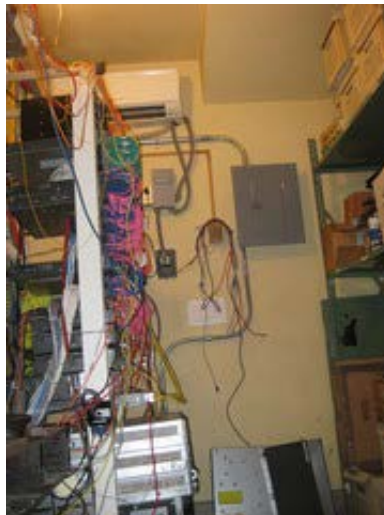
Data closet

**Recommendations:** The technology systems to meet OSDM requirements however, the system will need to be replaced with the replacement of the HVAC and Fire Suppression System. Provide a centralized clock system.
