Building Information - Shaker Heights City (44750) - Shaker Heights Middle School

Program Type	Classroom Facilities Assistance Program (CFAP) - Regular
Setting	Urban
Assessment Name	Shaker Heights MS Assessment - Shaker Heights CSD - CFAP Update (11-2-21)
Assessment Date (on-site; non-EEA)	2015-02-09
Kitchen Type	Full Kitchen
Cost Set:	2016
Building Name	Shaker Heights Middle School
Building IRN	4457
Building Address	20600 Shaker Blvd
Building City	Shaker Heights
Building Zipcode	44122
Building Phone	(216) 295-4100
Acreage	22.76
Current Grades:	7-8
Teaching Stations	32
Number of Floors	2
Student Capacity	1184
Current Enrollment	861
Enrollment Date	2014-04-23
Enrollment Date is the date in which the current enrollment was taken.	
Number of Classrooms	24
Historical Register	NO
Building's Principal	Danny Young
Building Type	Middle

Building Pictures - Shaker Heights City(44750) - Shaker Heights Middle School(4457)

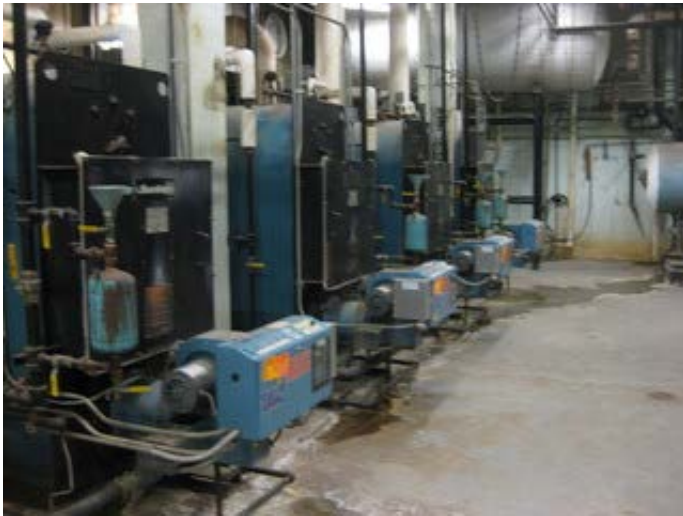
Description: The existing system for the overall facility consists of four, Burnham gas-fired steam boilers in fair condition, 1995. The capacity of each is 2,821 MBH. The steam boilers serve unit ventilators in each classroom, and fin tube in the common areas and several air handling units that serve larger spaces. The boilers and air handling units are controlled with DDC controls and the rest of the controls are pneumatic and in good condition considering their age. Each ventilator has an outside air grilled at the exterior wall. Overall, the ventilators and the air handling units do not provide the required outside air delivery to meet OBC mechanical code. The DDC controls were added two years ago under an energy performance contract. The staff indicates the controls keep the boilers on too long on mild days. On the day of the site visit, the staff turned off the boilers because the building was warm enough and no longer required the heating on. There is a dedicated steam boiler, Hydro- Therm, 105 MBH, for the kitchen kettle. The operation is controlled by the kitchen staff. The 1987 boiler is in poor condition. The pipe system does not provide a capacity for simultaneous heating and cooling operation which is not compliant with the OSDM requirements. The staff indicated that the site does not contain underground fuel tanks.

Rating: 3 Needs Replacement

Steam boilers

Recommendations: Provide a new overall heating ventilating and air conditioning system to achieve compliance with OBC and OSDM standards. Convert to ducted system to facilitate efficient exchange of conditioned air. Provide new DDC temperature controls with the new system. The new ducted system will likely require architectural soffits to accommodate the installation of the ductwork.

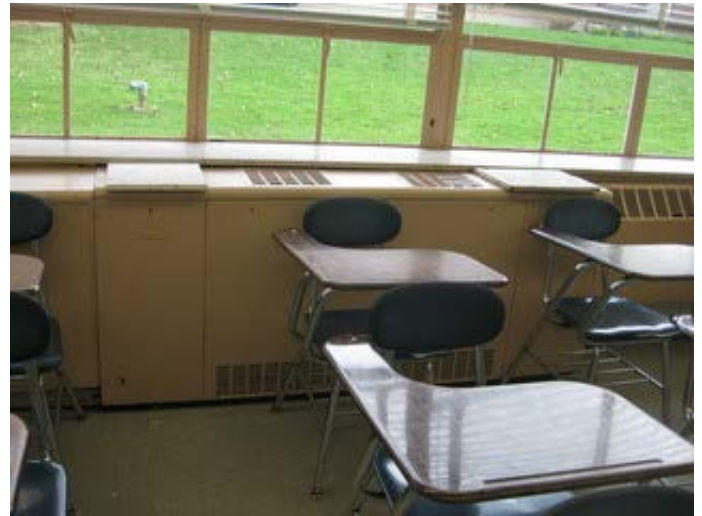
Classroom Unit Ventilator

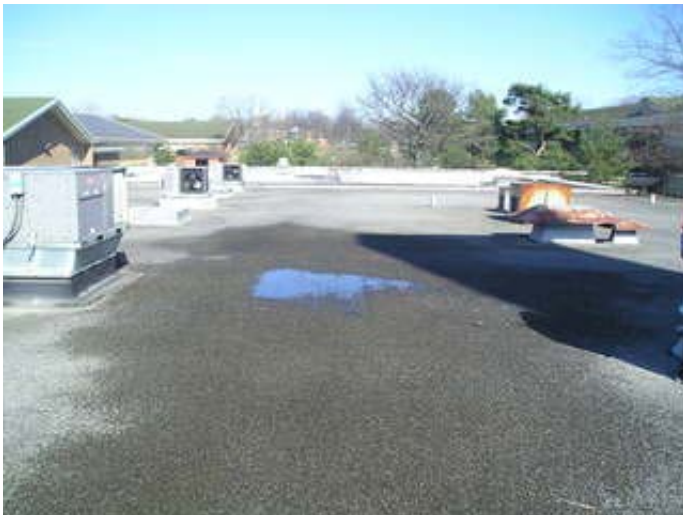
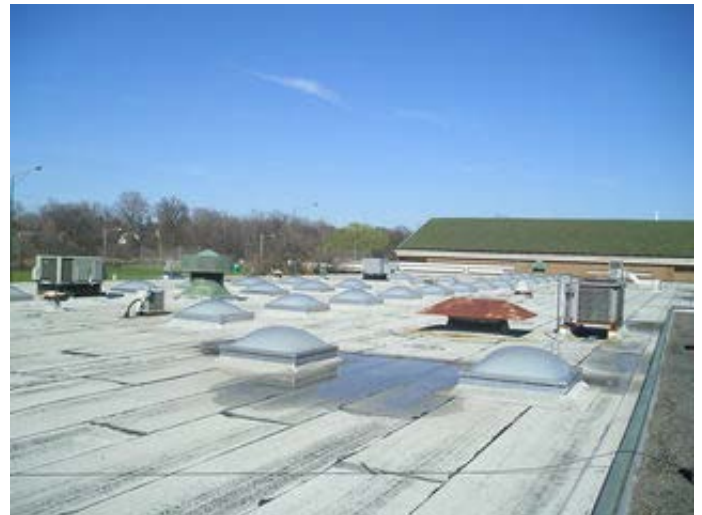
Description: Low slope roof areas are covered by a combination of built-up roofing (with and without a reflective coating) and ballasted membrane roofing. Ponding was observed over the built-up roof. Indications of ponding such as saturated gravel and biological growth were observed in some of the ballasted areas. In 2013, built-up roof was placed over the library and auditorium. Pitched roofs over the classroom wings are covered with asphalt shingles. Approximately 45 skylights were observed in the low slope roof areas. Several areas around the roof overhangs and eaves are finished with painted wood that is peeling. Evidence of birds and insects was observed in the roof overhangs.

Rating: 3 Needs Replacement

Recommendations: Replace underside of exterior roof overhangs and eaves with an exterior grade sheathing product. 01-27-16 UPDATE: REPLACE SLATE ROOF WITH ASPHALT SHINGLES ON 1955 ORIGINAL BUILDING. PROVIDE FOR DECK REPLACEMENT ON SLOPED ROOF SECTION OF 1955 ORIGINAL BUILDING. PROVIDE FOR DECK REPLACEMENT ON 1955 ORIGINAL BUILDING AND 1955 AUDITORIUM. REPLACE LOW SLOPED ROOF AREA ON 1955 AUDITORIUM. REPLACE GUTTERS AND DOWNSPOUTS ON 1955 ORIGINAL BUILDING. REPLACE ROOF DRAINS ON 1955 ORIGINAL BUILDING. PROVIDE FOR TAPERED INSULATION ON 1955 ORIGINAL BUILDING AND 1955 NATATORIUM TO PROVIDE FOR PROPER DRAINAGE. REPLACE WOOD FASCIA ON 1955 ORIGINAL BUILDING WITH AZEK OR FYPON FASCIA. PROVIDE VENTED ALUMINUM SOFFIT ON 1955 ORIGINAL BUILDING. 11-2-21 Update: Remove scope completed in 2018: built-up roof replacement.

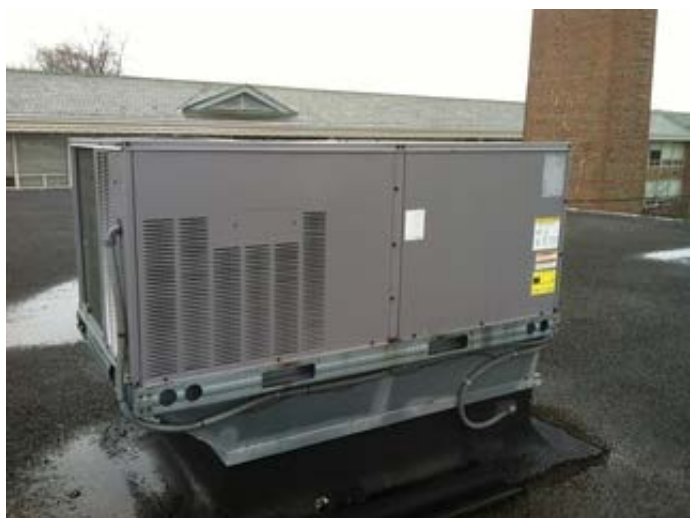
Description: Heating only Air handling units with minimum outside air serve the following areas: Pool, Boys Gym, and Girls Gym. The following areas have air conditioning: Main office: AHU with DX cooling (original equipment, ACCU has been rebuilt) Band Room, Choir Rm, and Auditorium Classroom: fan coil units with DX cooling Teachers Lounge: RTU, 2 years old. Library: RTU1: older than 20 years (poor condition), RTU2: 6-7 years old (good condition) Computer Labs: RTUs about 10 years old in good condition Data/server room: wall AC with roof mounted DX cooling - good condition. The ventilation system does not meet the OBC fresh air requirement. The pool does not have enough ventilation to meet current requirements. The overall system is not compliant with Ohio School Design Manual requirements. The general building exhaust systems located in the restrooms are dated and in poor condition.

Rooftop unit

Recommendations: Provide an air conditioning system to meet OBC and OSDM requirements. Pricing included in Item A.

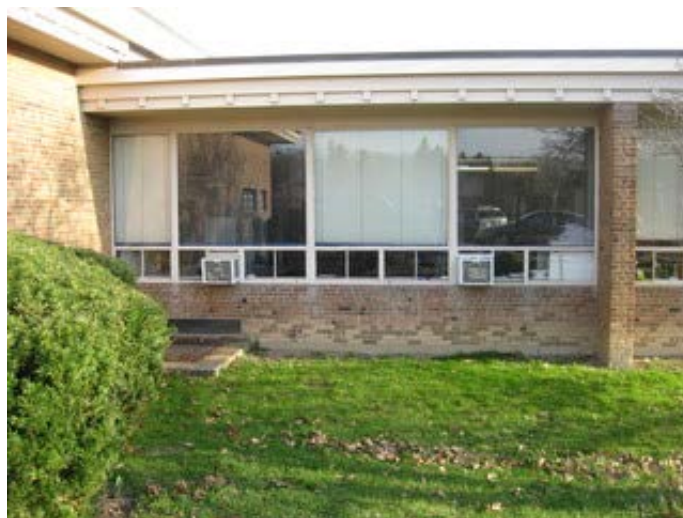
Window air conditioners

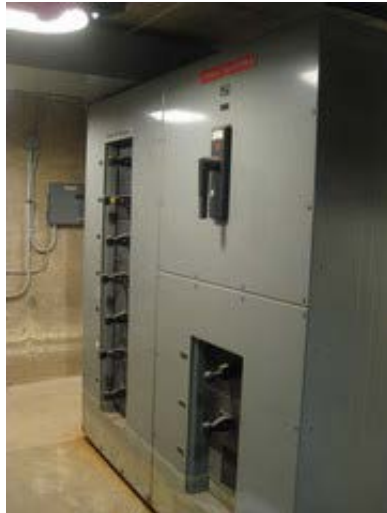
Description: There are two power feeds for electrical system in the facility. One is 480V, 3 phase, 1600 amps and the other is 480V, 3 phase, 1600 amps. The main breakers and electrical distribution equipment are original and in fair to poor condition. The panel boards are original equipment and in poor condition. The panel boards are recessed in the corridor walls where students have access to the front panel cover. These covers are kept locked. There is an electric meter installed on each power main line that reports the electric usage to the DDC temperature control system. This was installed 2 years ago. The transformer is owned by the utility and is in a vault in the basement. The power into the transformer is fed underground. The electric meter outside the vault, near the main disconnect. The panel board system is in poor condition and is also beyond the normal equipment life. There is no extra capacity in most sections of the building. Additional outlets have been added to the classrooms, but some the classrooms are still not equipped with adequate electrical outlets. Adequate GFI protected exterior outlets are not provided around the perimeter of the building. The facility is equipped with a diesel emergency generator. There is no lightning protection. The overall electrical equipment is in fair to poor condition and is beyond the normal equipment life and should be replaced. The panel boards should be moved into a secure area so students do not have access. Most of the classrooms do not meet OSDM requirements in supporting the current needs of the school and will be inadequate to meet the facility's future needs. The overall electrical system does not meet OSDM requirements in supporting the current needs of the school and will not be adequate to meet the facility's future needs.

Rating: 3 Needs Replacement

Main Electrical Switch Gear

Recommendations: Provide lightning protection system. The entire electrical system does not meet Ohio School Design Manual guidelines for overall capacity.

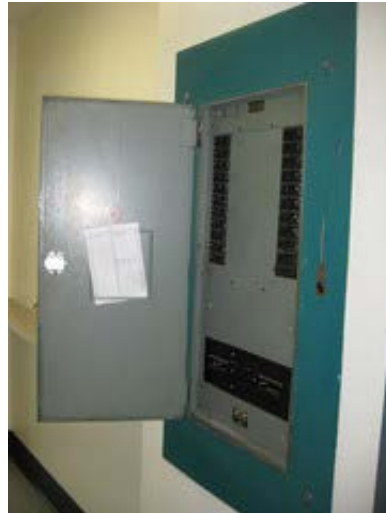
Panel Board mounted in corridor wall

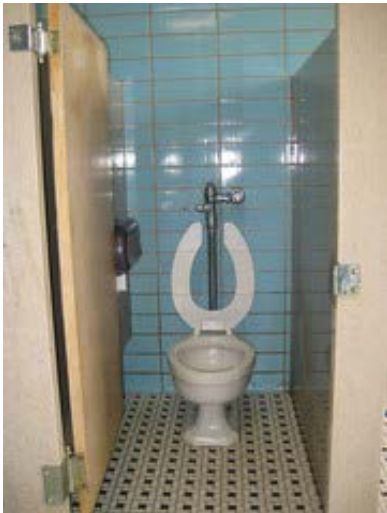
Description: The domestic water supply piping in the original building is copper and most is in satisfactory condition. A water treatment system is not required for the domestic water system. There is a small water softener for the boiler water make-up. The facility has three gas fired condensing domestic water boilers; Weil-McLain 2005, with an external storage tank that serves the locker rooms and pool area. The approximate 500 gallon storage tank is original construction and was converted from steam heat in satisfactory condition. There is one AO Smith domestic water heater (less than 5 years old) in the main mechanical room with an external storage tank that serves the rest of the school. The storage tank was converted from steam heat and is approximately 1000 gallons. The sanitary waste piping is cast iron and is in fair condition. No issues were noted by the staff. There is no backflow preventer on the incoming water service in the building, however there is a pressure reducing valve. There are the required backflow preventers for non-potable water usage in the building, i.e. heating system make-up water and pool make up water. The pool filter is the original configuration, with a manual backwash cycle. The internal filter bags and leafs media are 5-6 years old and appear to be in satisfactory condition. The pool pumps are 1-2 years old and in good condition. The school contains 10 restrooms for boys, 10 restrooms for girls, and 18 restrooms for the staff. The First floor has 1 boys ADA restroom and 1 girls ADA restroom. There are no ADA restrooms on the Second floor. One girl's restroom has been updated to wall mounted toilets. All the original toilets are floor mounted. There are 63 LAVs, 2 ADA LAVs, 76 toilets, 3 ADA toilets, and 30 floor mounted urinals. The Art room has 6 stainless steel sinks in fair to good condition. The manual faucets are in fair to poor condition and showing age. There are 4 electric water coolers and 19 drinking fountains in the school in generally good condition. There is an Ansul suppression system in the kitchen hood and a grease trap for the three compartment sink in the kitchen.

Rating: 3 Needs Replacement

Floor mounted toilet

Recommendations: Provide all of the faucets and flush valves with sensor, and low flow devices/fixtures to meet OSFC requirements. Replace art room sink faucets. Provide backflow preventer for main service entrance and pool. 01-27-16 UPDATE: PROVIDE FOR ADDITIONAL ELECTRIC WATER COOLERS IN 1955 ADDITION. DUE TO AGE AD CONDITION, REPLACE EXISTING SANITARY WASTE PIPING IN 1955 ORIGINAL BUILDING AND 1955 NATATORIUM.

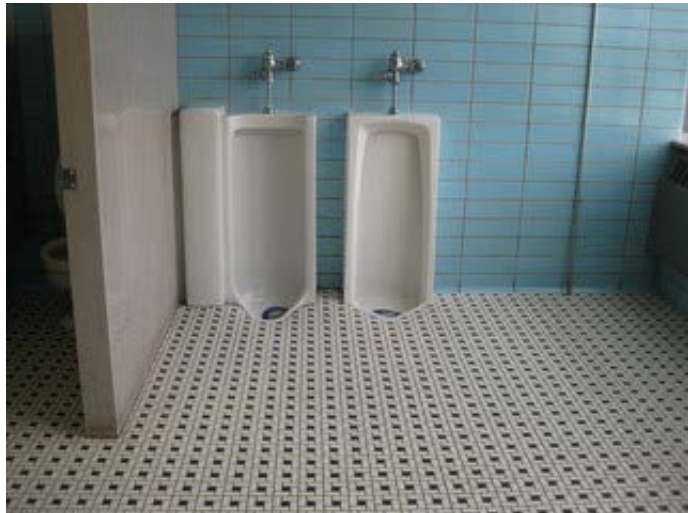
floor mounted urinal

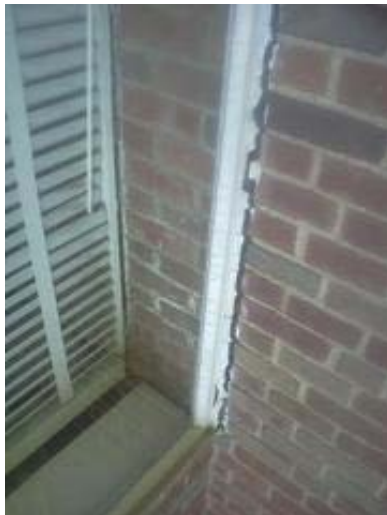
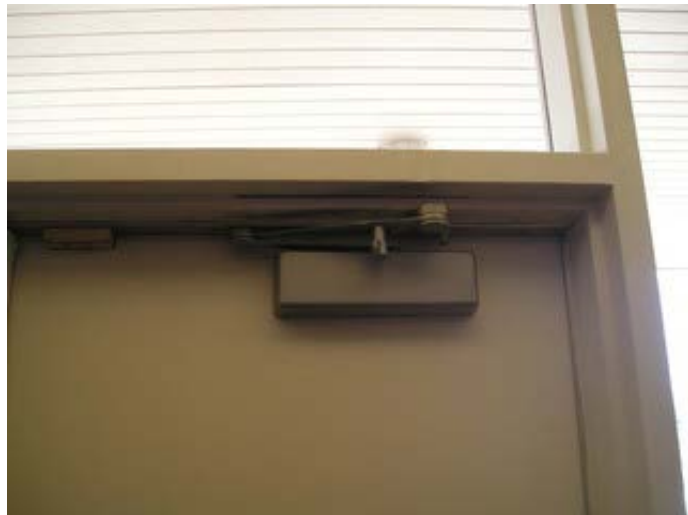
Description: Single pane metal windows account for almost 80% of the building envelope at classrooms wings and many corridors around the building. This glazing system offers no thermal benefit and is in some instances severed at the jamb from the adjacent wall. New insulating units have been provided along the north wall of the athletic wing. Exterior doors are not insulated and their vision panels are not thermally broken or safety treated. Translucent panels at the natatorium appear to be past the end of their service life. The building has approximately 45 skylights. Indications of moisture penetration were not observed with the skylights.

Rating: 3 Needs Replacement

Recommendations: Provide new windows throughout the entire building with integral blinds in learning areas. Exterior doors will need to be replaced as they are part of a hollow metal framed entrance system with single pane glazing.

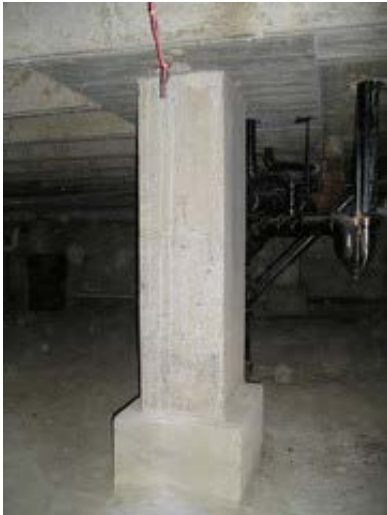
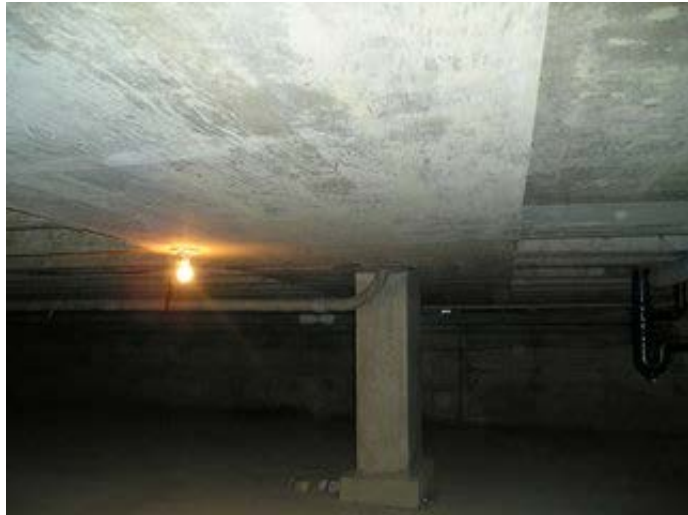
Description: Poured concrete foundation walls and columns were observed under the building. Steel columns are supported by the perimeter foundation walls.

Rating: 2 Needs Repair

Recommendations: Moisture was observed at the east end of the building where playing fields have a higher elevation than the grade around the building. 01-27-16 UPDATE: REPAIR CRACKING AND SPALLING CONCRETE FLOOR IN BASEMENT OF ORIGINAL 1955 BUILDING. REVISE QUANTITY OF AREA TO RECEIVE WATERPROOFING MEMBRANE ON 1955 ORIGINAL BUILDING. REVISE LF OF FOUNDATION DRAIN TILE ON 1955 ORIGINAL BUILDING. PROVIDE A SUMP PUMP BELOW EAST GYMNASIUM AND PROVIDE SLOPE IN FLOOR TO SUMP. 11-2-21 Update: Remove scope completed in 2020: partial waterproofing & drain tile.

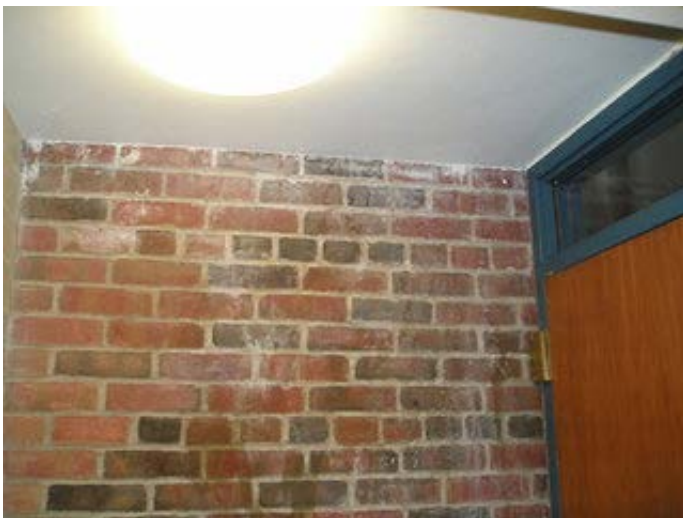
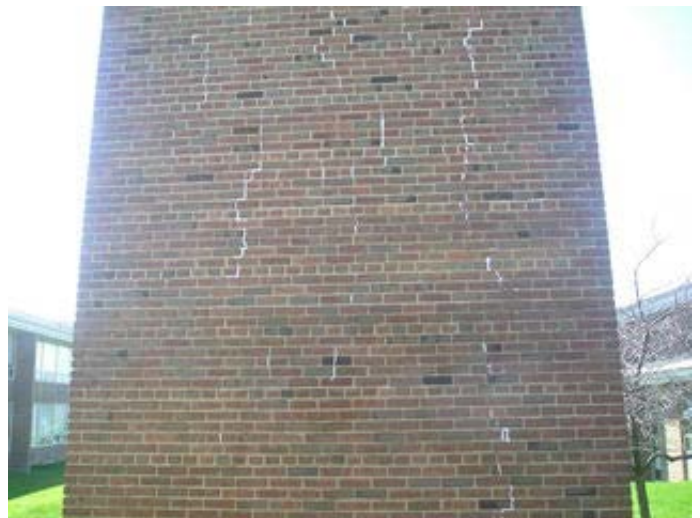
Description: Most of the exterior walls are not load bearing. The auditorium walls are likely load bearing and display signs of efflorescence. The chimney displays several repaired cracks in the mortar.

Rating: 2 Needs Repair

Recommendations: Even though a new roof has been provided over the auditorium the exterior walls should be cleaned and sealed to protect against future moisture penetration. 01-27-16 UPDATE: REPAINT STEEL LINTELS AND RE-CAULK. ADD WEEPS AT LINTELS ABOVE WINDOWS. REPLACE DAMAGED CONCRETE SILLS ON 1955 ORIGINAL BUILDING. PROVIDE EXTERIOR MASONRY CLEANING AND SEALING OF EXTERIOR MASONRY ON 1955 NATATORIUM AND 1955 ORIGINAL BUILDING. PROVIDE CONTROL JOINTS ON 1955 ORIGINAL BUILDING. PROVIDE TUCKPOINTING ON 1955 ORIGINAL BUILDING, 1955 AUDITORIUM AND 1955 NATATORIUM. REPLACE EXPANSION JOINT ON 1955 ORIGINAL BUILDING. REBUILD BRICK VENEER CORNER ON 1955 AUDITORIUM. 11-2-21 Update: Remove work completed in 2019: partial tuckpointing, cleaning & sealing; brick replacement.

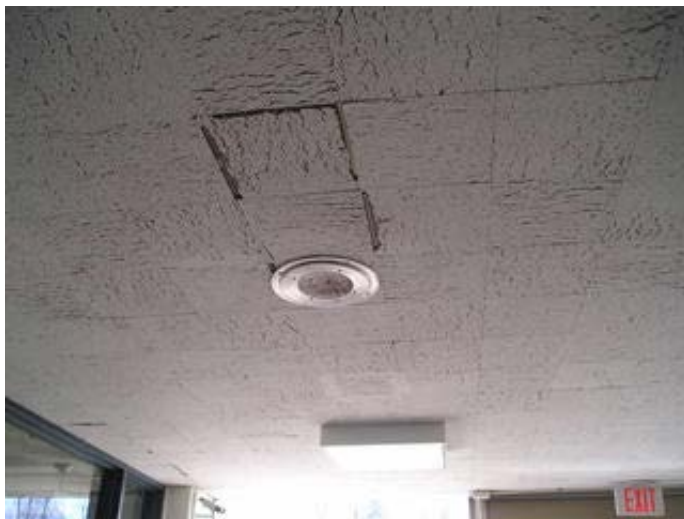
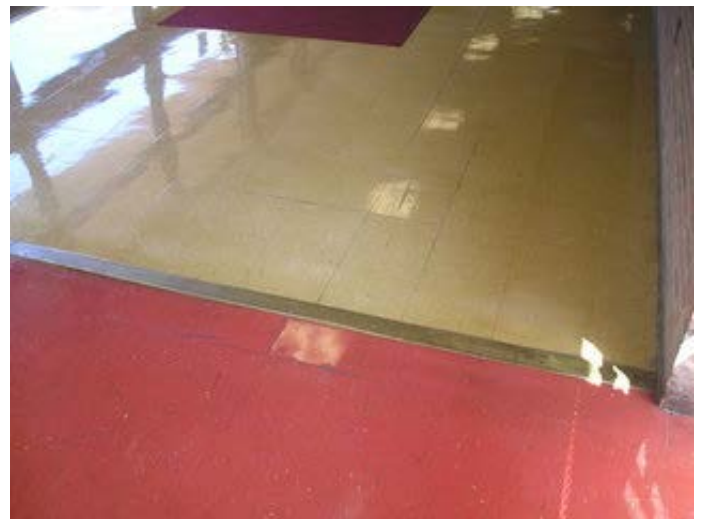
Description: Most corridors have VCT flooring and walls clad with wood veneer wainscot on plaster walls. Separation between vinyl tiles was observed in most of the joints. The wood veneer displays slight indications of wear and minor scratching. Most ceilings are direct adhered acoustic tiles. Some signs of wear are visible. Carpeted floors and brick walls are present in the performing arts wing of the school. Most of the finishes display only minima signs of wear. The kitchen is utilized for production of meals served in-house as well as at for delivery to some of the middle schools. The food service equipment is functioning properly. Recent model toilet partitions were observed in the restroom. The partition doors have piano hinge hardware and the stalls are sized to accommodate grab bars. Wood athletic flooring was observed in the gymnasium. The flooring does not display any sings of deterioration.

Rating: 3 Needs Replacement

Recommendations: Provide new suspended ceiling in conjunction with installation of new sprinklers and ductwork. Provide new flooring where VCT is now in place. 01-27-16 UPDATE: REPLACE KITCHEN EQUIPMENT.

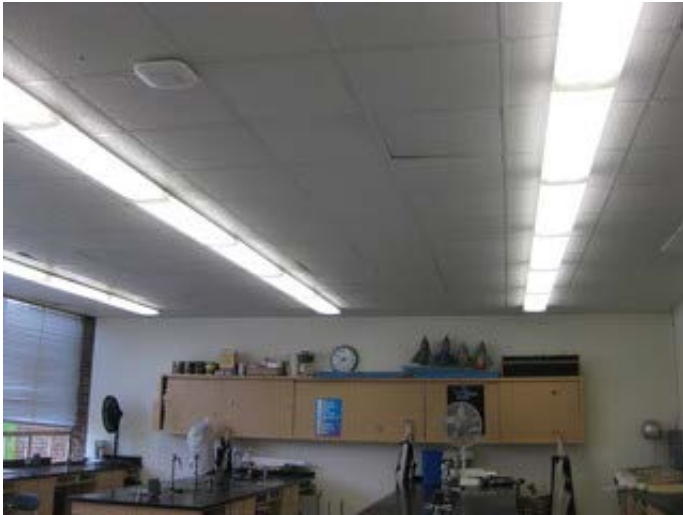
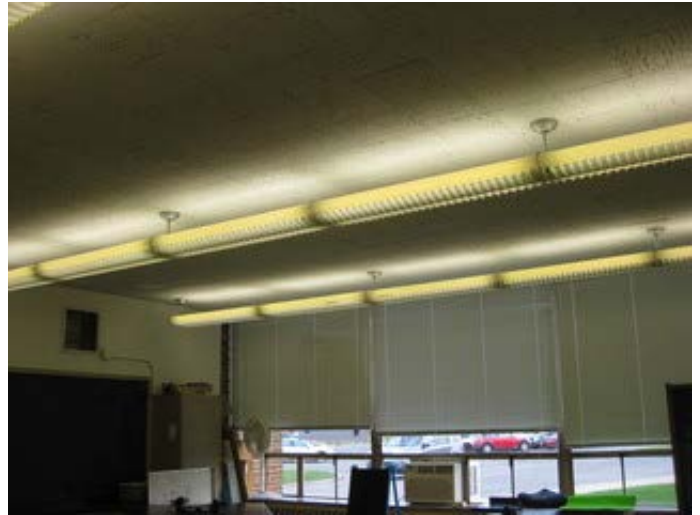
Rating: 3 Needs Replacement

classroom lighting

Recommendations: Provide complete replacement of lighting system due to installation of ducted HVAC systems and fire suppression systems.

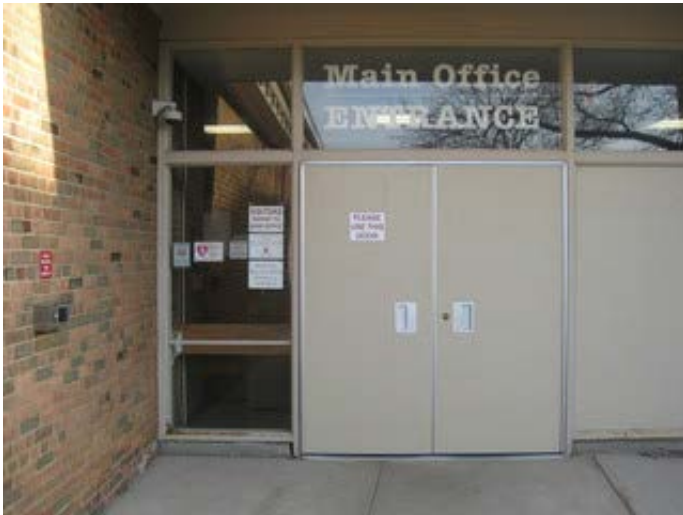
Rating: 3 Needs Replacement

Security at Front Entrance Door

Recommendations: The security system meets OSFC design manual guidelines, however, replace system due to new HVAC/fire suppression system. 01-27-16 UPDATE: PROVIDE SITE LIGHTING FOR 1955 ORIGINAL BUILDING, 1955 AUDITORIUM AND 1955 NATATORIUM.

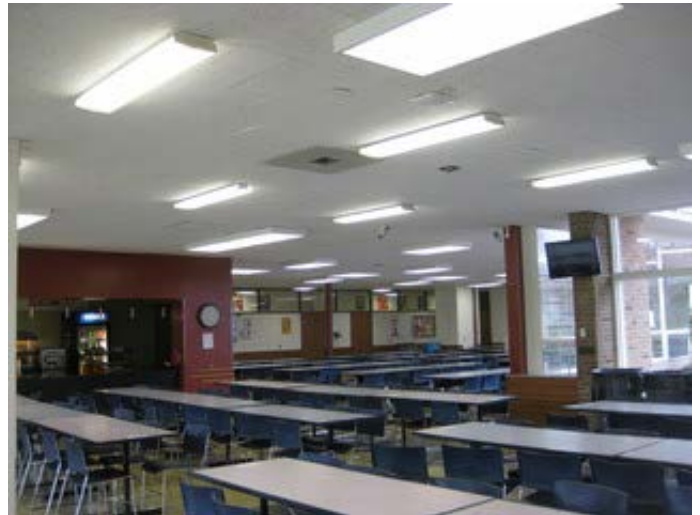
Camera in cafeteria

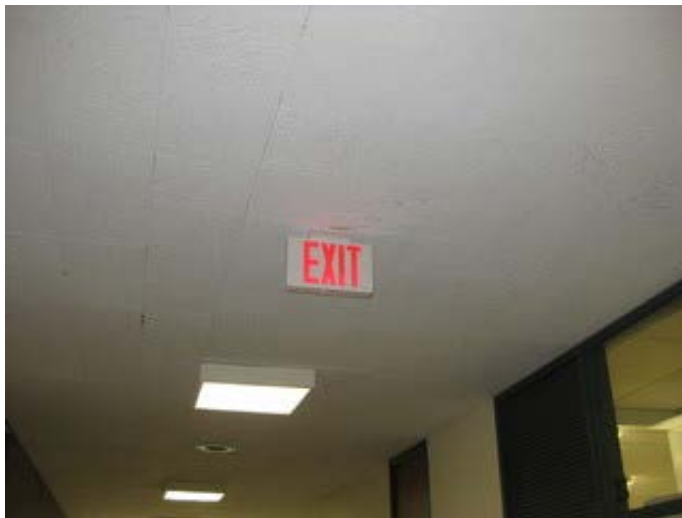
Description: The overall facility is equipped with emergency egress lighting system consisting of a LED exit signs and emergency lighting on a panel served by the emergency generator. The system is in good condition. The system is adequately provided throughout, and is compliant with OSFC design manual guidelines.

Rating: 3 Needs Replacement

Emergency exit light

Recommendations: Provide a complete replacement of emergency egress lighting due to installation of systems outlined in J, K, and U.

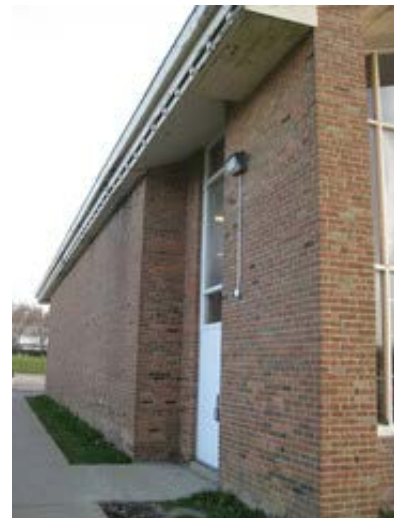
Exterior lighting near entrance

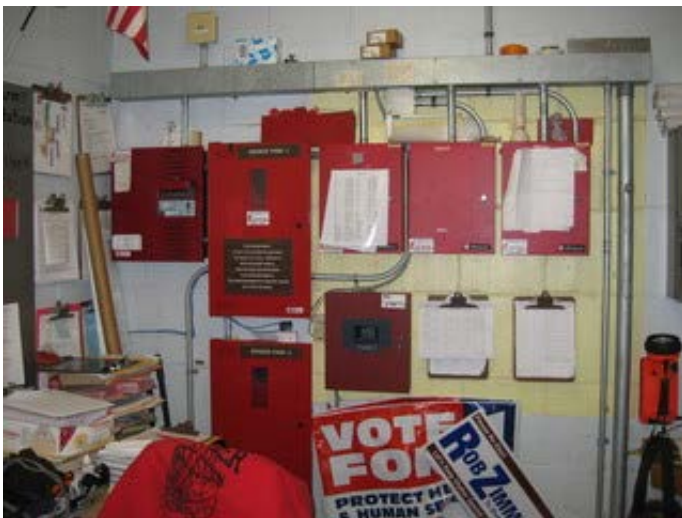
Rating: 3 Needs Replacement

Main Fire Alarm panels

Recommendations: Replace fire alarm system with the installation of the fire suppression system.

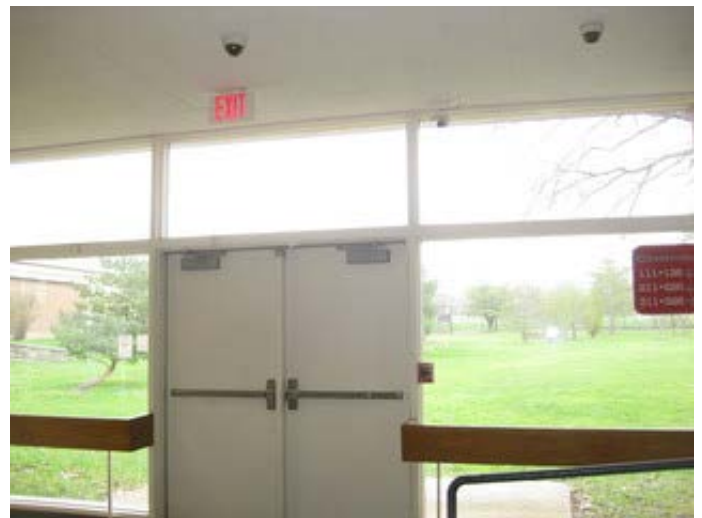
Fire Alarm devices

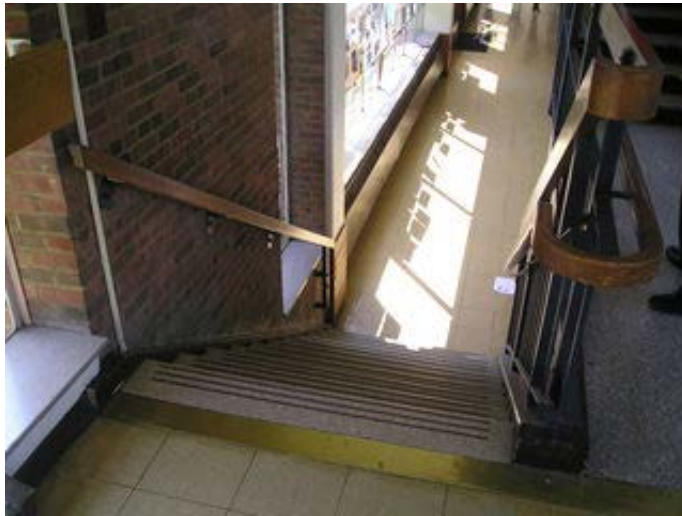
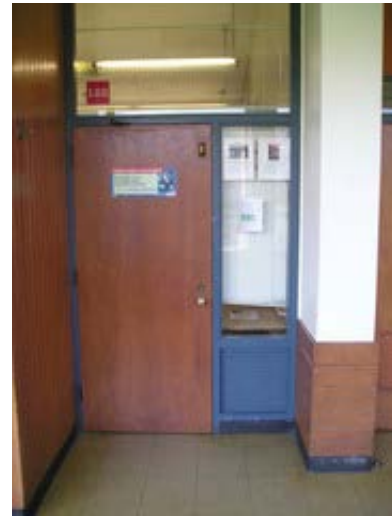
Rating: 2 Needs Repair

Recommendations: Provide new door hardware of ADA compliant lever type throughout the building. Provide 2 power assist door openers at exterior doors. High contrast signage with embossed braille should be provided. 01-27-16 UPDATE: REVISE ADA HARDWARE ON INTERIOR DOORS IN 1955 ORIGINAL BUILDING, 1955 AUDITORIUM AND 1955 NATATORIUM TO DOOR REPLACEMENT. REVISE DOOR QUANTITY ON 1955 ORIGINAL BUILDING. PROVIDE ADA COMPLIANT HANDRAILS ON ATHLETIC WING RAMP AND CLASSROOM WING B & C IN 1955 ORIGINAL BUILDING. PROVIDE ELEVATOR (3 STOP) ON CLASSROOM WING OF 1955 ORIGINAL BUILDING. PROVIDE FOR 3 HANDICAP RAMPS AT 1955 ORIGINAL BUILDING.

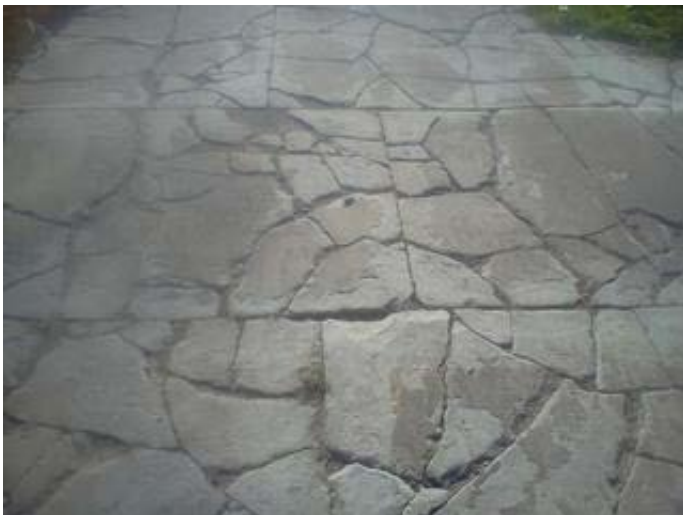
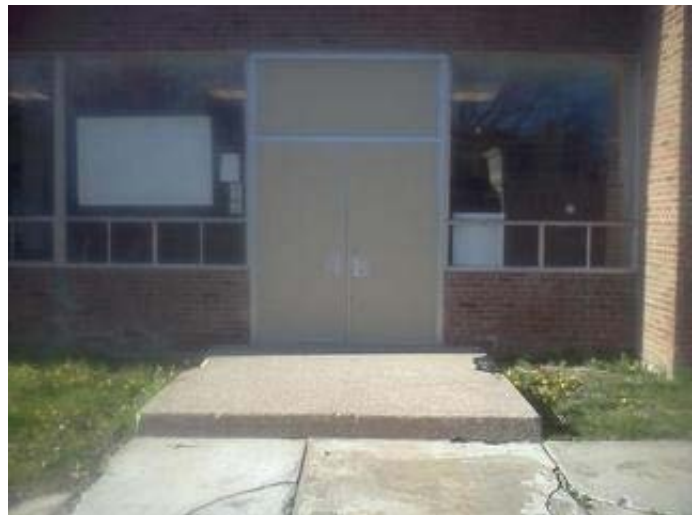
Description: The nearly 23 acre site is surrounded by open green space and athletic fields. Soil conditions appear to be stable and most paved areas were safely walkable without unnecessary comingling of vehicular and pedestrian traffic. There were some limited areas of damaged pavement and ponding around the north side of the site.

Rating: 2 Needs Repair

Recommendations: Replace asphalt drive along south side of building with heavy duty asphalt. Replace damaged areas of concrete paved walk around the south side of the building. REPLACE ASPHALT PAVING. REPLACE HANDRAILS. REPLACE DOCK BUMPERS. 01-27-16 UPDATE: PROVIDE ADDITIONAL STORM CATCH BASINS AND PIPING ADJACENT TO STUDENT DINING (BETWEEN EAST GYM AND CLASSROOM WING) AND INTERIOR COURTYARD ON 1955 ORIGINAL BUILDING FOR SITE DRAINAGE. PROVIDE REPLACEMENT OF CONCRETE SIDEWALKS, STAIRS, RAMPS AND LANDSCAPING DUE TO EXCAVATION FOR EXTERIOR FOUNDATION WALL WATERPROOFING ON 1955 ORIGINAL BUILDING. 11-2-21 Update: Remove scope completed in 2020: partial sidewalk replacement & partial landscaping.

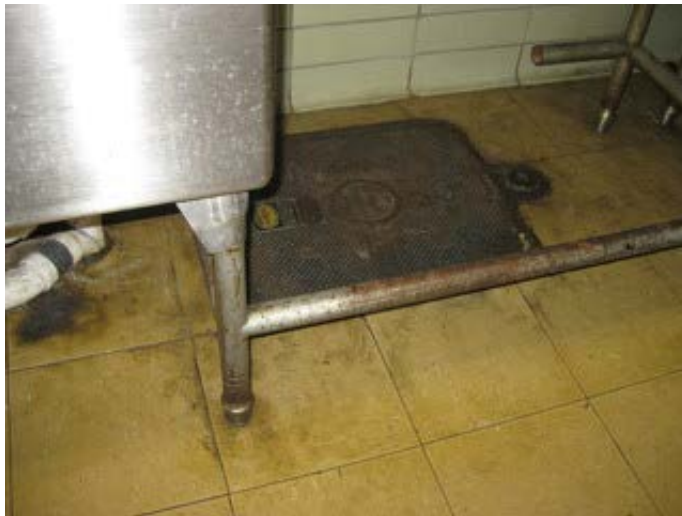
Description: AThe sanitary sewer system drains to the city system and is fair condition. No significant sytem deficiencies were reported by the school district. There is a glass pipe acid waste system serving the Science Classrooms with an acid neutralization sump accessible in the tunnel. The sump is no longer required to be maintained since no acids are used in the classrooms.

Kitchen Grease trap access

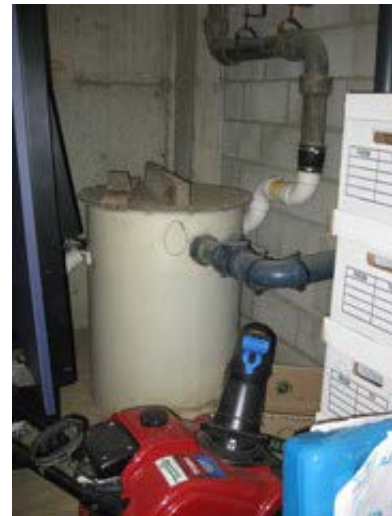
Acid neutralization sump

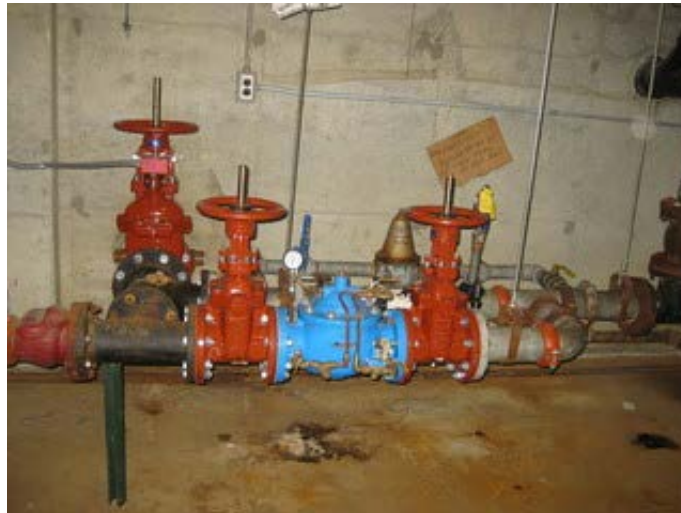
Rating: 3 Needs Replacement

Pressure regulator at water entrance

Recommendations: Replace water main to meet the sprinkler requirements and install a backflow preventer. 01-27-16 UPDATE: PROVIDE FOR NEW BACKFLOW PREVENTER ON EXISTING DOMESTIC WATER SUPPLY.

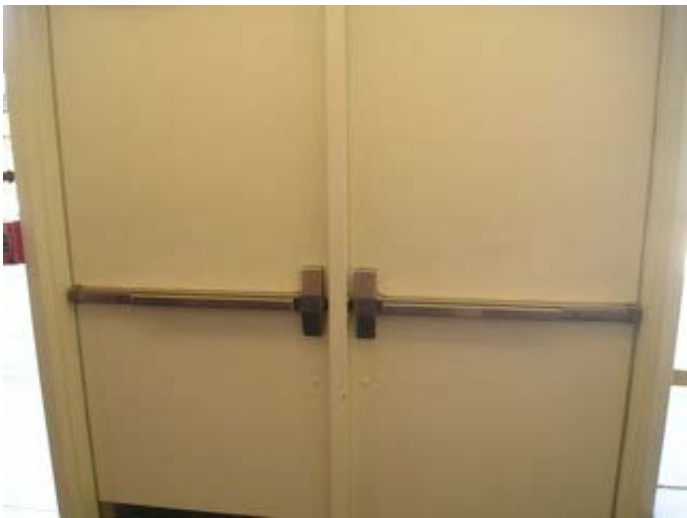
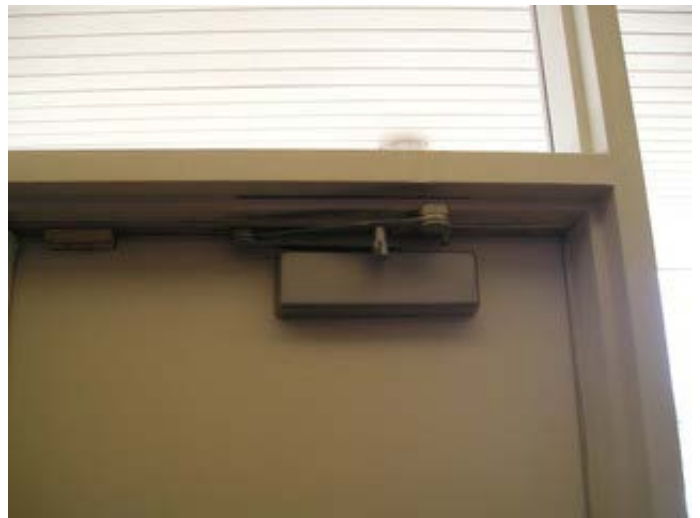
Description: New doors will be needed if entrance systems are replaced with thermally broken aluminum systems.

Rating: 3 Needs Replacement

Recommendations: Provide new insulated exterior doors with panic hardware. 01-27-16 UPDATE: REPLACE EAST GYMNASIUM DOORS (TOTAL OF 3) ON 1955 ORIGINAL BUILDING.

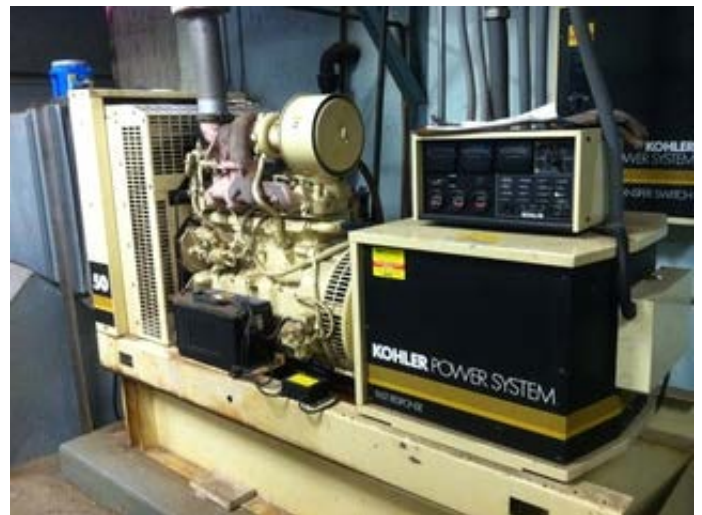
Emergency Generator

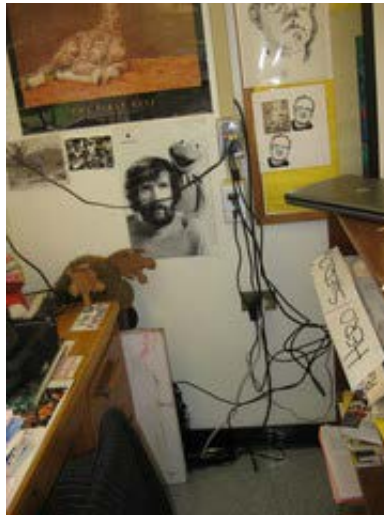
Rating: 3 Needs Replacement

typical classroom technology

Recommendations: The current system meets the requirements however, will need replaced with the installation of the HVAC system and fire suppression system.
