FACILITY ASSESSMENT - LUDLOW BUILDING

SHAKER HEIGHTS PUBLIC SCHOOL DISTRICT

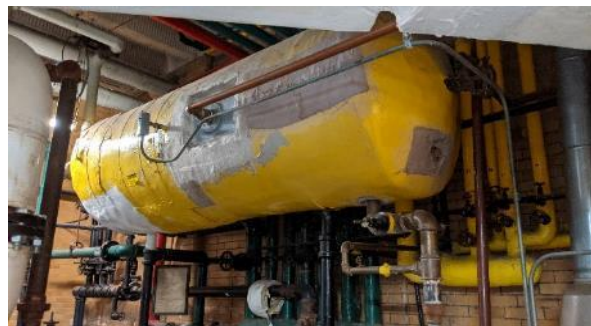
Tank

- The building heating system consists of two (2) Weil Mclain Steam Boilers, each 1820 MBH. The age is unknown, but they appear to be in good condition.
- The steam Condensate Vacuum system and pump are visibly in poor condition.
- Temperature controls are pneumatic technology.
- All Classrooms have steam radiators except the Computer Lab, which has a unit ventilator.
- The Student Dining/Auditorium space has steam radiators only.
- The Gymnasium has steam radiators and steam cabinet unit heaters.

- Boilers should be upgraded to condensing type, high efficiency type at the time of future replacement.
- Condensate return piping would need to be replaced if converted to a hot water system.
- Temperature controls should be upgraded to Direct Digital Controls (DDC) at time of equipment replacement.
- Provide a ducted HVAC system that provides mechanical ventilation as required by building codes.
- Eliminate steam radiators if not desired as part of future renovations.
