SHAKER HEIGHTS

FACILITY ASSESSMENT

Stephanie Tubbs Jones Community Building

December 15, 2021

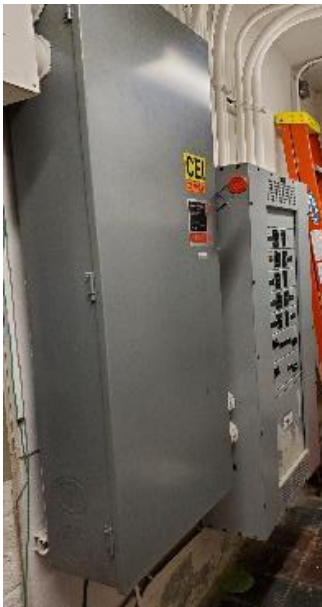
Main Electrical Disconnect

- The electrical service is 600A, 208/120V, 3-phase. The panels in the Basement Electrical Room are in good condition.
- A 75kW outdoor generator provides back-up power to select building loads.
- The recessed panels on the First and Second Floors are very old and in poor condition.

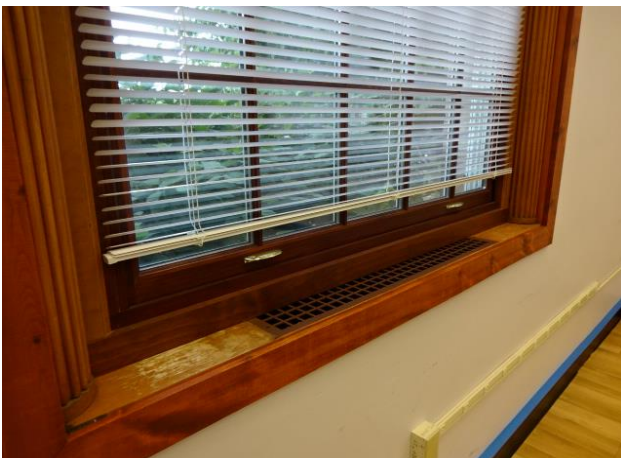
Interior Window

- The overall facility is equipped with metal clad wood frame windows with double glazed insulated glazing type window system, which are in good condition. The window system features operable and inoperable windows throughout the building, and operable windows are equipped with opening limiters in good condition and insect screens in good condition. Window system seals are in good condition, with no air and water infiltration being experienced. Window system hardware is in good condition. The window system features surface mounted blinds, which are in good condition, or no blinds
- The building does not contain skylights or clerestories.

- Existing conditions require no renovation or replacement at the present time.

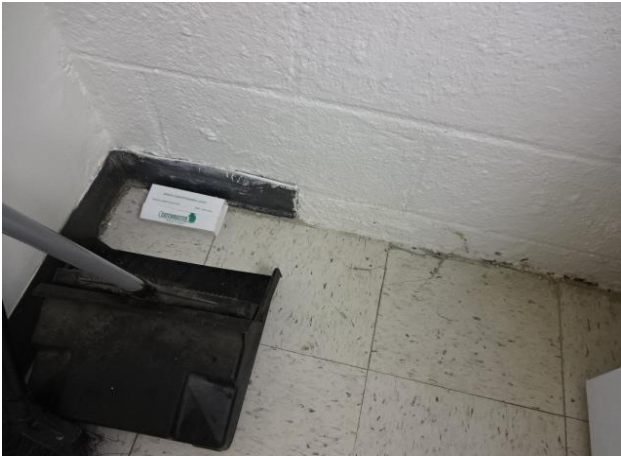
CMU Foundation Wall Interior

- The overall facility is equipped with concrete masonry unit foundation walls on concrete footings, which displayed no locations of significant differential settlement, cracking, or leaking, and are in good condition. No significant issues related to foundation cracking or spalling were encountered. No grading or site drainage deficiencies were noted around the perimeter of the structure that are contributing or could contribute to foundation / wall structural deterioration.

- Existing conditions require no renovation or replacement at the present time.
