**Building Information - Shaker Heights City (44750) - Lomond Elem**

**Building Pictures - Shaker Heights City(44750) - Lomond Elem(21279)**

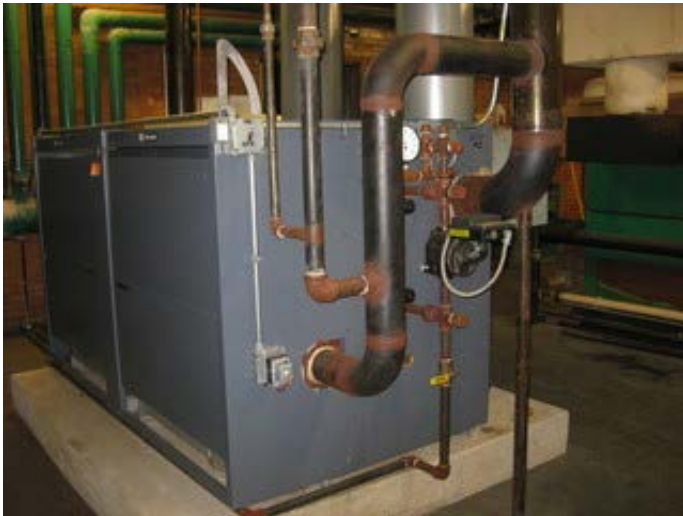
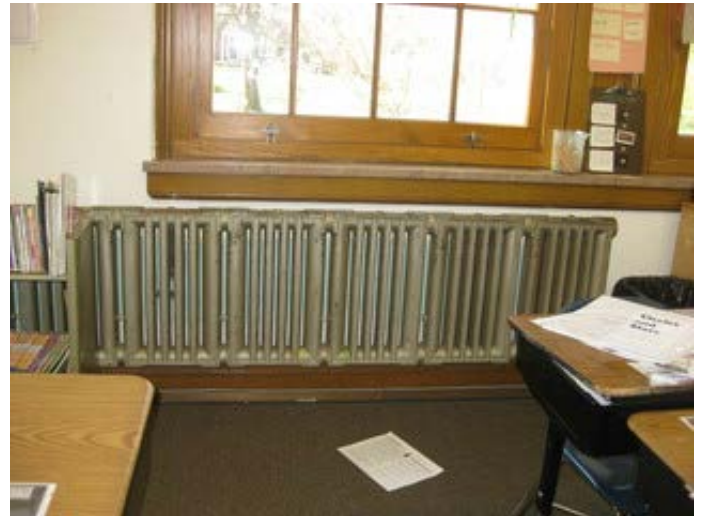
**Description:** The existing system for the building consists of two Weil-McLain steam boilers at 2080 MBH Each, they are approximately ten years old. The boilers appear to be in good condition. There is one boiler that has been abandoned in place. Building is heated with steam heat to unit ventilators, fin tube or radiators. There are unit ventilators located on the inside of the classrooms with outside air ducted to each from the attic area. These classrooms have fin tube or radiators located on the exterior wall. There are two central ventilation fans; each provide outside air for half of the building. The fans are not longer operational. The boilers and air handling units are controlled with DDC controls and the rest of the controls are pneumatic and in fair to poor condition due to the equipment age. Generally, all the equipment has been well maintained. Overall, the ventilators and the air handling units in the building do not provide the required outside air delivery to meet OBC mechanical code. The DDC controls were added two years ago under an energy performance contract. The staff indicates they generally try to leave the controls enabled for the equipment. The boilers are manually turned off during the mild temperatures. The steam system does not provide a capacity for simultaneous heating and cooling operation which is not compliant with the OSDM requirements. The staff indicated that the site does not contain underground fuel tanks.

**Rating:** 3 Needs Replacement

**Recommendations:** Provide a new overall heating ventilating and air conditioning system to achieve compliance with OBC and OSDM standards. Convert to ducted system to facilitate efficient exchange of conditioned air. Provide new DDC temperature controls with the new system. The new ducted system will likely require architectural soffits to accommodate the installation of the ductwork.

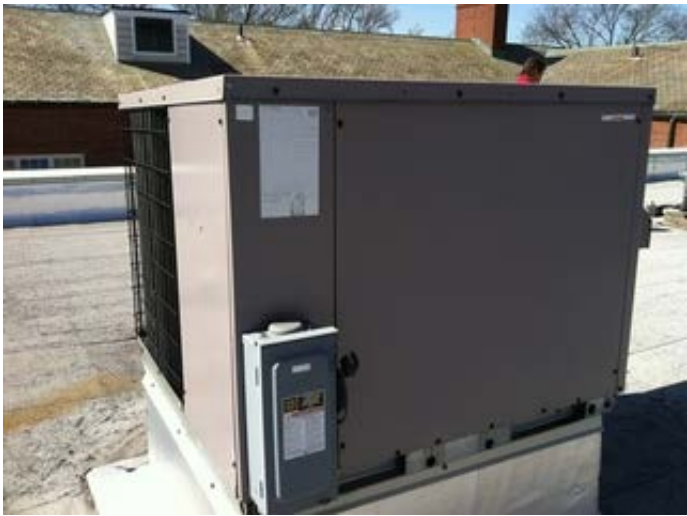
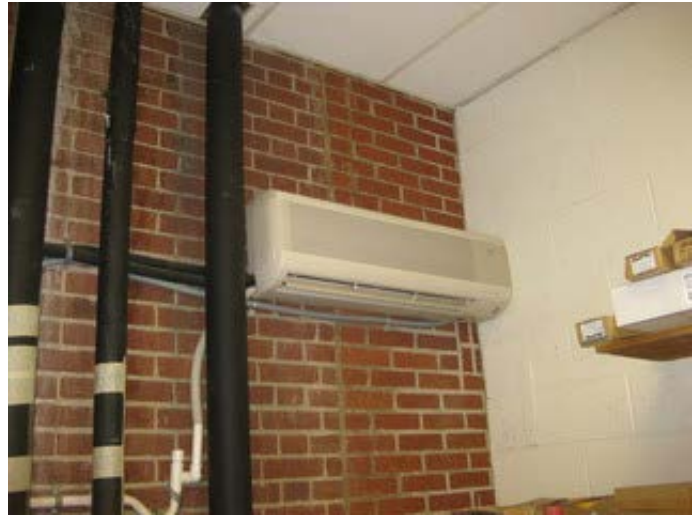
**Description:** The Office and Clinic area have window air conditioners. The teachers lounge and server room have Mitsubishi wall mounted air conditioners with an outside air cooled condensing units. The Art Room and the Computer Lab are cooled with rooftop units. There is no air conditioning in the classrooms. The ventilation system in the building generally does not meet the OBC fresh air requirements. The overall system is not compliant with Ohio School Design Manual requirements. The general building exhaust systems located in the restrooms are functional and in satisfactory condition.

**Recommendations:** Provide an air conditioning system to meet OBC and OSDM requirements. Pricing included in Item A.

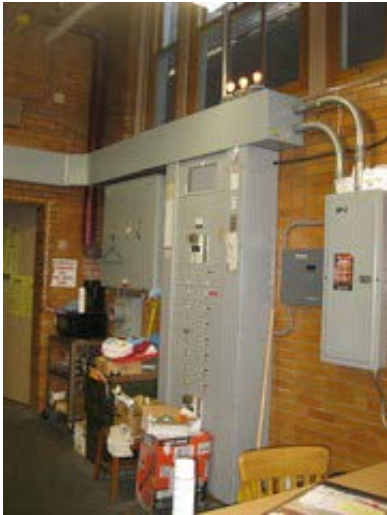
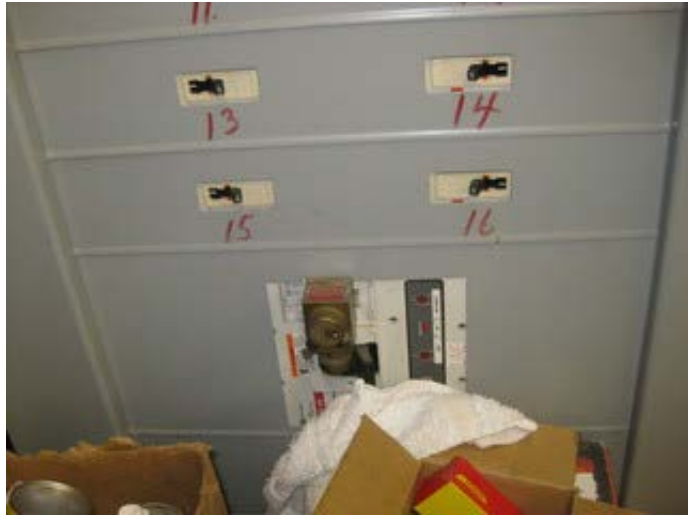
**Rating:** 3 Needs Replacement

**Recommendations:** The electrical system down stream of the main electrical gear requires replacement to meet Ohio School Design Manual guidelines for overall capacity due to poor condition and age of the panel boards.

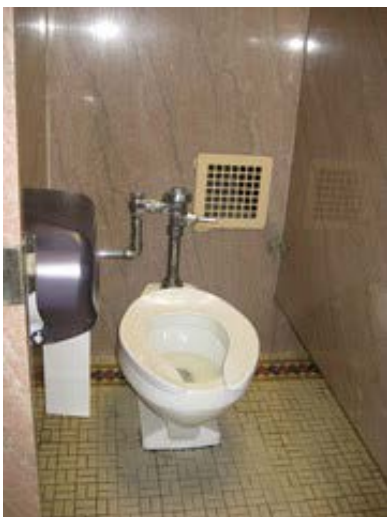
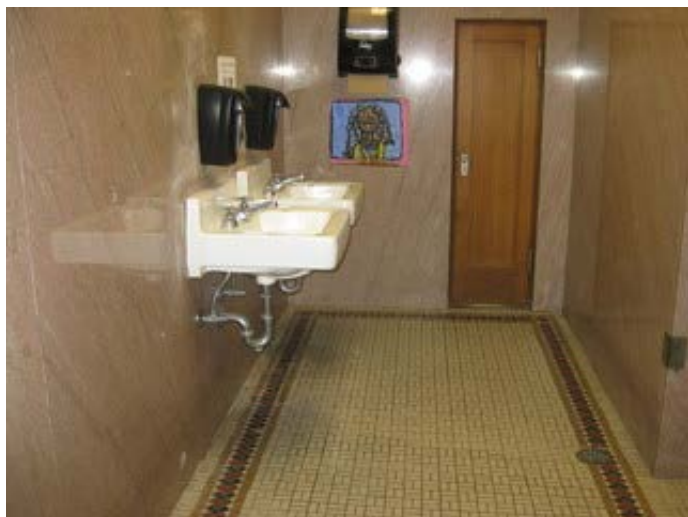
**Description:** The 4" domestic water supply piping is galvanized piping at the building entrance and throughout most of the building. There is a pressure reducing valve on the water service line but there is no backflow preventer. The pressure reducing valve appears to be in poor condition. There were no water pressure issues indicated by the staff. The galvanized piping continues to present periodic challenges for the staffs with leaks. A water treatment system is not required for the domestic water system. There is a small water softener for the boiler water make-up. Approximately 2007, Prestige 200 MBH water heater with storage tank with a recirculation pump provides the domestic hot water for the building. The water heater appears to be in good condition. One men's and one women's staff toilet has been upgraded with new fixtures and electronic sensor faucets. The rest of the building has no electronic sensor faucets and flush valves. All of the toilets are floor mounted. The plumbing fixtures are generally in good to fair condition. The school contains 4 restrooms for boys, 4 restrooms for girls, and 7 restrooms for the staff. There are 23 LAVs, 42 toilets, 2 ADA toilets, 15 urinals. There are 4 classroom sinks in good condition, but the faucets are in fair to poor condition. The LAVs have manual faucets in fair to poor condition and showing age. There are 8 drinking fountains in the school in generally good condition. There is no kitchen in this school.

**Rating:** 3 Needs Replacement

**Recommendations:** Provide all of the faucets and flush valves with sensors and low flow fixtures to meet OSFC requirements. Replace the galvanized piping and classroom sink faucets. 01-27-16 UPDATE: INSTALL A MIXING VALVE ON THE DOMESTIC WATER HEATER. REPLACE SANITARY WASTE PIPING IN 1928 ORIGINAL BUILDING AND 1954 ADDITION.

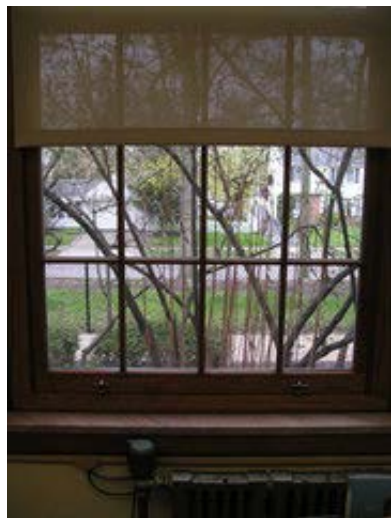
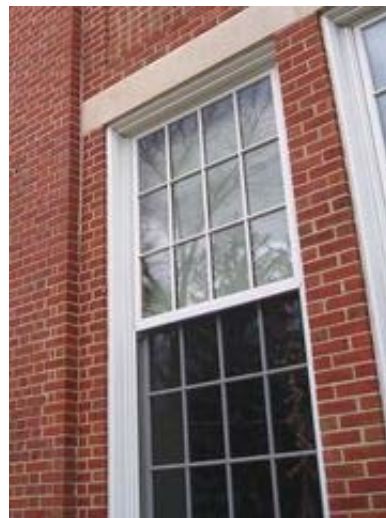
**Rating:** 2 Needs Repair

**Recommendations:** No work is recommended at this time. 01-27-16 UPDATE: REPLACE TRANSOM OVER EXTERIOR DOOR ON 1928 ORIGINAL BUILDING AND 1954 ADDITION. REPLACE INSECT SCREEN ON 1928 ORIGINAL BUILDING.
