# SHAKER HEIGHTS

## FACILITY ASSESSMENT

Bertram Woods Branch Library

January 19, 2022 - Revision 1

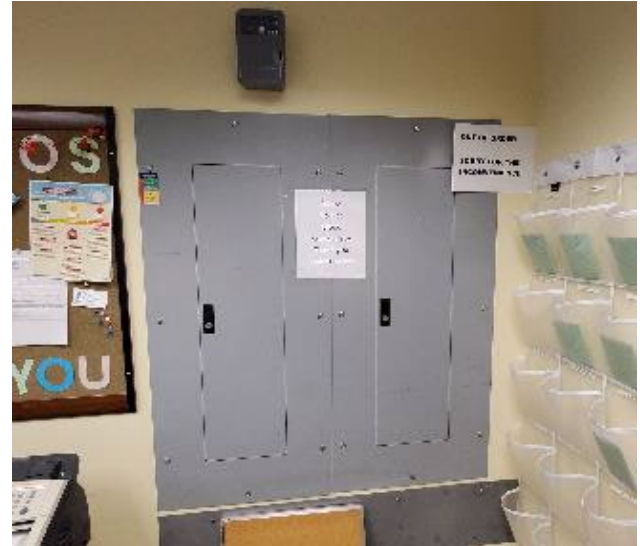
2002 Panelboards

- The building contains two electrical services: a 400A, 208/120V, 3-phase service and a 200A, 208/120V, 3-phase service. The building does not have an emergency generator.
- Most of the electrical equipment is old and in poor condition.
- Three panelboards were installed in 2002. These are in good condition and do not need replacement.

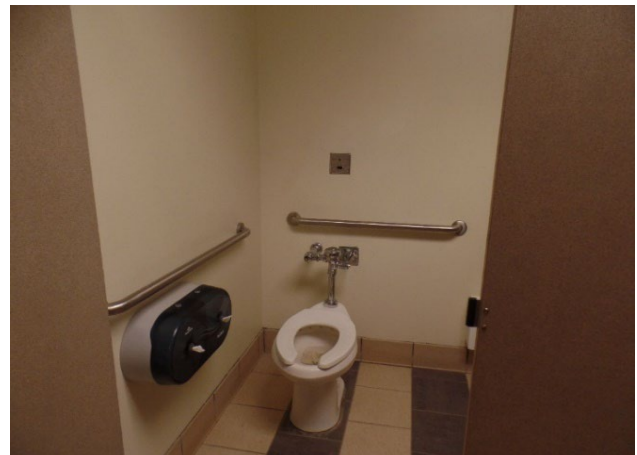
ADA Stall

- The facility contains one Men's Restroom, one Women's Restroom, and one Staff Restroom. The Men's Restroom contains one floor-mounted toilet with flush valve, one wall-mounted urinal with flush valve, and one wall-mounted lavatory. The Women's Restroom contains two floor-mounted toilets with flush valves and one wall-mounted lavatory. The Staff Restroom contains one floor-mounted tank type toilet and one wall-mounted lavatory. The public restrooms are ADA-compliant; the Staff Restroom is not. The fixtures are in good condition. Fixtures have electronic sensors.

- Replace plumbing fixtures

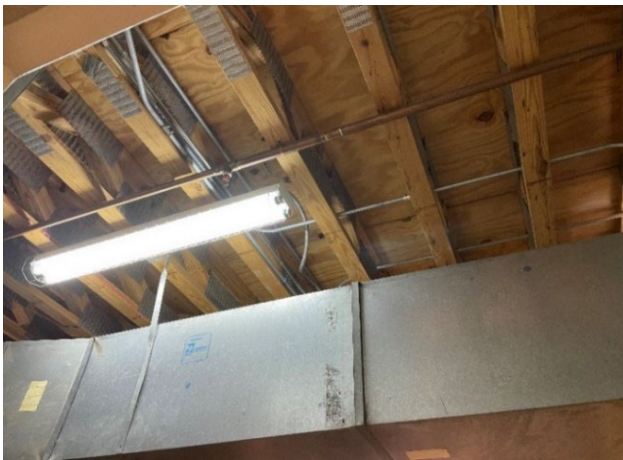
Wood Truss Joist Structure over Basement

- Existing conditions require no renovation or replacement at the present time.

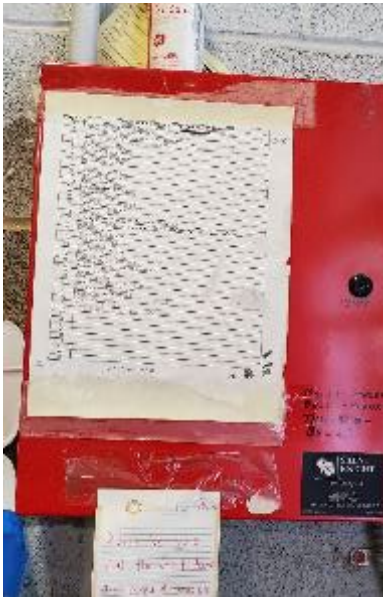
Main Fire Alarm Panel

- Existing conditions require no renovation or replacement at the present time. Include costs for relocation of existing devices and additional devices due to interior building alterations.
