Building Information - Shaker Heights City (44750) - Mercer Elem

Building Pictures - Shaker Heights City(44750) - Mercer Elem(24307)

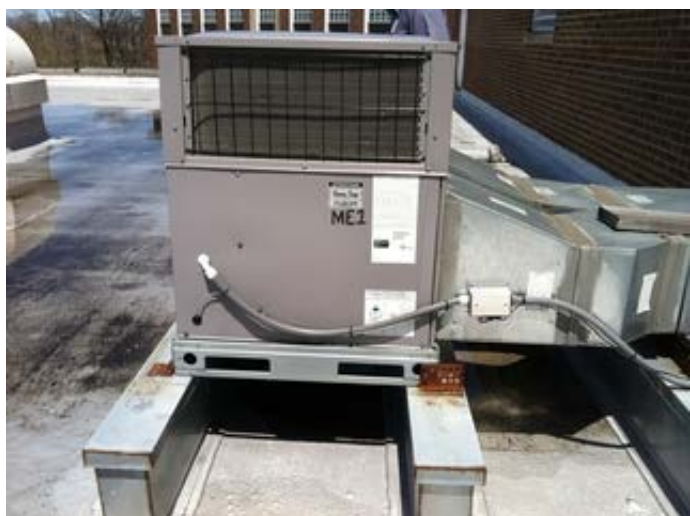
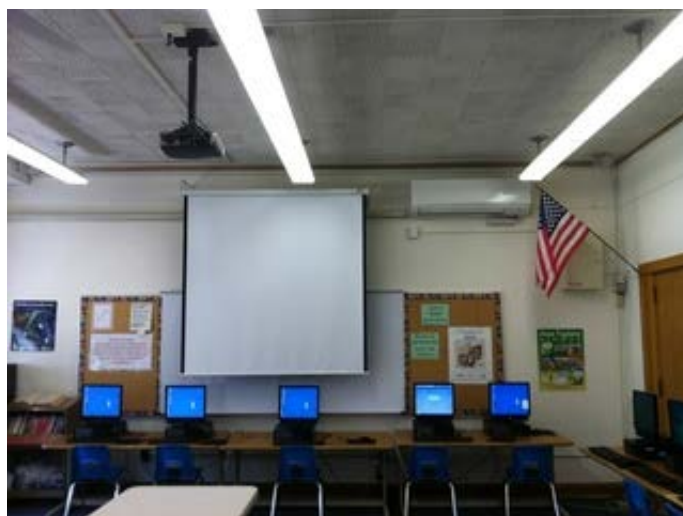
C. Ventilation / Air Conditioning

Description: There is a 5 ton Rooftop unit, 2011, serving the office area and a wall AC unit with an outdoor air cooled condensing unit serving the Data Closet. The computer room has two, Mitubishi wall air conditioning units with air cooled condensing units. There is no other air conditioning in the school. The air conditioning equipment is in good condition. There is no air conditioning in the classrooms. The ventilation system in the building generally does not meet the OBC fresh air requirements. The overall system is not compliant with Ohio School Design Manual requirements. The general building exhaust systems located in the restrooms are functional and in satisfactory condition.

Recommendations: Provide an air conditioning system to meet OBC and OSDM requirements. Pricing included in Item A.
