Building Information - Shaker Heights City (44750) - Shaker Heights Middle School

Program Type	Classroom Facilities Assistance Program (CFAP) - Regular
Setting	Urban
Assessment Name	Shaker Heights MS Assessment - Shaker Heights CSD - CFAP Update (11-2-21)
Assessment Date (on-site; non-EEA)	2015-02-09
Kitchen Type	Full Kitchen
Cost Set:	2016
Building Name	Shaker Heights Middle School
Building IRN	4457
Building Address	20600 Shaker Blvd
Building City	Shaker Heights
Building Zipcode	44122
Building Phone	(216) 295-4100
Acreage	22.76
Current Grades:	7-8
Teaching Stations	32
Number of Floors	2
Student Capacity	1184
Current Enrollment	861
Enrollment Date	2014-04-23
Enrollment Date is the date in which the current enrollment was taken.	
Number of Classrooms	24
Historical Register	NO
Building's Principal	Danny Young
Building Type	Middle

Building Pictures - Shaker Heights City(44750) - Shaker Heights Middle School(4457)

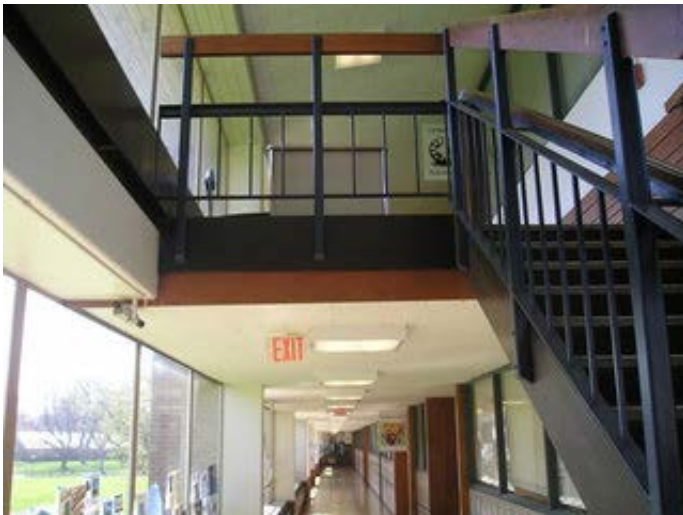
Item	Cost	Unit	Whole Building	Auditorium (1955) 6,935 ft²	Natatorium (1955) 7,034 ft²	Original Building (1955) 153,115 ft²	Sum	Comments
Sprinkler / Fire Suppression System:	\$3.20	sq.ft. (Qty)		6,935 Required	7,034 Required	153,115 Required	\$534,668.80	(includes increase of service piping, if required)
Interior Stairwell Closure:	\$5,000.00	per level				6 Required	\$30,000.00	(includes associated doors, door frames and hardware)
Water Main	\$40.00	in.ft.				500 Required	\$20,000.00	(new)
Handrails:	\$5,000.00	level				6 Required	\$30,000.00	
Other: Backflow Preventer	\$8,500.00	per unit		1 Required			\$8,500.00	Install New Backflow Preventer
Other: Attic Sprinklers	\$3.50	sq.ft. (Qty)		74,672 Required			\$261,352.00	Pre-Action Fire Suppression System for Affic Space
Other: Handrails	\$43.00	in.ft.				150 Required	\$6,450.00	Replace Handrails @ Interior Stairs
Other: Provide safety glass at all interior door vision panels and adjacent sidelights and transoms	\$358,200.00	lump sum				Required	\$358,200.00	Current codes required safety provisions for glass adjacent to doors or near the floor.
